# STRUCTURAL AND USE STUDY OF CITY HALL EAST

PREPARED for  
**CITY OF FORT BRAGG**

MAY 2010

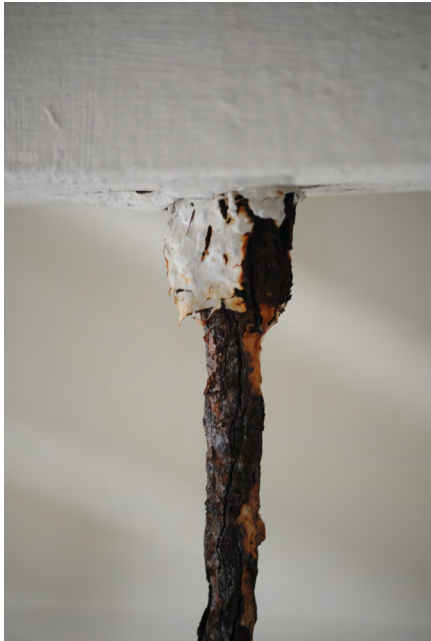
HEAVILY CORRODED STEEL ROD SUPPORT HANGERS AT CATWALK

- The catwalk at the west end of the building has badly deteriorated steel rod support hangers (see photo, this page). We cannot determine a reliable capacity for these members.
- The pool truss heel connections are also severely deteriorated (see photo, this page). It is assumed that the bolts through the connection have not corroded to the same extent as the exposed steel plate and are providing the strength in this connection but it is not readily apparent.

- Post the pool space with “Do Not Enter”. Lock or close off access to all spaces within the pool building and the catwalk area.  
OR
- Provide temporary strengthening to the truss connections, and shore or remove the entire catwalk, if it is desired to provide limited access by maintenance personnel.

deterioration of truss connections and the catwalk support members the indoor pool. At the time of this writing, it is not clear what is providing the support for either of these systems. It is important that the catwalk be removed or shored and the truss heel connections be strengthened with a temporary method of strengthening as indicated in this report. It is also highly suggested that very limited access be afforded this space until such remediation measures are completed.

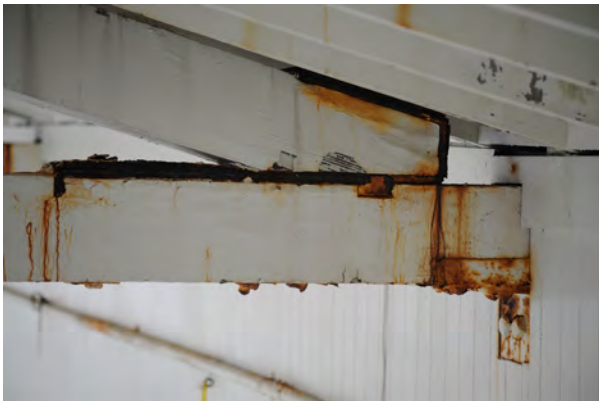
The pool truss is a classic Howe Truss that has been modified since the original construction. The connections are showing heavy corrosion and deterioration, with the worst exhibited at the heel joints. The condition of the steel plates at the joint are severely deteriorated.

HEAVILY CORRODED POOL TRUSS HEEL CONNECTION

A suggested temporary fix for the truss heel connection is provided as Detail 9/S3.0 in this report. Note that this is only temporary and must also be coupled with limited personnel access.

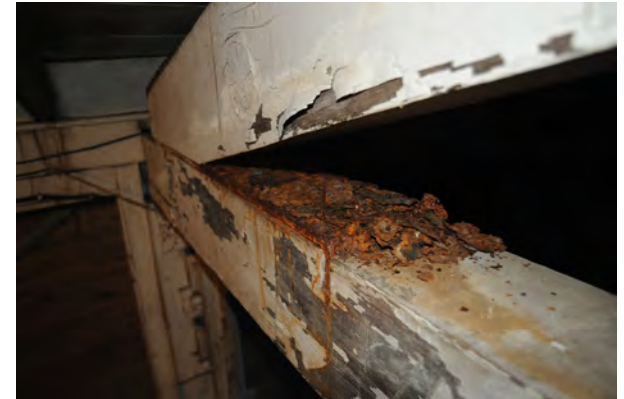
HEAVILY CORRODED POOL TRUSS HEEL CONNECTION IN SOUTH WING LOW BAY SPACE

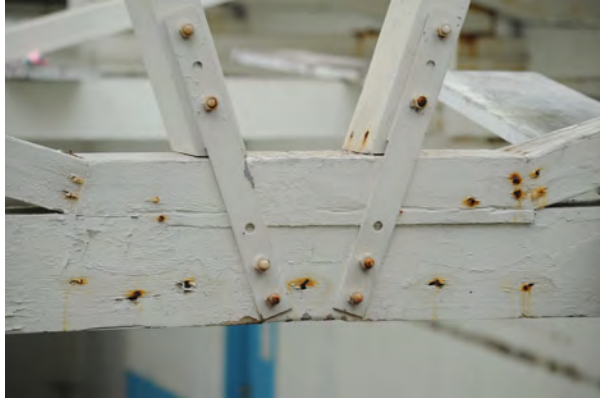
POOL TRUSS SHOWING FORMER REPAIR WORK

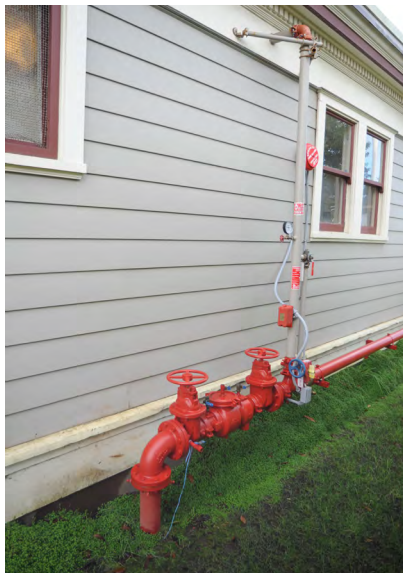
FIRE SPRINKLER RISER SERVING CITY HALL EAST
