UST Enforcement Unit Inspection Report Form

CERS ID	10586686	Inspection Date		9/9/2022	
Facility Name	Reese Classic's	Inspector Name		Douglas McDevitt / Troy Cox	
Facility Address	225 N Main St	Time In	1130	Time Out	1245
Consent to Inspect (Name)	Mohammad Obeid	Consent to Inspect (Title)		Property Attendent	
Underground Storage Tank System Description					
Tank Construction			Tank Contents and Capacity		
Containment	Material	No.	Contents	Capacity (gals)	
Double Walled	Fiberglass	1	87 regular	12,000	
Double Walled	Fiberglass	2	91 premium	12,000	
Piping					
Piping Construction		No.	Transmission		
Double Walled Fiberglass		1	Pressure/Turbine Sump/		
Double Walled Fiberglass		2	Pressure/Turbine Sump/		
Piping Monitoring Methods					
Double Walled Piping		No.	Single Walled Piping		No.
Continuous Monitoring/LLD/Pump Shutdown/Annual Piping Integrity Test		1			
Continuous Monitoring/LLD/Pump Shutdown/Annual Piping Integrity Test		2			
Dispenser Pan Monitoring		No.	Automatic LLD Detector Type		No.

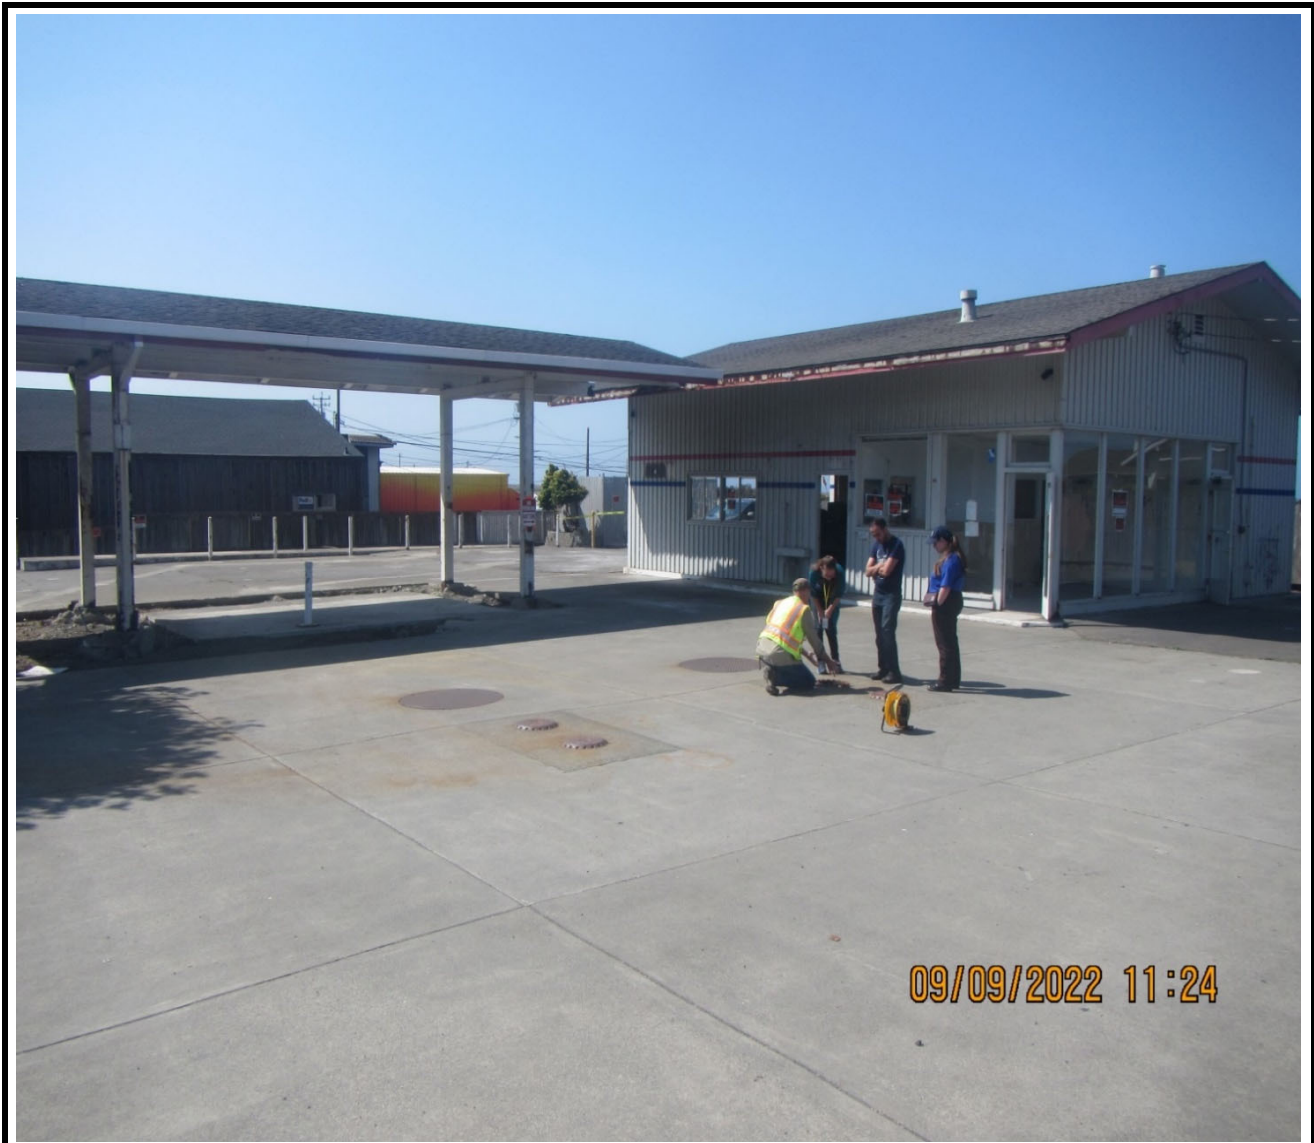
Photo No. IMG_0001-Overview of service station with the two tanks in the foreground

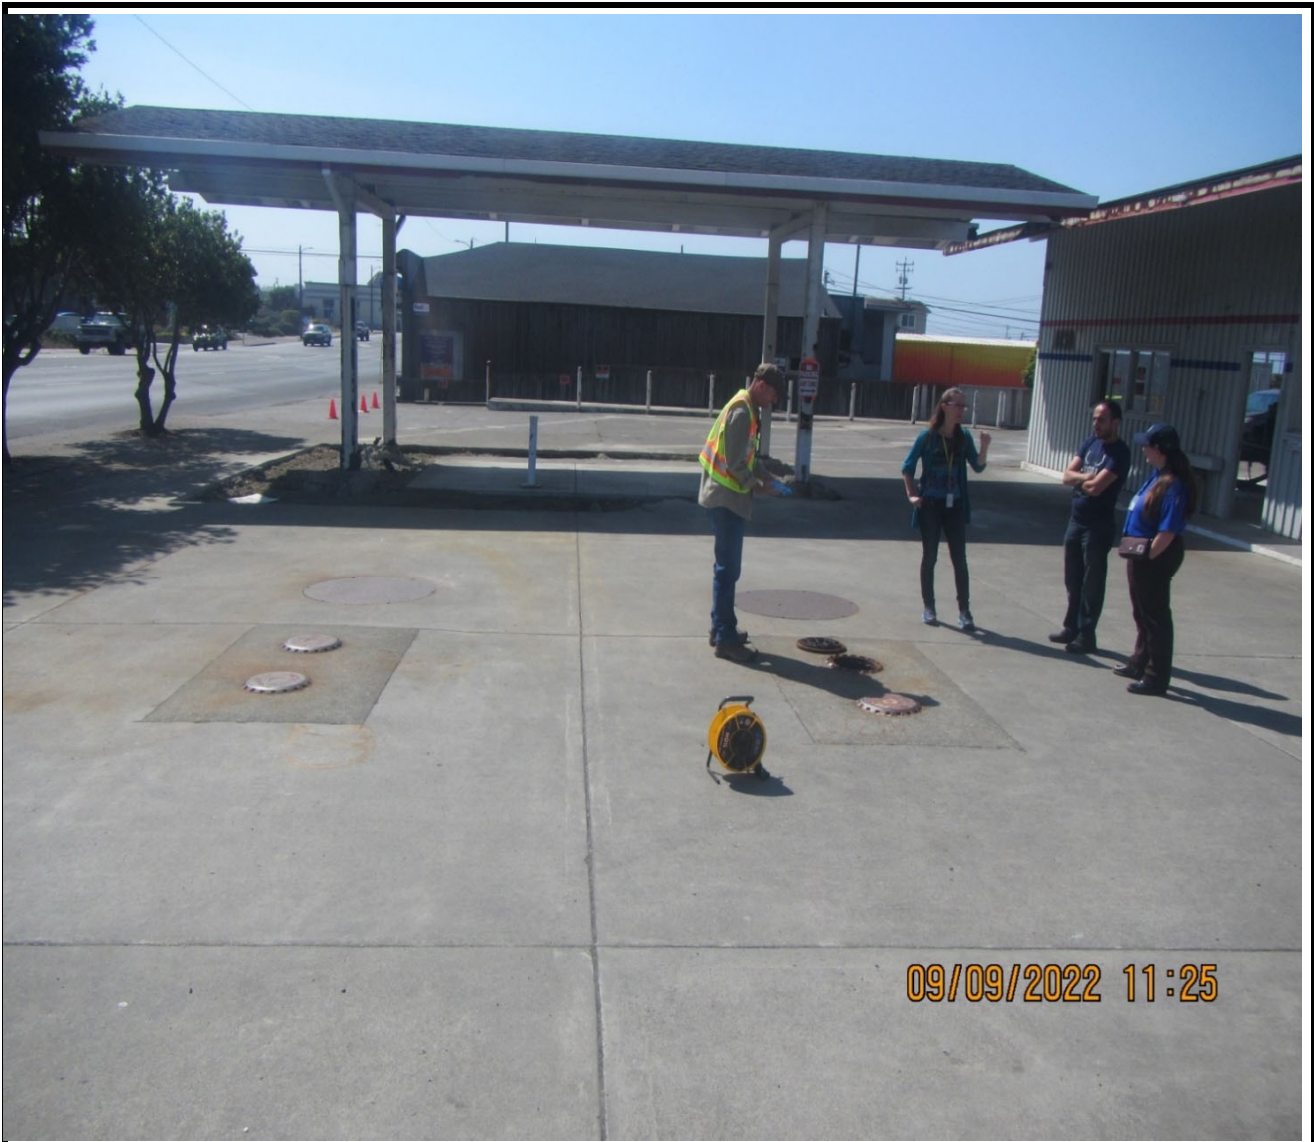
Photo No. IMG_0003-Overview of tank locations

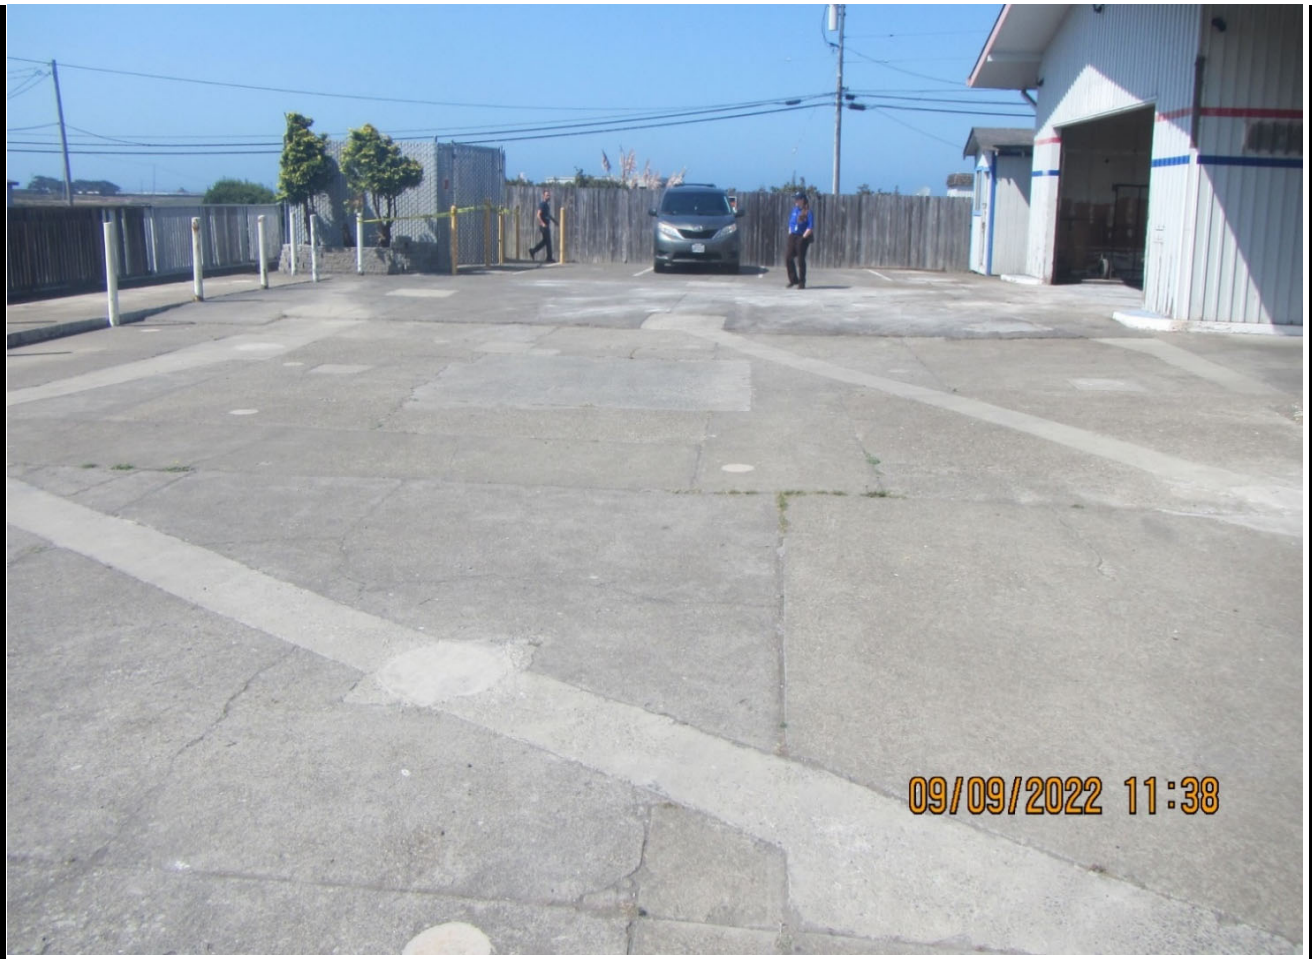
Photo No. IMG_0005-Overview of pavement patches from former site remediation and investigation events.

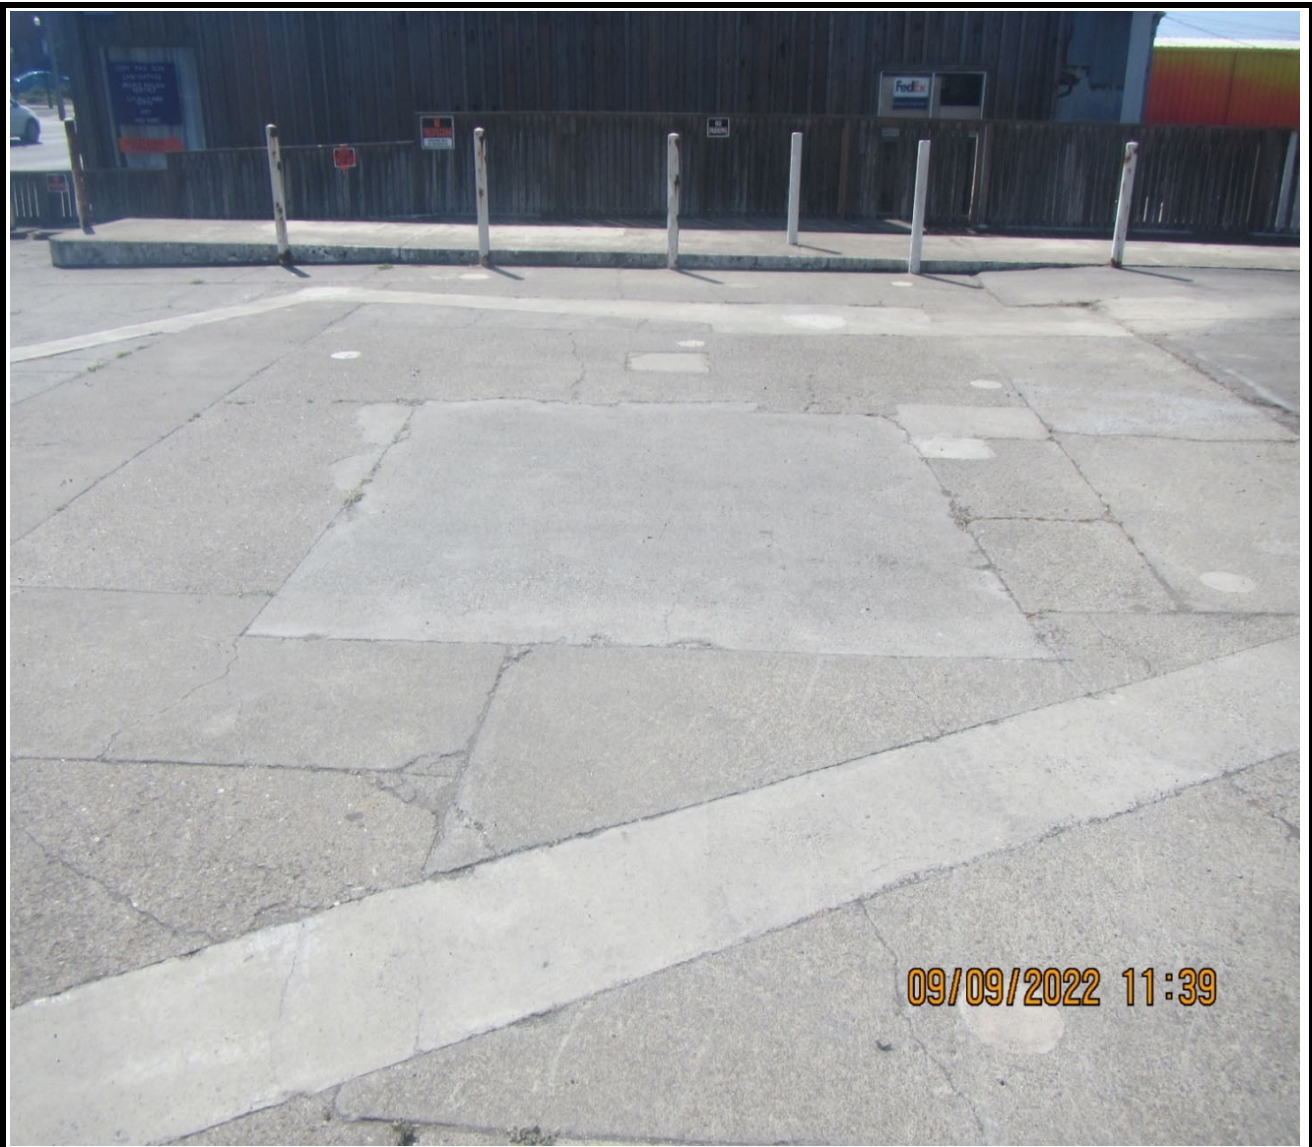
Photo No. IMG_0007-Close-up of possible former UST location

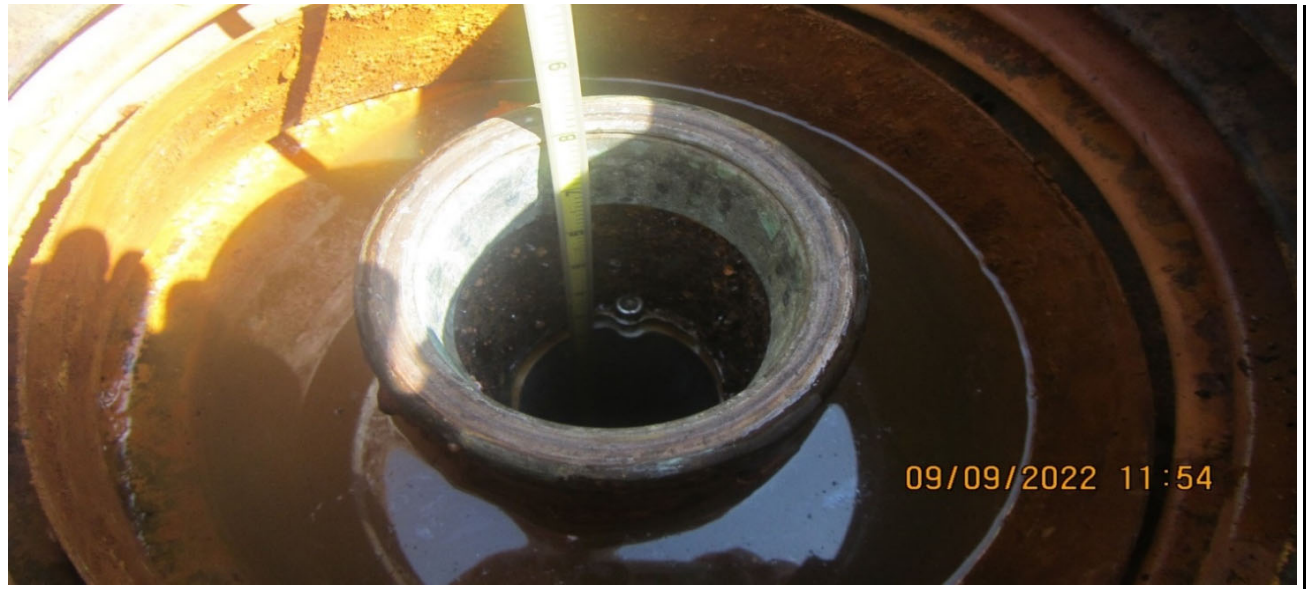
Photo No. IMG_0008-Tape measurement of product level inside tank one, western tank.

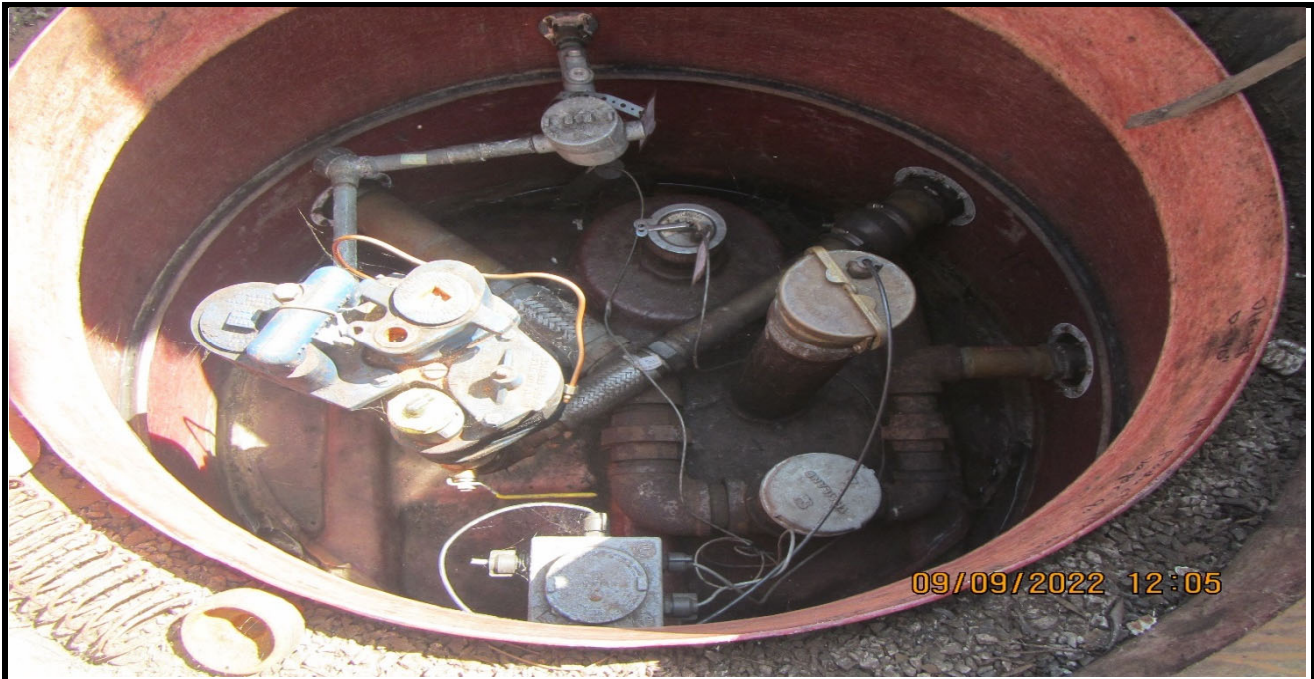
Photo No. IMG_0009- Tank one, western tank turbine sump

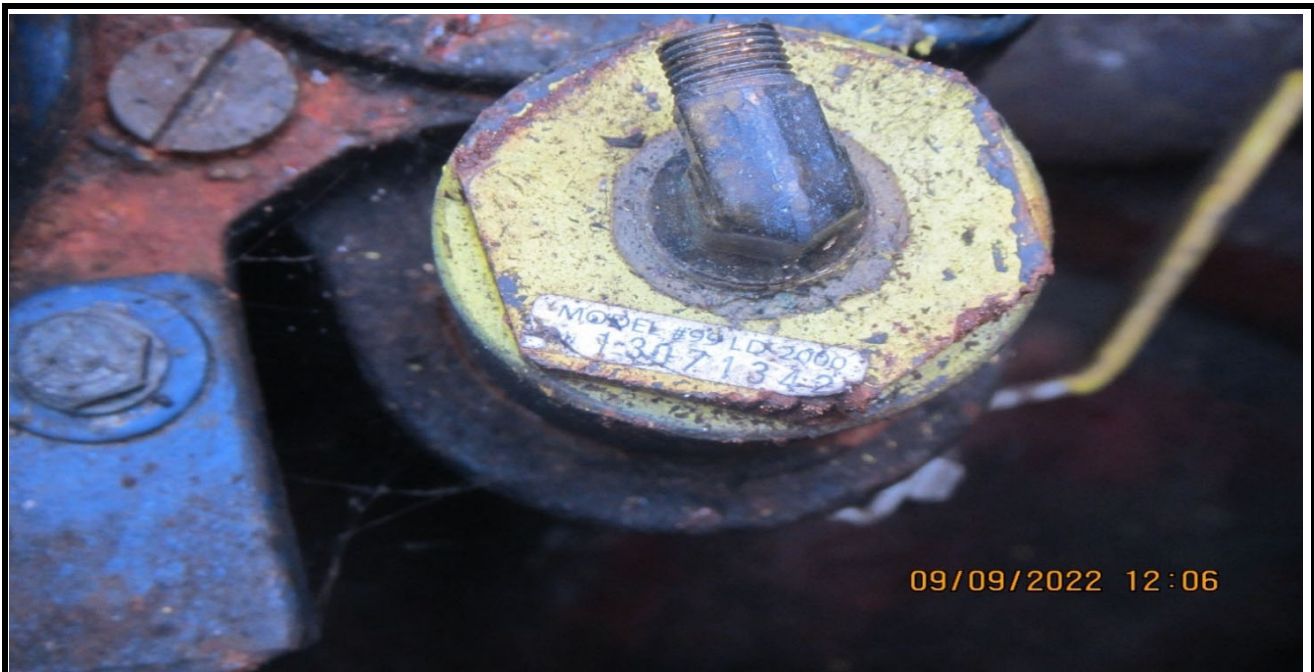
Line leak detectors shared the same serial number 99 LD-200. The Vaproless website specifies this LLD can be used with Alcohols, Biodiesel, Aviation, Gasoline, Diesel. The scent of diesel was not detected. Mr. Obied reports no diesel at the facility. Detail consistent with google maps evidence.		
Two underground storage tanks were located on the property. A third above ground tank, 350 gallons, was located behind the structure. Evidence of demolition operations visible in relation to product some piping, absent dispensers and absent UDCs.

Photo No. IMG_0010-LLD inside tank one, western tank turbine sump

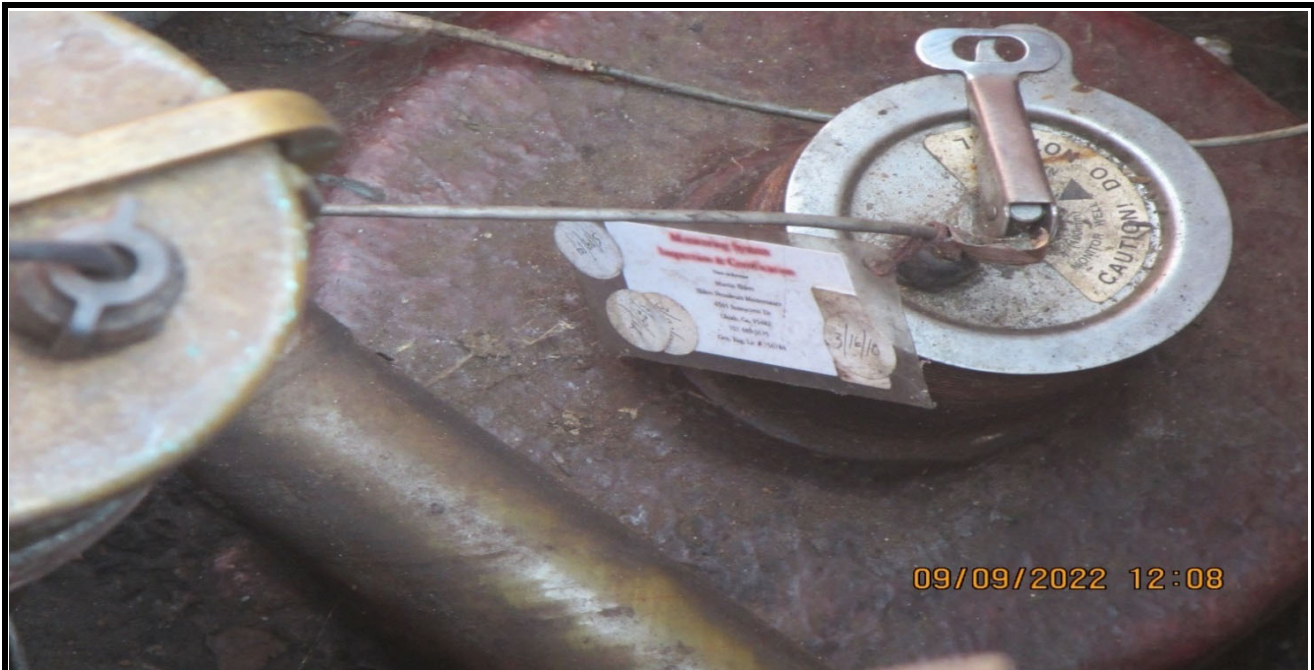
Photo No. IMG_0014-Close-up of annular space sensor riser for tank one, western tank

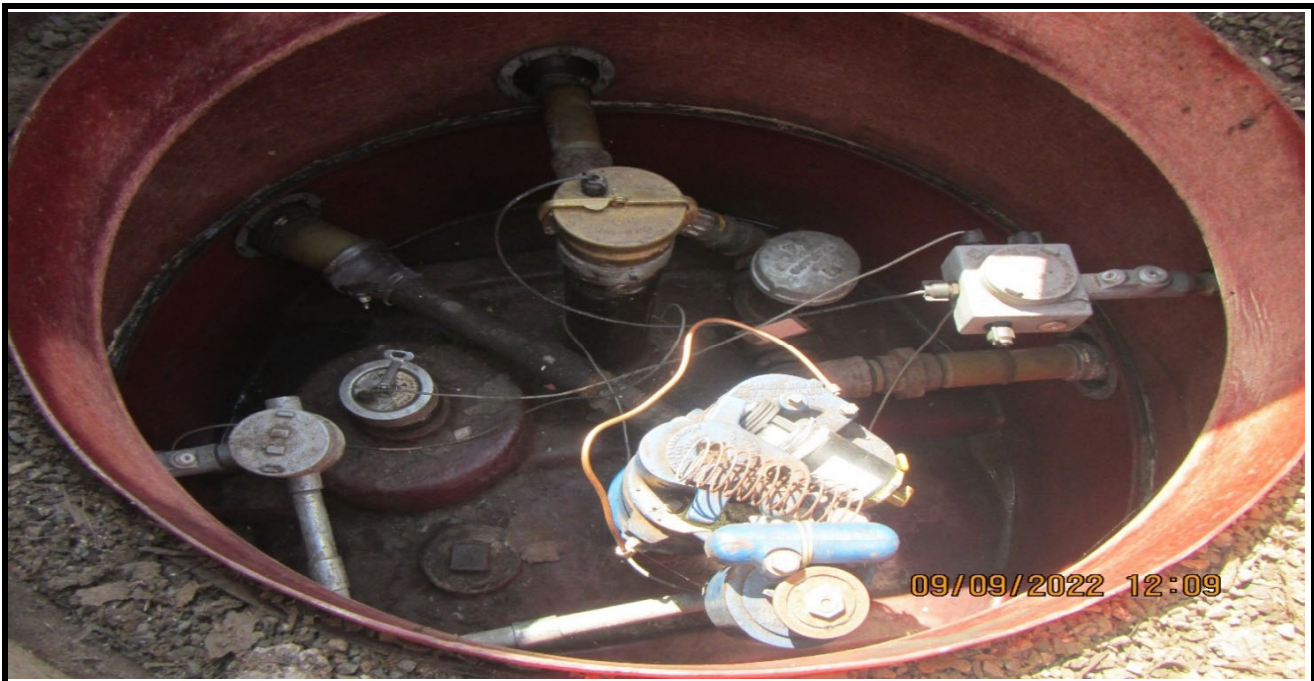
Photo No. IMG_0017-Turbine Sump of tank two, eastern tank

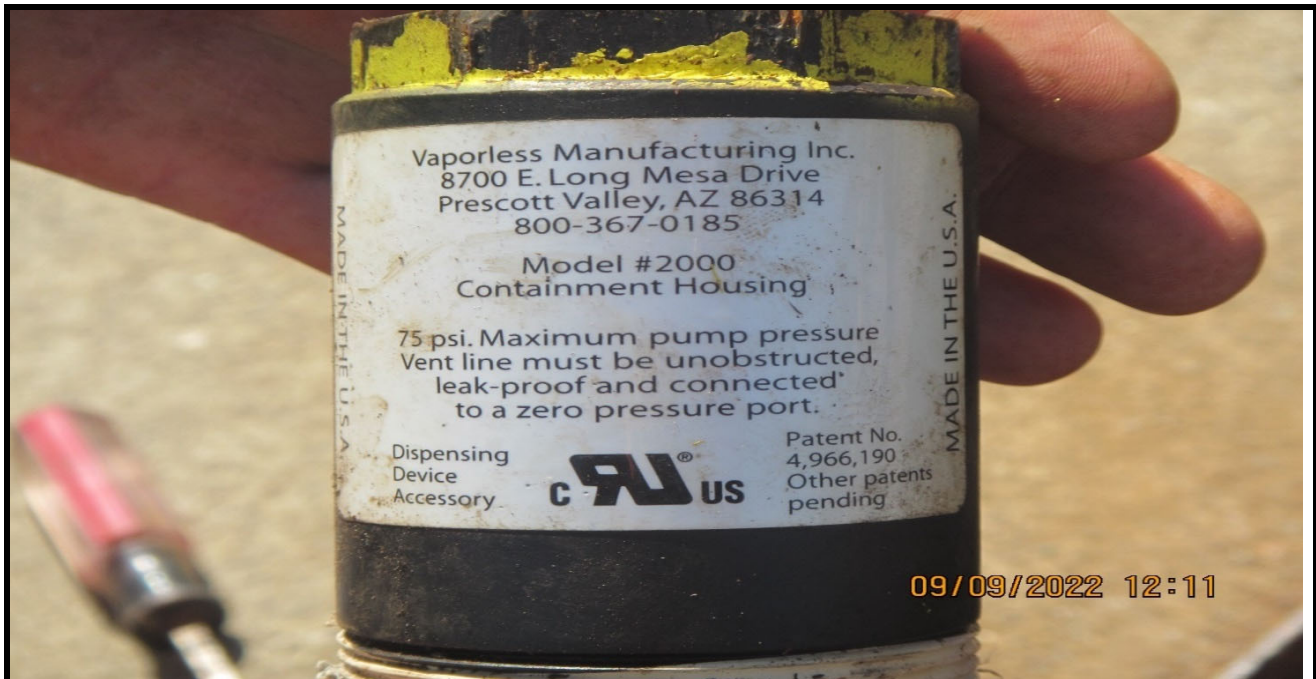
Photo No. IMG_0022-Close-up of LLD inside tank two, eastern turbine sump

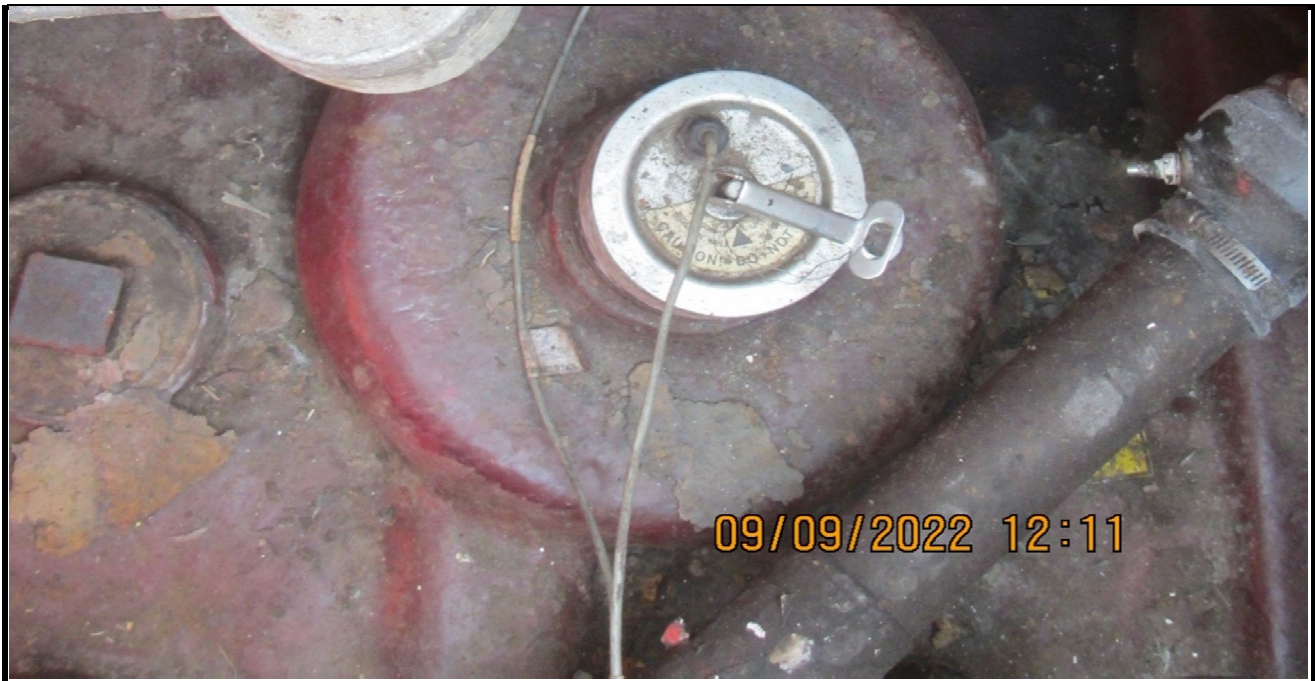
Photo No. IMG_0024-Close-up of annular space sensor riser for tank two, eastern tank

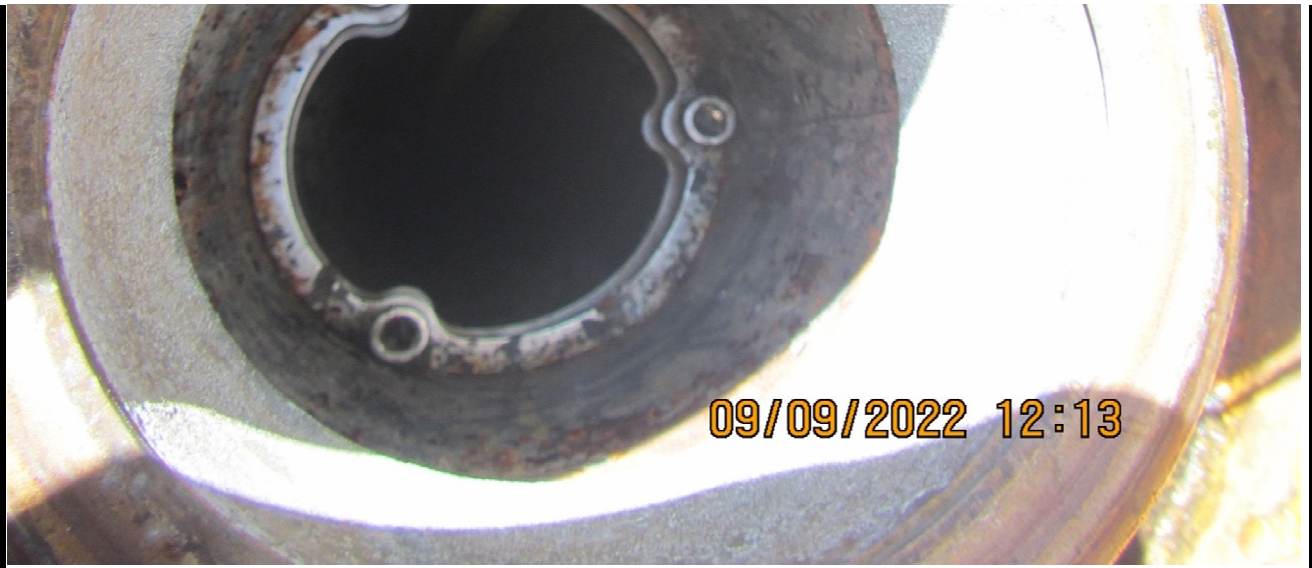
Photo No. IMG_0025-Tape measurement of product level inside tank two, eastern tank
