**Kennedy/Jenks Consultants**  
**Engineers & Scientists**

31 January 2017

Subject: Structural Assessment of Storm Damage  
Dry Shed No. 4  
Georgia-Pacific  
Fort Bragg, California  
K/J 1665018\*04

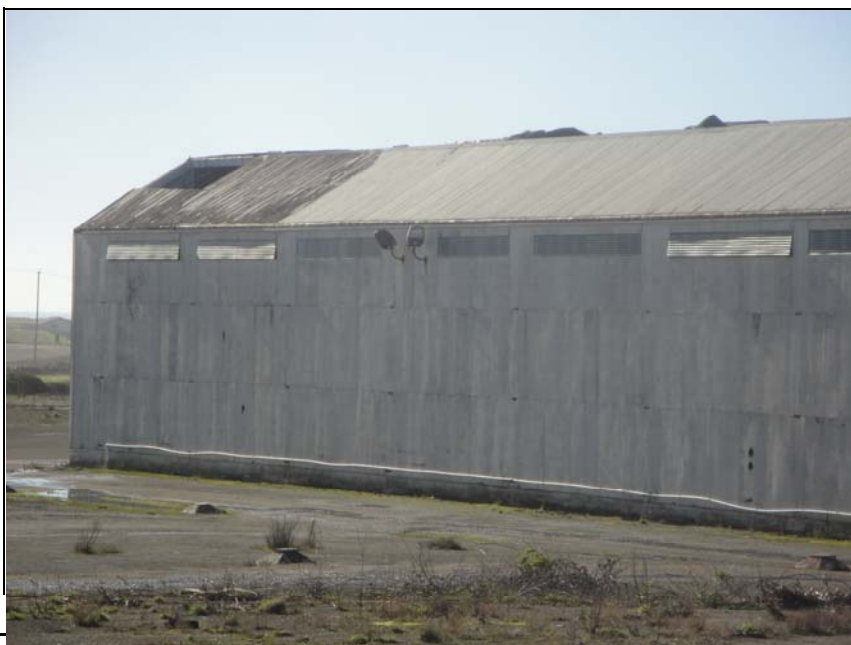
5. The loss of the plywood at two openings in the roof as well as the loss of the girder in the beam seat on the southeast corner of the building removes the strength of the roof diaphragm connection to the south wall of the building in the southeast corner. It also appears that another approximately 16'-0" x 8'-0" section of roof is about to be lost from the building in the southeast corner. The remaining roof girders appeared to be in adequate condition still supporting and attaching the south gable wall to the remainder of the roof.

**Photo #3:**  
Dry Shed #4 East Side with  
Roof Damage in Southeast  
Corner; 16'-0" x 8'-0"  
Opening

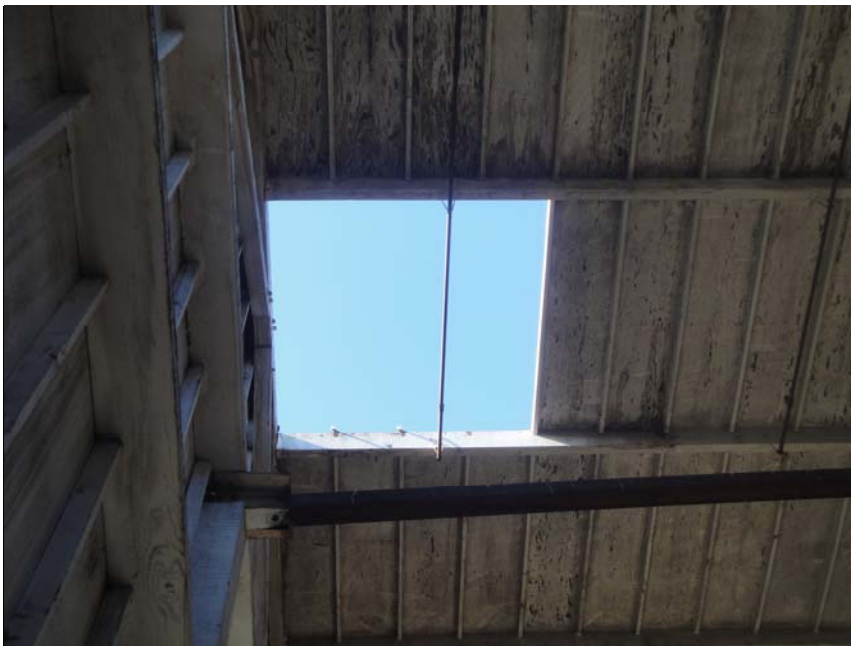
**Photo #10:**

3. An approximately 8'-0" x 8'-0" damaged open area in the plywood sheathing and roof purlins was observed in the roof of the building near the southeast corner of the building. See Photos 6, 7, 8, and 10.

Dry Shed #4 Roof Damage and 8'-0" x 8'-0" Opening in Southeast Corner; Loss of Plywood Sheathing and 2x4 Purlins

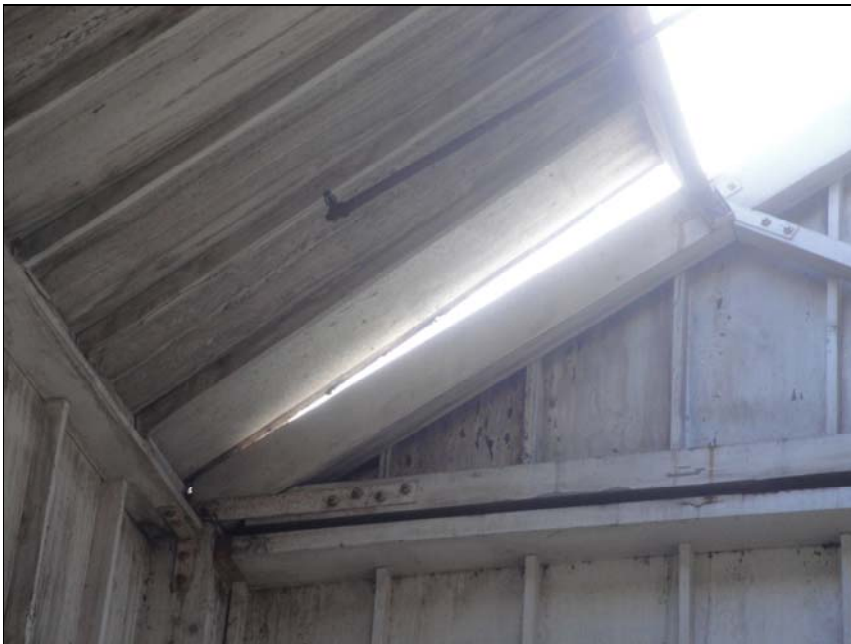
**Photo #11:**

4. Besides the loss of the plywood sheathing and purlins one of the girders supporting and attaching the south transverse wall to the building has pulled out of its beam hanger and has failed. See Photo 11.

Dry Shed #4 East Side with Roof Damage in Southeast Corner; Rafter Pullout from Beam Seat

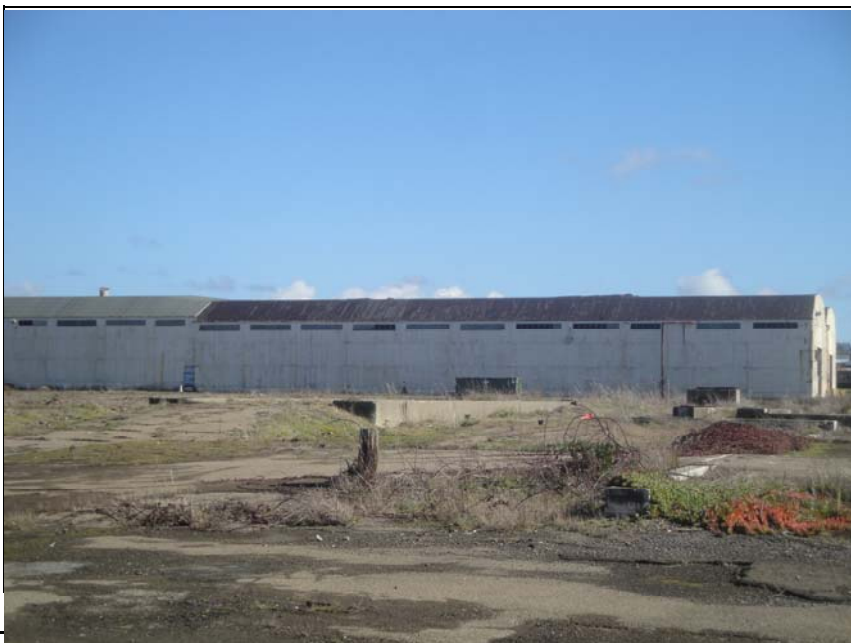
**Photo #12:**

8. There is a large area on the south half of the building where the modified bitumen roof material has blown off and has collected and blocks the roof drainage depression between the two roofs. There is extensive modified bitumen roofing material debris along the entire length of the south half of the roof drain cricket. The APP Modified Bitumen roofing material used on the building roof was manufactured by Dibiten. See Photo 12.

Dry Shed #4 West Side with Loss of Modified Bitumen Material on Half of Roof
