***Re: November 27, 2017 City Council Meeting Regarding  
Dry Shed #4 Coastal Development Permit and Demolition***

Subject: Coastal Development Permit Application  
Former Georgia-Pacific Wood Products Facility  
90 West Redwood Avenue, Fort Bragg, Mendocino County, California

### **Coastal Development Permit Application**

Subject: Structural Assessment of Storm Damage  
Dry Shed No. 4  
Georgia-Pacific  
Fort Bragg, California  
K/J 1665018\*04

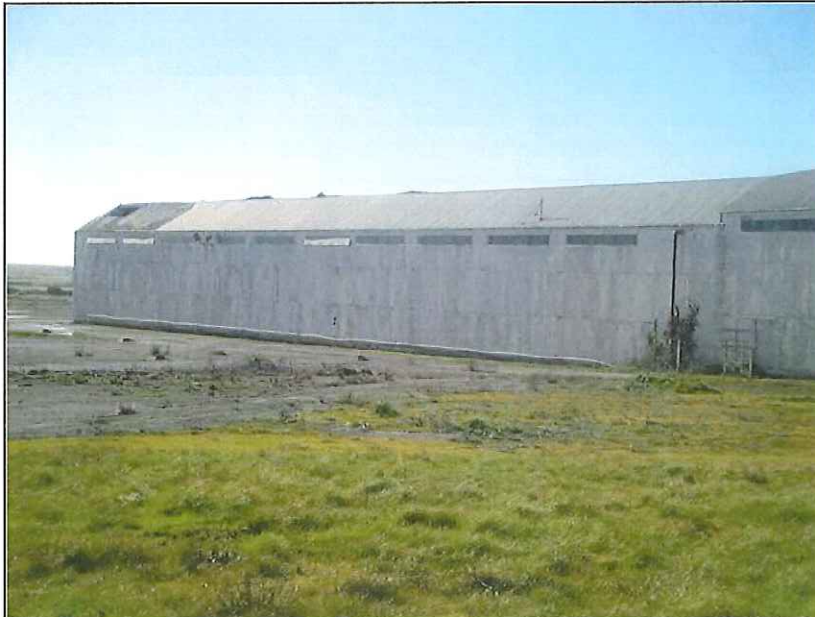
**Photo #1:**  
Dry Shed #4

**Photo #2:**  
Dry Shed #4 East Side with  
Roof Damage in Southeast  
Corner

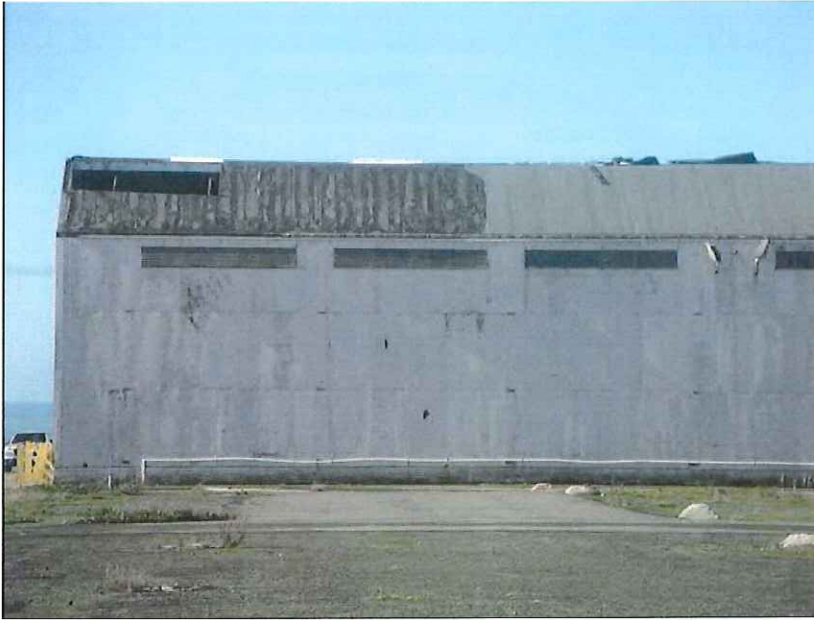
**Photo #4:**

Dry Shed #4 East Side with  
Roof Damage in Southeast  
Corner; 16'-0" x 8'-0"  
Opening

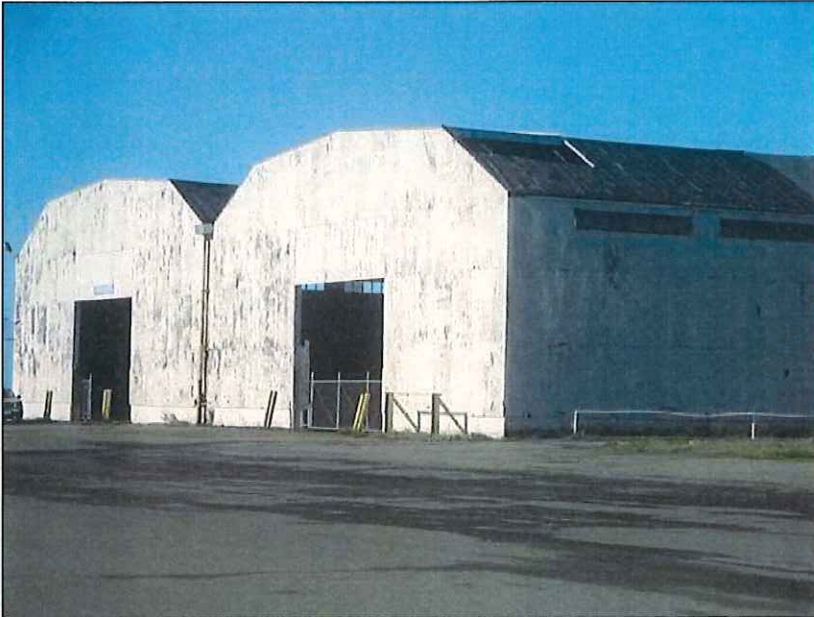
**Photo #5:**

Dry Shed #4 East Side with  
Roof Damage in Southeast  
Corner; 16'-0" x 8'-0"  
Opening

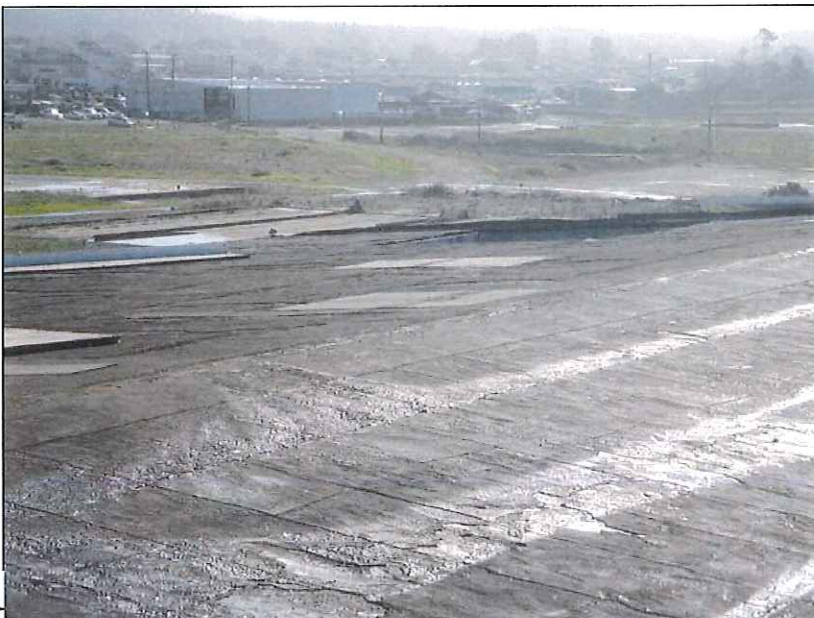
**Photo #6:**

3. An approximately 8'-0" x 8'-0" damaged open area in the plywood sheathing and roof purlins was observed in the roof of the building near the southeast corner of the building. See Photos 6, 7, 8, and 10.

Dry Shed #4 Roof Damage  
and 16'-0" x 8'-0" Opening  
in Southeast Corner

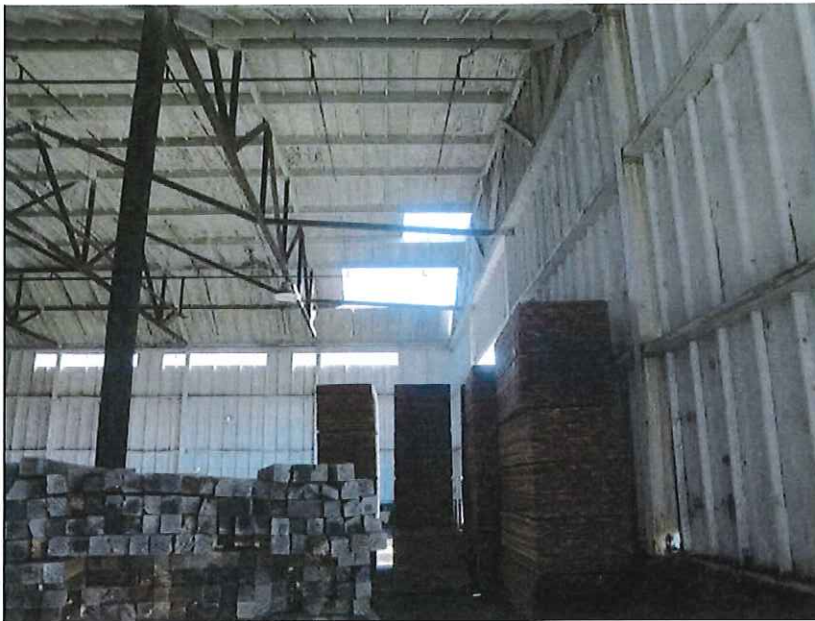
**Photo #7:**

Dry Shed #4 East Side with Roof Damage in Southeast Corner; Two Opening in Roof, Loss of 2x4 Purlins, Plywood Sheathing, and Modified Bitumen Roofing Material

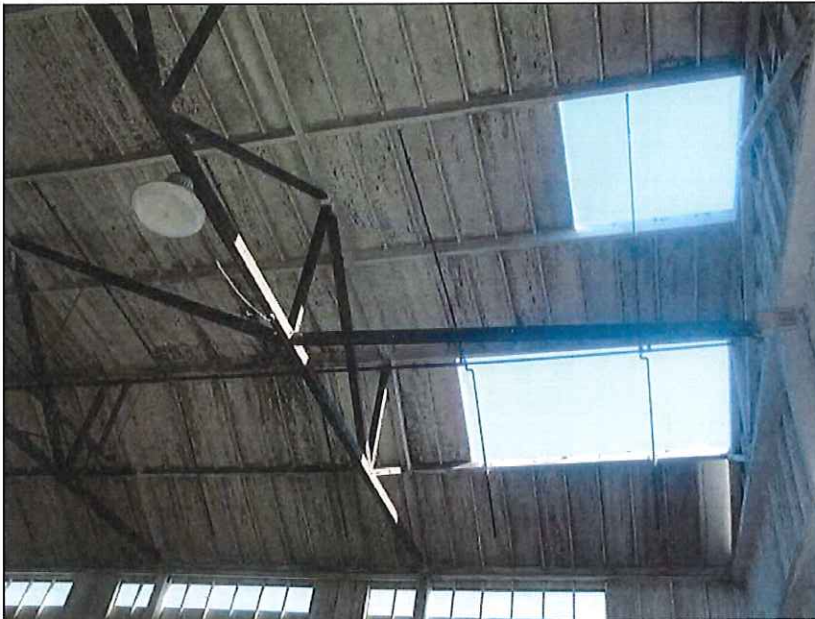
**Photo #8:**

Dry Shed #4 East Side with Roof Damage in Southeast Corner; Two Opening in Roof, Loss of 2x4 Purlins, Plywood Sheathing, and Modified Bitumen Roofing Material

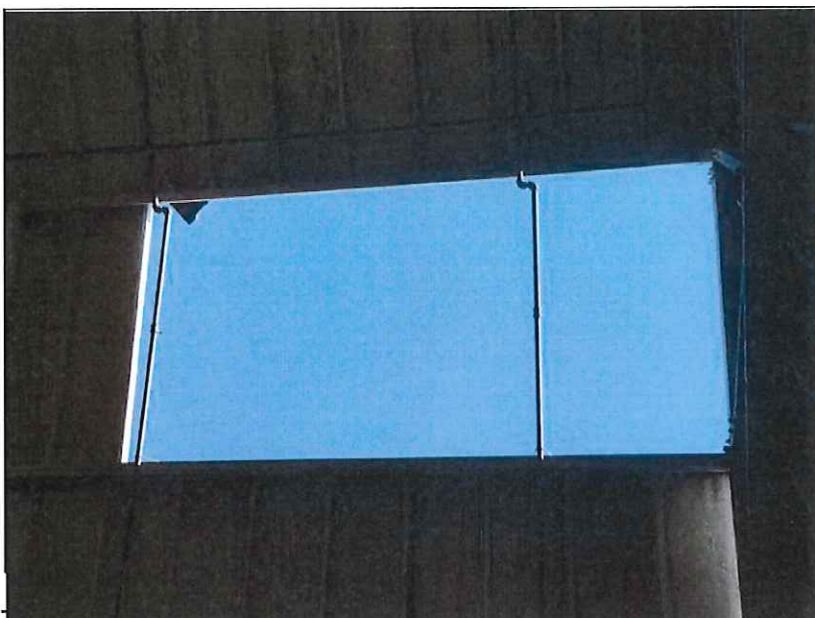
**Photo #9:**

Dry Shed #4 Roof Damage and 16'-0" x 8'-0" Opening in Southeast Corner; Loss of Plywood Sheathing and 2x4 Purlins

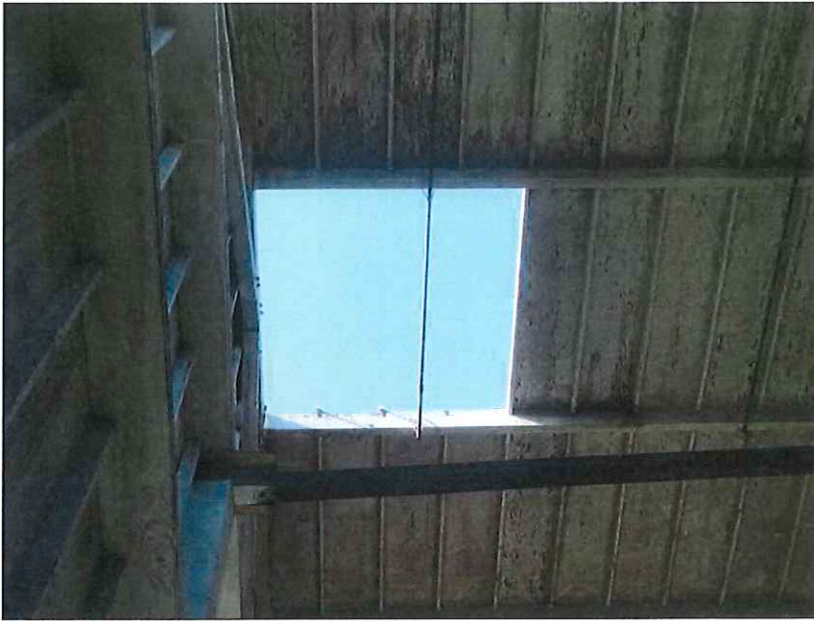
**Photo #10:**

Dry Shed #4 Roof Damage and 8'-0" x 8'-0" Opening in Southeast Corner; Loss of Plywood Sheathing and 2x4 Purlins

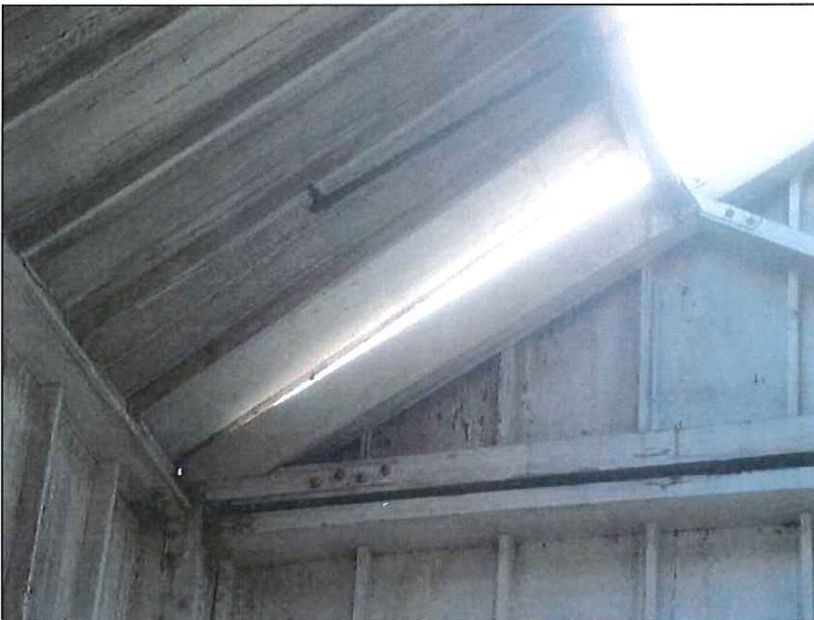
**Photo #11:**

4. Besides the loss of the plywood sheathing and purlins one of the girders supporting and attaching the south transverse wall to the building has pulled out of its beam hanger and has failed. See Photo 11.

Dry Shed #4 East Side with Roof Damage in Southeast Corner; Rafter Pullout from Beam Seat

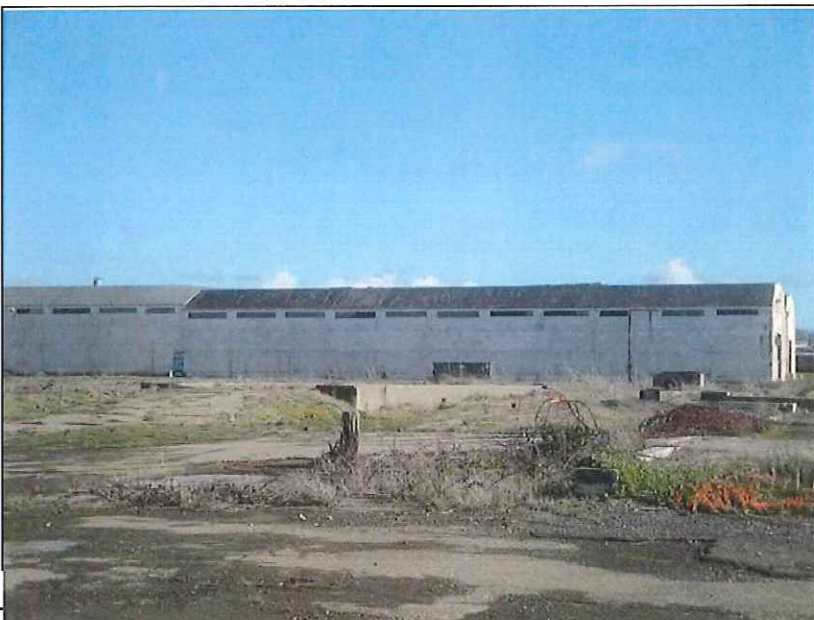
**Photo #12:**

Dry Shed #4 West Side with Loss of Modified Bitumen Material on Half of Roof

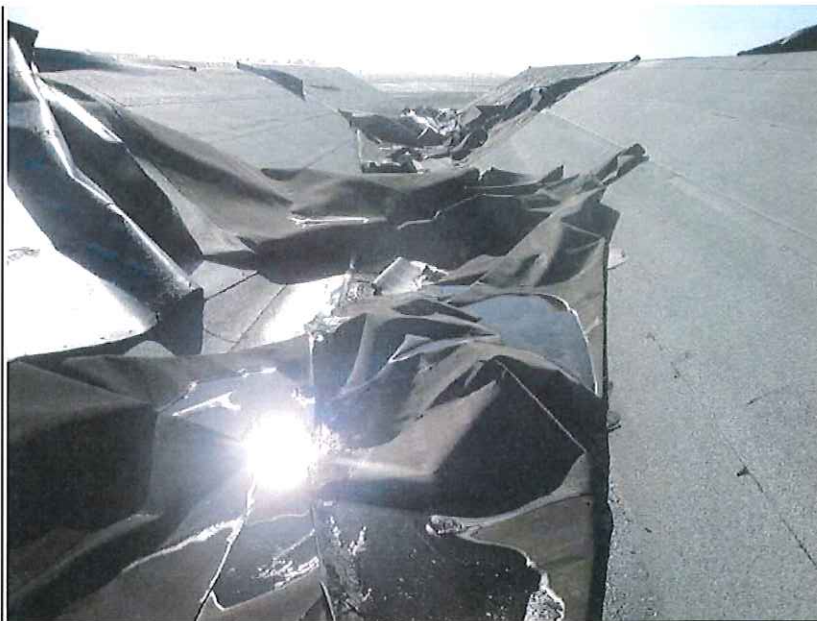
**Photo #13:**

Dry Shed #4 South Half  
Roof with Modified Bitumen  
Material in Roof Drain  
Cricket

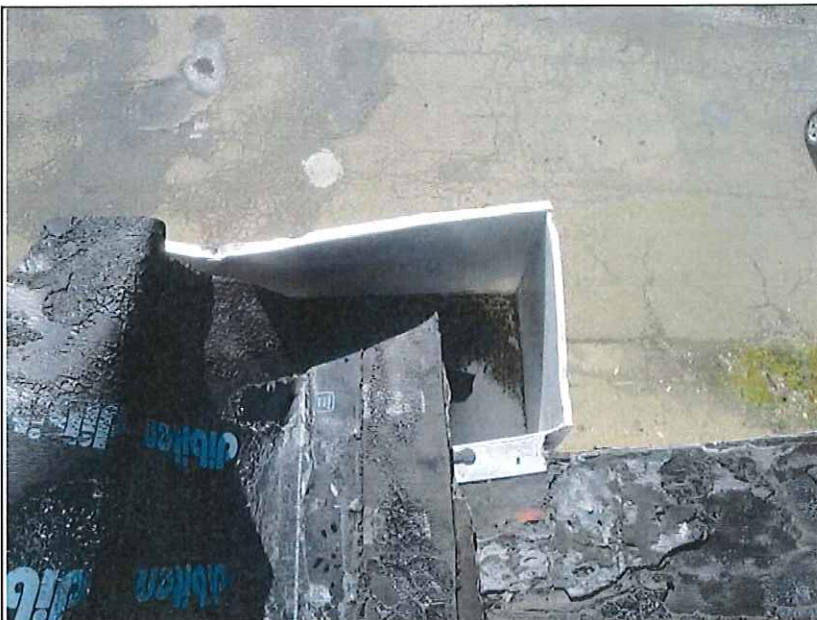
**Photo #14:**

Dry Shed #4 South Half  
Roof with Modified Bitumen  
Material in Roof Drain  
Cricket and Blocked  
Downspout Inlet

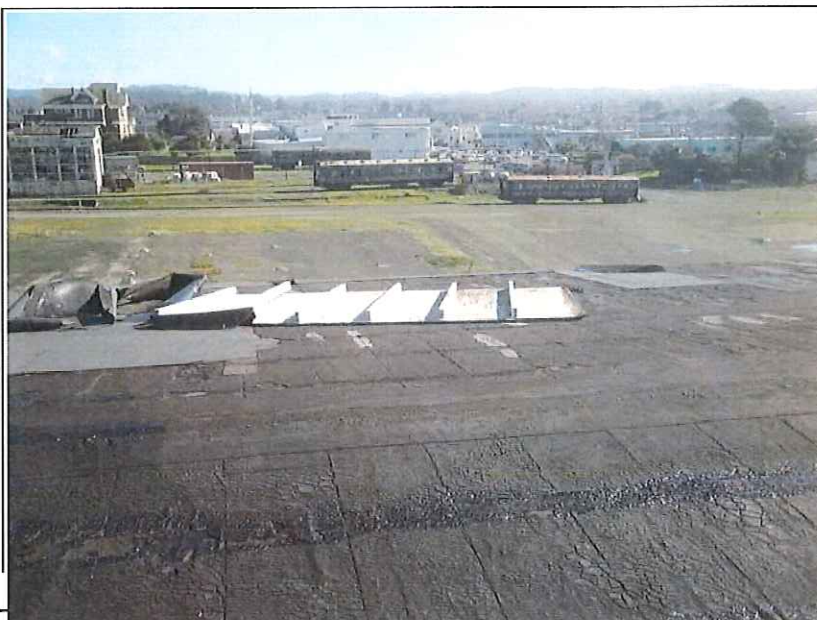
**Photo #15:**

Dry Shed #4 Roof Damage  
and 16'-0" x 8'-0" Plywood  
and 2x4 Purlin Debris on  
Roof

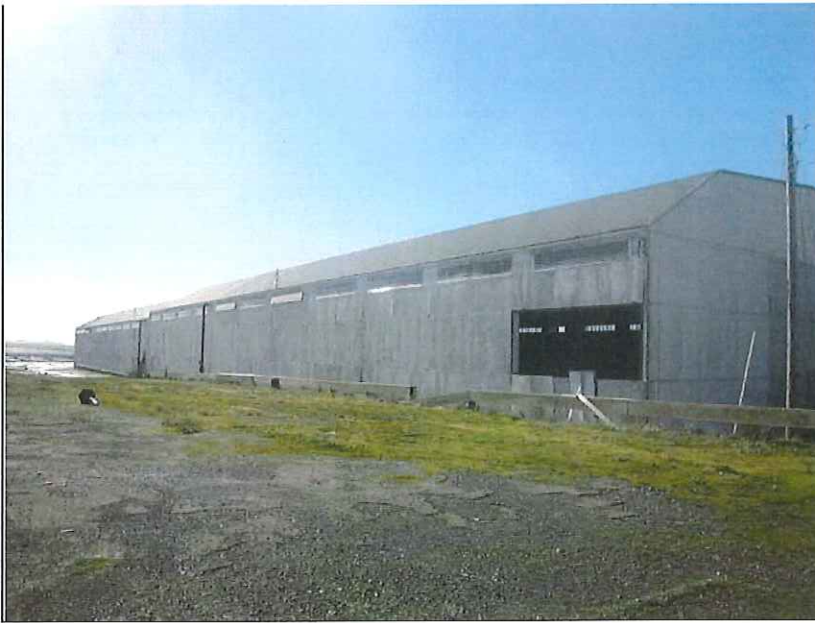
**Photo #16:**

7. An approximately 20'-0" x 16'-0" damaged open area in the plywood sheathing, wall studs, and walers was observed on east wall of the building near the northeast corner of the building. See Photos 16, 17, and 18. This area was reportedly not damaged in the recent storms. The area is missing one 3x10 waler and the second 3x10 waler is split. The 2x4 studs and plywood sheathing have been lost in this area.

Dry Shed #4 East Side with Wall Damage in Northeast Corner; 20'-0" x 16'-0" Opening; Loss of Plywood Sheathing, 2x4 Studs

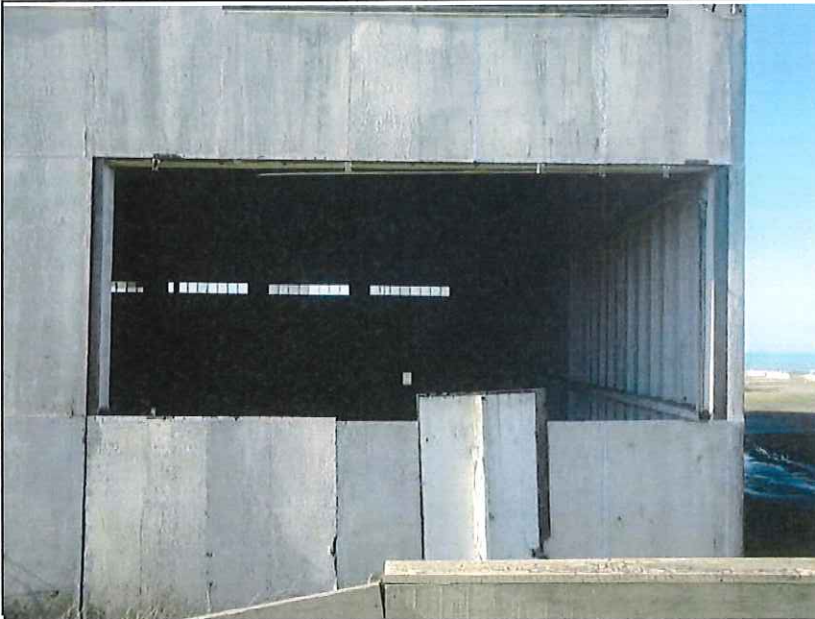
**Photo #17:**

Dry Shed #4 East Side with Wall Damage in Northeast Corner; 20'-0" x 16'-0" Opening; Loss of Plywood Sheathing, 2x4 Studs

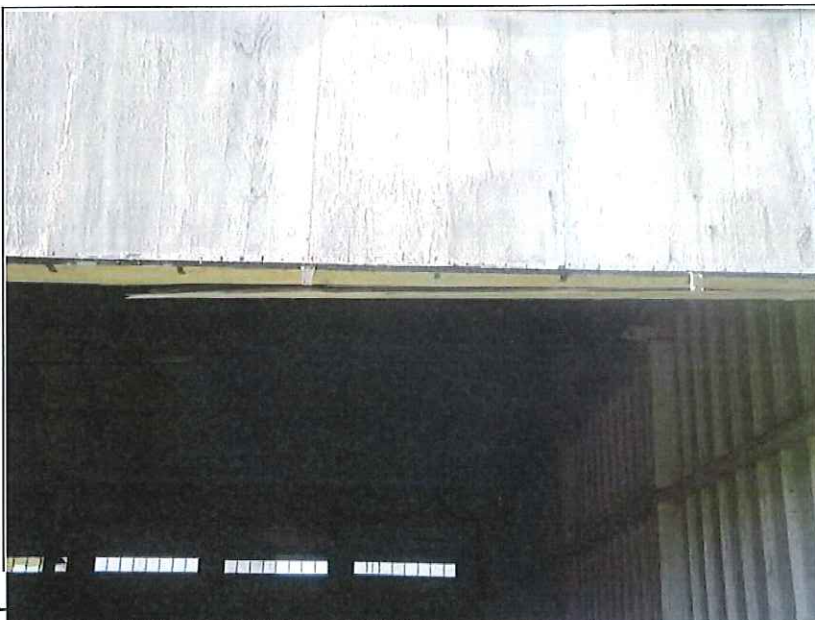
**Photo #18:**

Dry Shed #4 East Side with Wall Damage in Northeast Corner; 20'-0" x 16'-0" Opening; Loss of Plywood Sheathing, 2x4 Studs; Split 3x10 Waler
