31 January 2017

Subject: Structural Assessment of Storm Damage  
Dry Shed No. 4  
Georgia-Pacific  
Fort Bragg, California  
K/J 1665018\*04

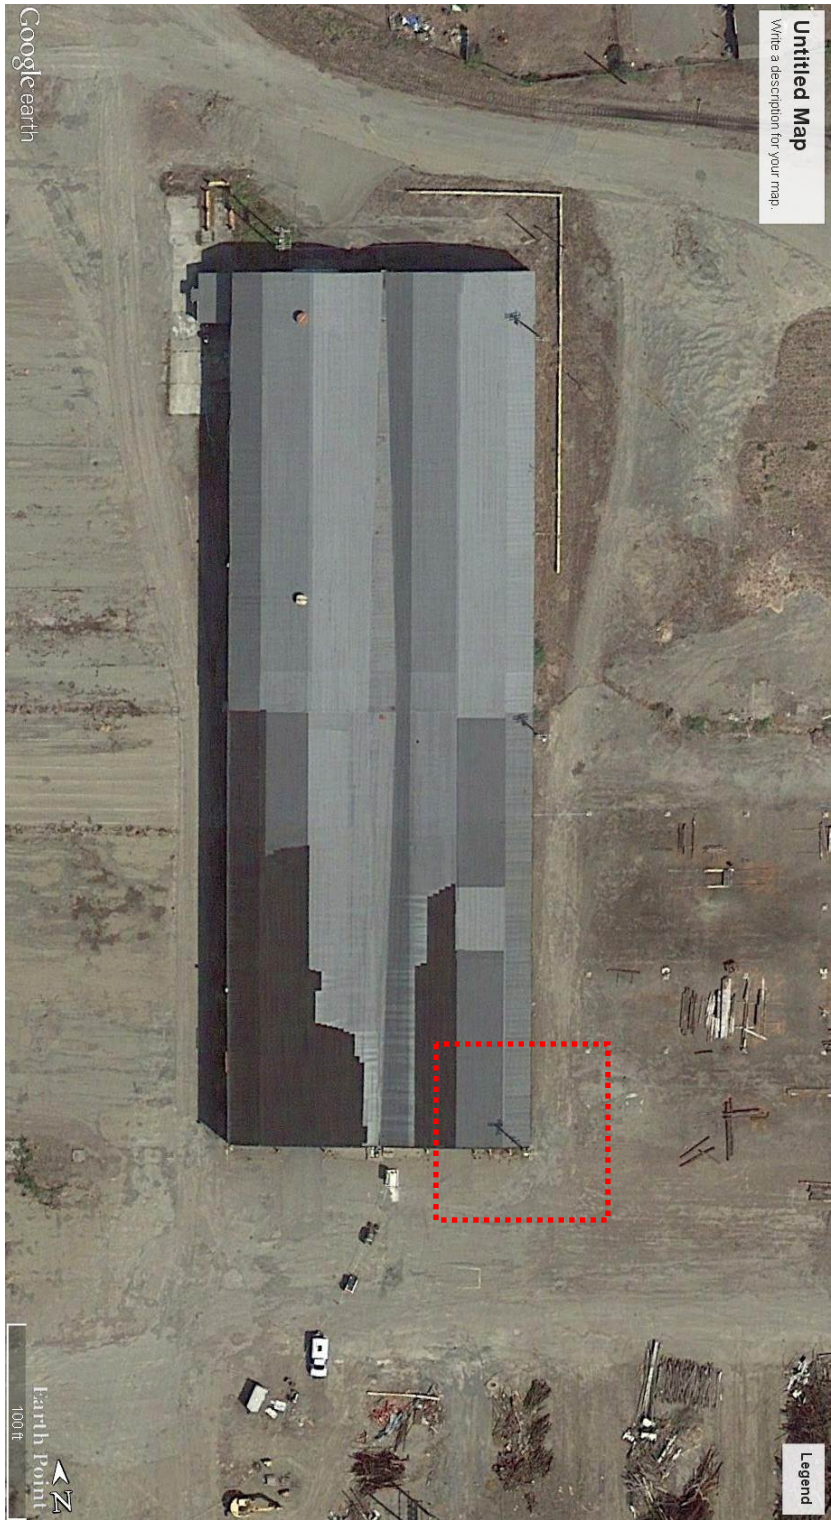
Figure 1: Building Restriction Area

The recent storm related roof damage in the southeast corner of the building has seriously weakened the roof framing in the southeast corner of the building and support for the gable end at the southeast corner of the building. The loss of roof framing in the southeast corner and the potential for future loss of roof and wall framing in the southeast corner of the building pose an unsafe and potential hazardous condition to operations, personnel, equipment, and vehicles

inside and outside the building in the general vicinity. The loss of additional roof framing or damage to wall framing could cause the south wall of the building to become unstable requiring shoring or bracing. The Owner should take measures to restrict activities in the general vicinity shown in Figure 1. Do to the limited intended remaining use of the building we would not recommend further non-destructive testing of building materials or exploratory removal, sampling, testing or physical measurements of the overall structure. As previously noted, it is clear that the physical properties of the construction materials have degraded significantly with water and wind related damage to the plywood sheathing and wall and roof structural wood framing members. The loss of the modified bitumen roof waterproofing material from many areas of the south half of the building has contributed to the degradation of the wood roof framing.

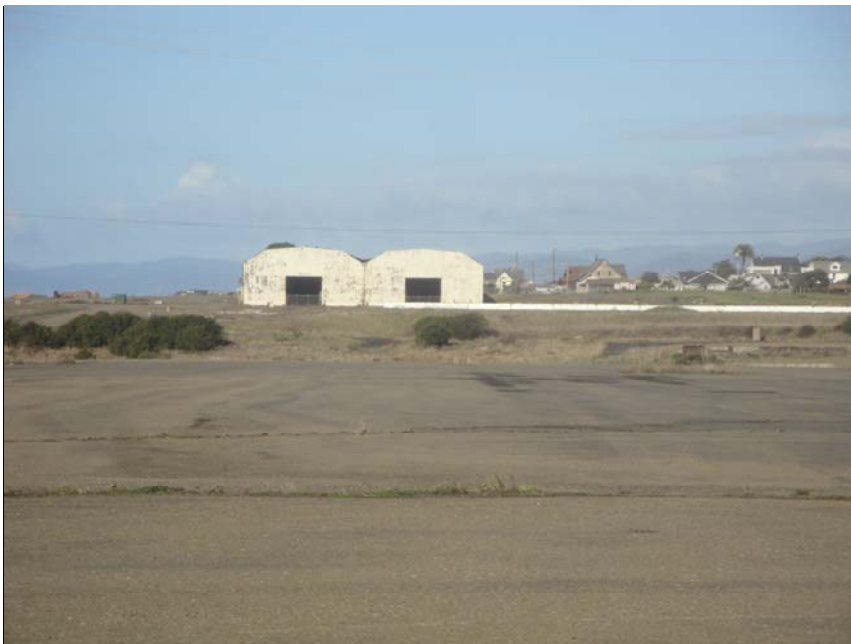
**Photo #1:**  
Dry Shed #4

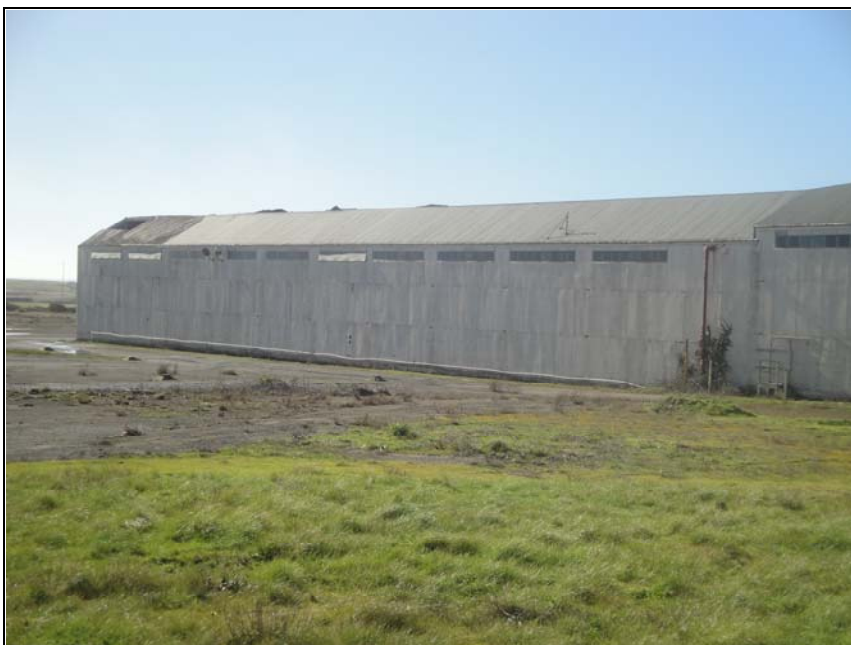
**Photo #2:**  
Dry Shed #4 East Side with  
Roof Damage in Southeast  
Corner

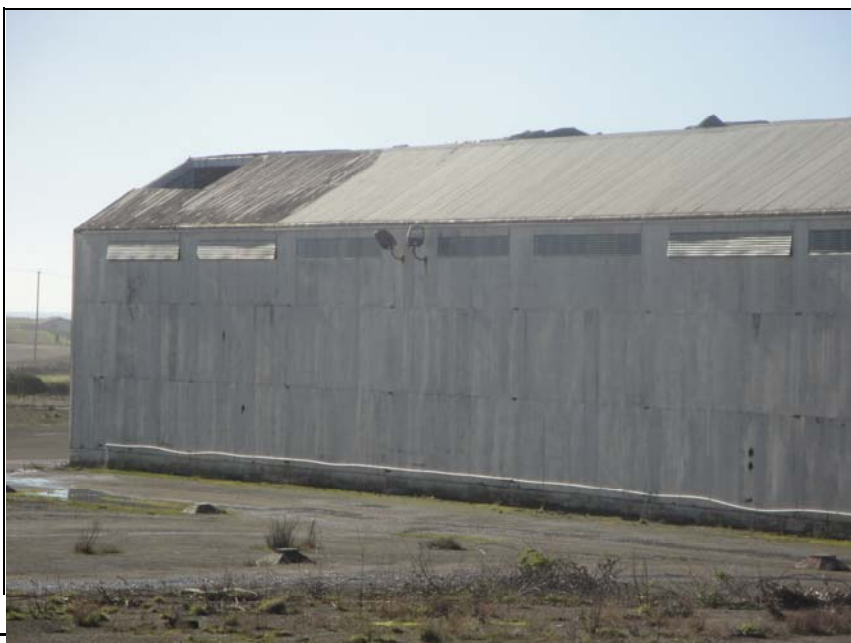
**Photo #3:**  
Dry Shed #4 East Side with  
Roof Damage in Southeast  
Corner; 16'-0" x 8'-0"  
Opening

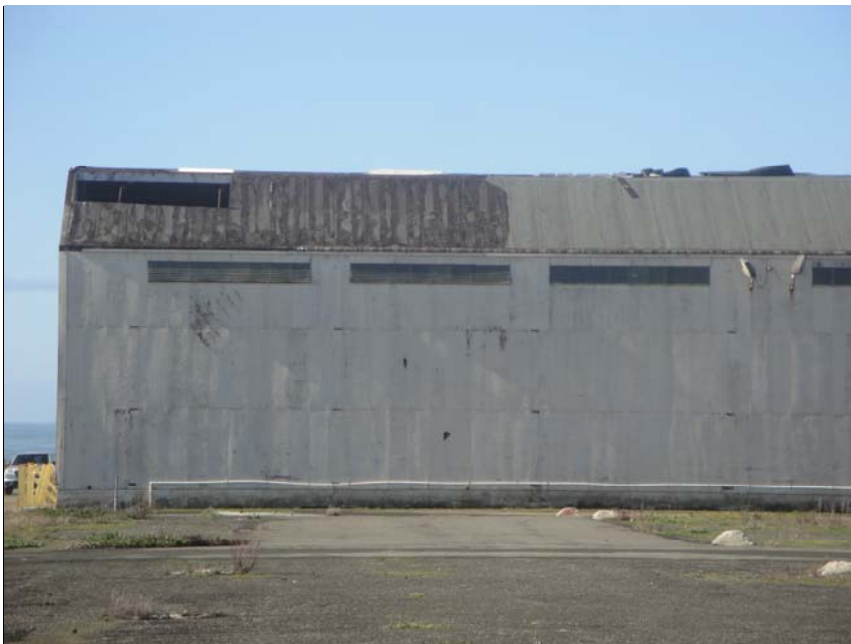
**Photo #4:**

Dry Shed #4 East Side with  
Roof Damage in Southeast  
Corner; 16'-0" x 8'-0"  
Opening

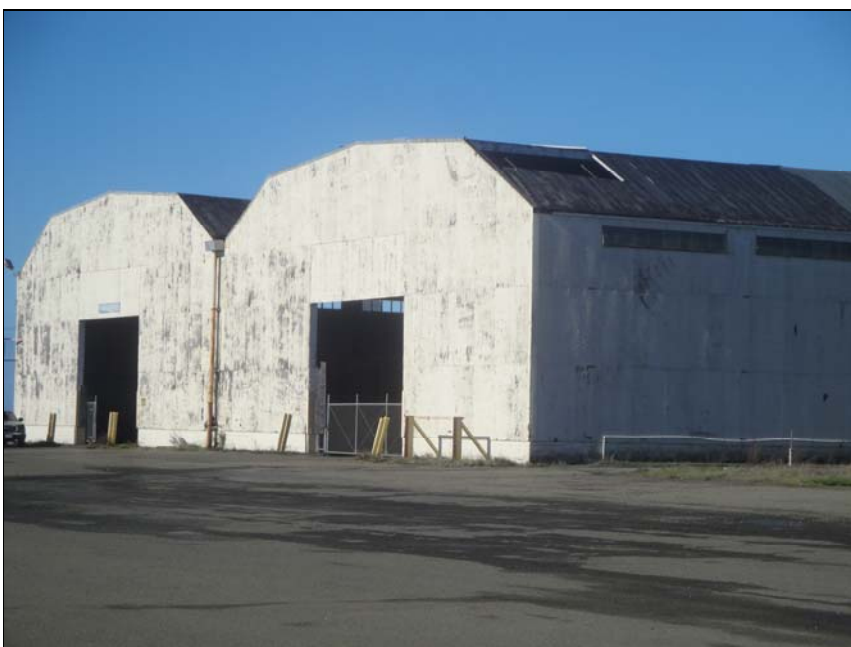
**Photo #5:**

Dry Shed #4 East Side with  
Roof Damage in Southeast  
Corner; 16'-0" x 8'-0"  
Opening

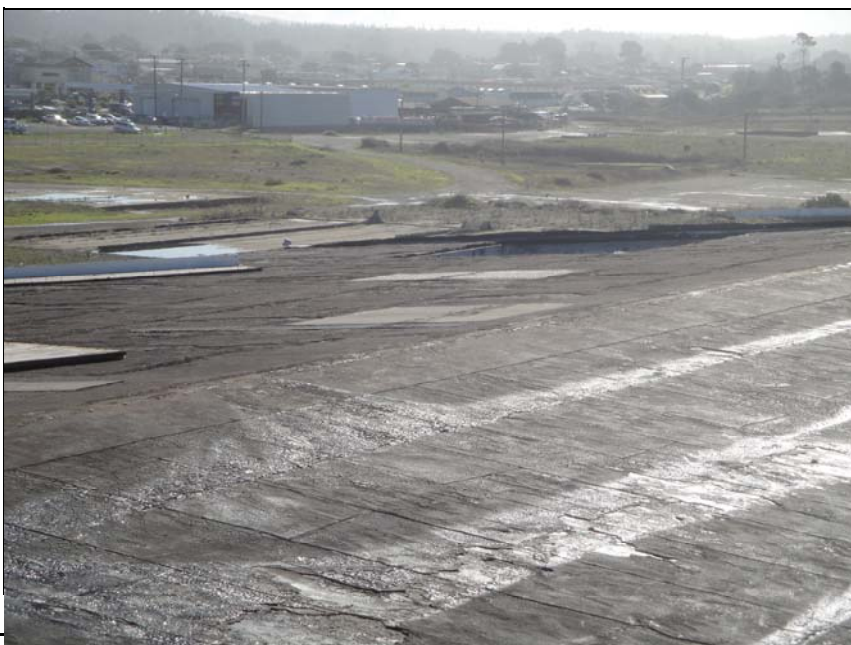
**Photo #6:**

3. An approximately 8'-0" x 8'-0" damaged open area in the plywood sheathing and roof purlins was observed in the roof of the building near the southeast corner of the building. See Photos 6, 7, 8, and 10.

Dry Shed #4 Roof Damage  
and 16'-0" x 8'-0" Opening  
in Southeast Corner

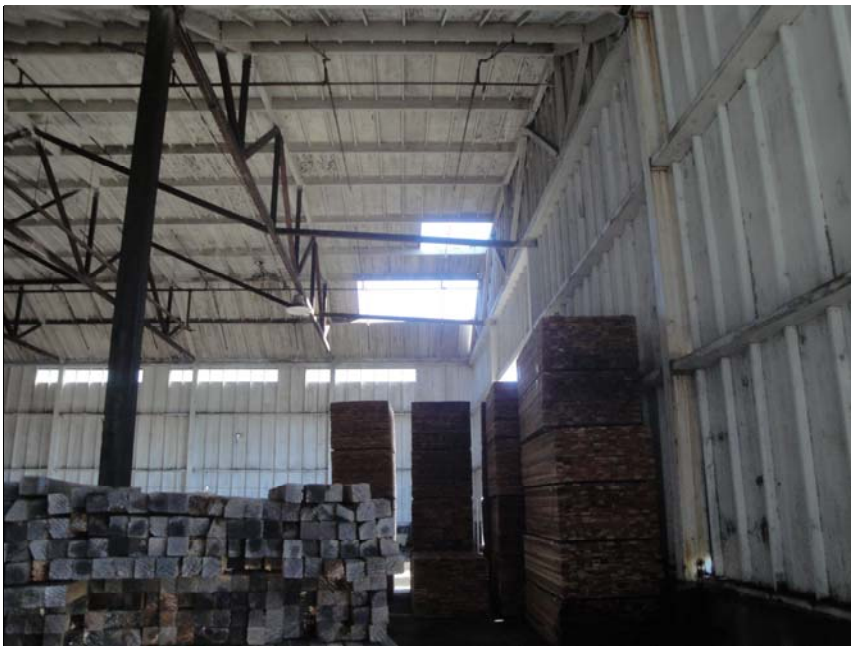
**Photo #7:**

Dry Shed #4 East Side with Roof Damage in Southeast Corner; Two Opening in Roof, Loss of 2x4 Purlins, Plywood Sheathing, and Modified Bitumen Roofing Material

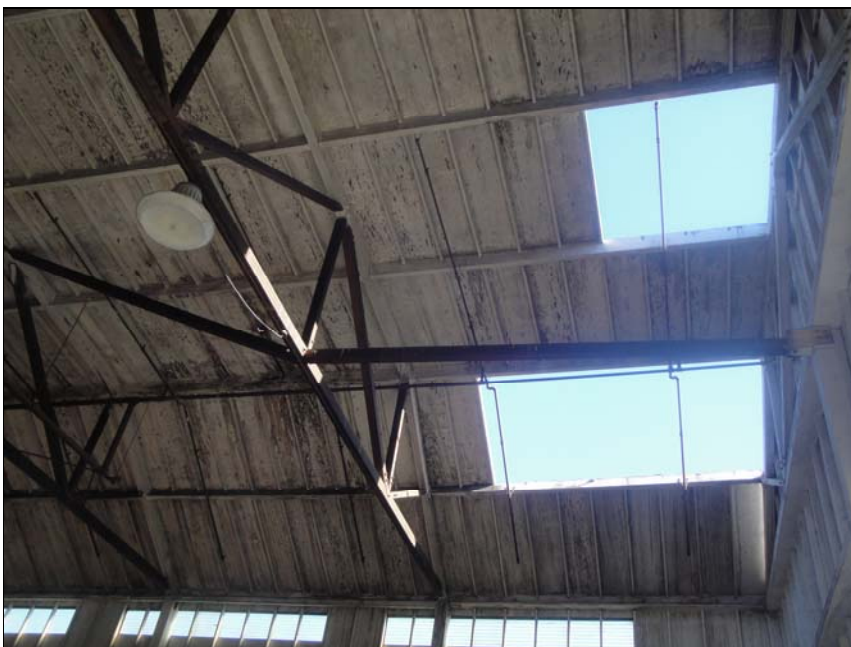
**Photo #8:**

Dry Shed #4 East Side with Roof Damage in Southeast Corner; Two Opening in Roof, Loss of 2x4 Purlins, Plywood Sheathing, and Modified Bitumen Roofing Material

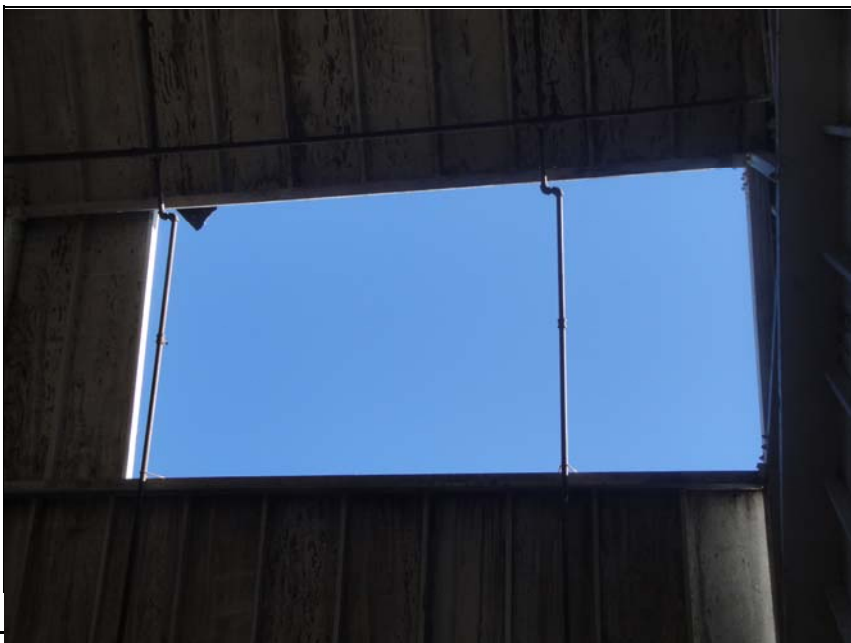
**Photo #9:**

Dry Shed #4 Roof Damage and 16'-0" x 8'-0" Opening in Southeast Corner; Loss of Plywood Sheathing and 2x4 Purlins

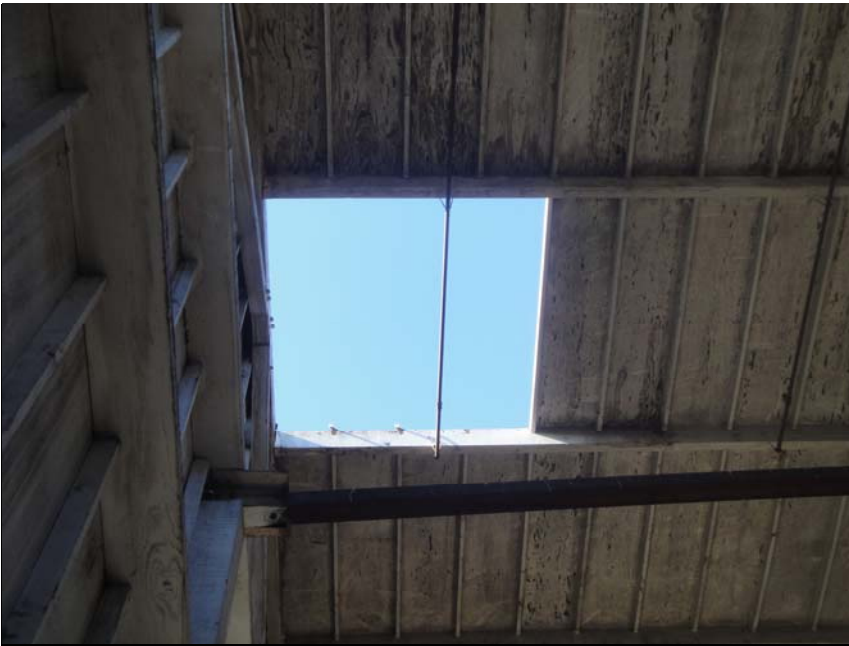
**Photo #10:**

Dry Shed #4 Roof Damage and 8'-0" x 8'-0" Opening in Southeast Corner; Loss of Plywood Sheathing and 2x4 Purlins

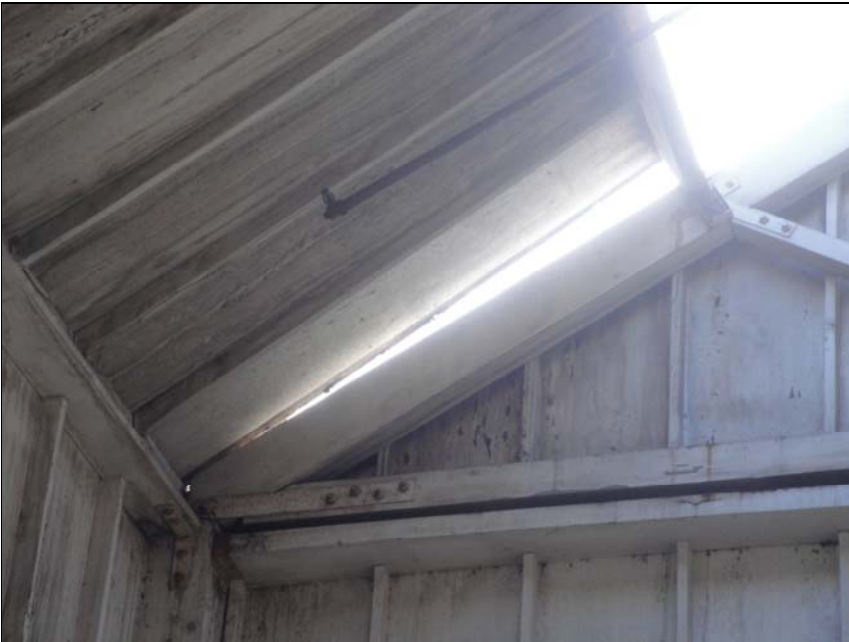
**Photo #11:**

4. Besides the loss of the plywood sheathing and purlins one of the girders supporting and attaching the south transverse wall to the building has pulled out of its beam hanger and has failed. See Photo 11.

5. The loss of the plywood at two openings in the roof as well as the loss of the girder in the beam seat on the southeast corner of the building removes the strength of the roof diaphragm connection to the south wall of the building in the southeast corner. It also appears that another approximately 16'-0" x 8'-0" section of roof is about to be lost from the building in the southeast corner. The remaining roof girders appeared to be in adequate condition still supporting and attaching the south gable wall to the remainder of the roof.

Dry Shed #4 East Side with Roof Damage in Southeast Corner; Rafter Pullout from Beam Seat

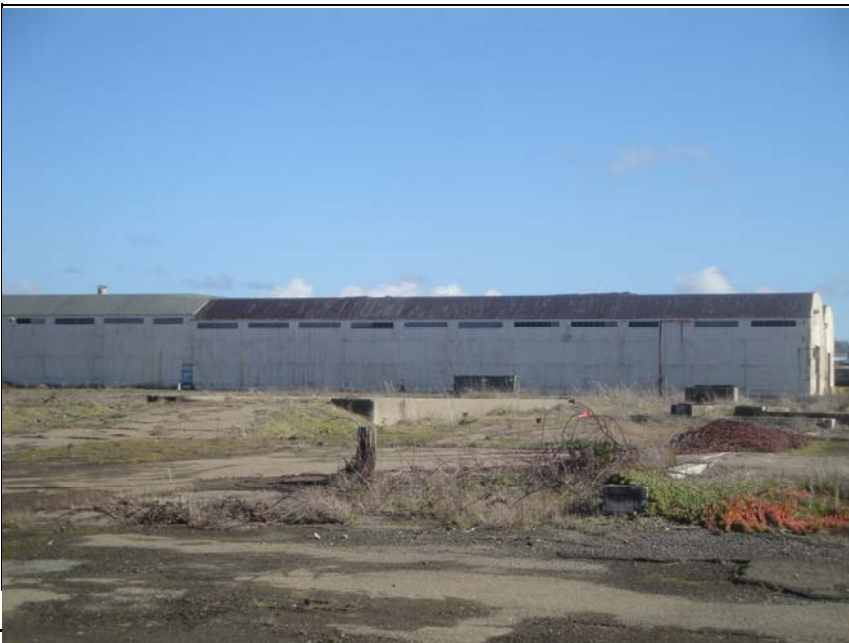
**Photo #12:**

8. There is a large area on the south half of the building where the modified bitumen roof material has blown off and has collected and blocks the roof drainage depression between the two roofs. There is extensive modified bitumen roofing material debris along the entire length of the south half of the roof drain cricket. The APP Modified Bitumen roofing material used on the building roof was manufactured by Dibiten. See Photo 12.

Dry Shed #4 West Side with Loss of Modified Bitumen Material on Half of Roof

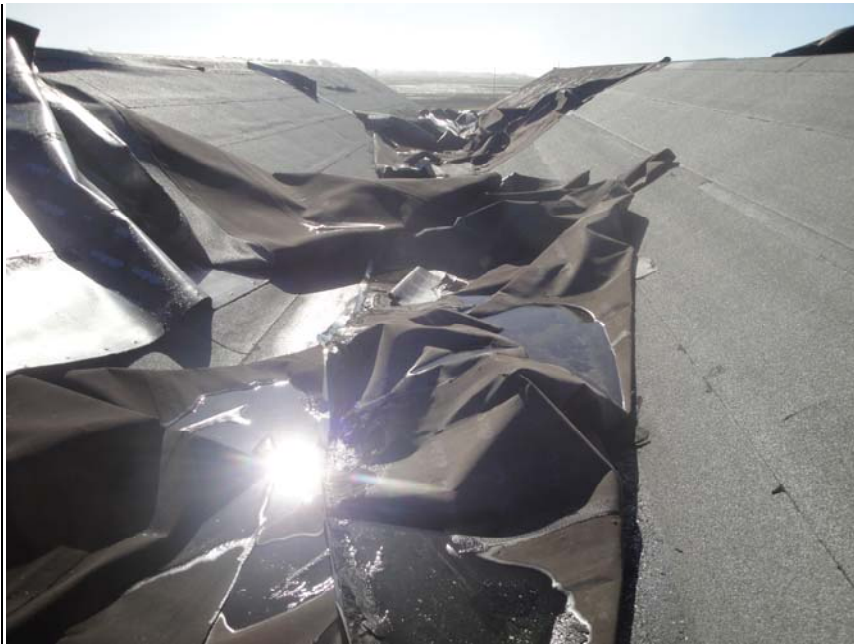
**Photo #13:**

Dry Shed #4 South Half  
Roof with Modified Bitumen  
Material in Roof Drain  
Cricket

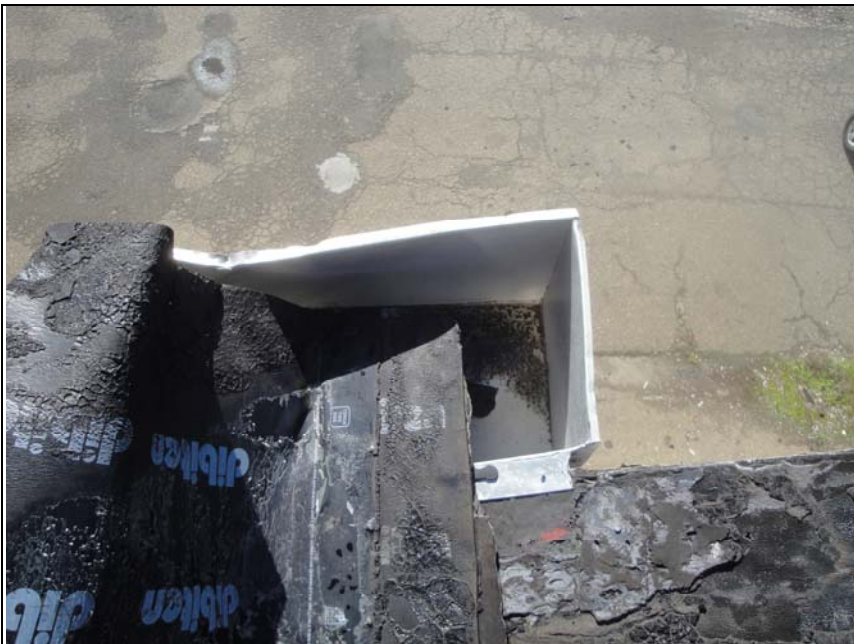
**Photo #14:**

Dry Shed #4 South Half  
Roof with Modified Bitumen  
Material in Roof Drain  
Cricket and Blocked  
Downspout Inlet

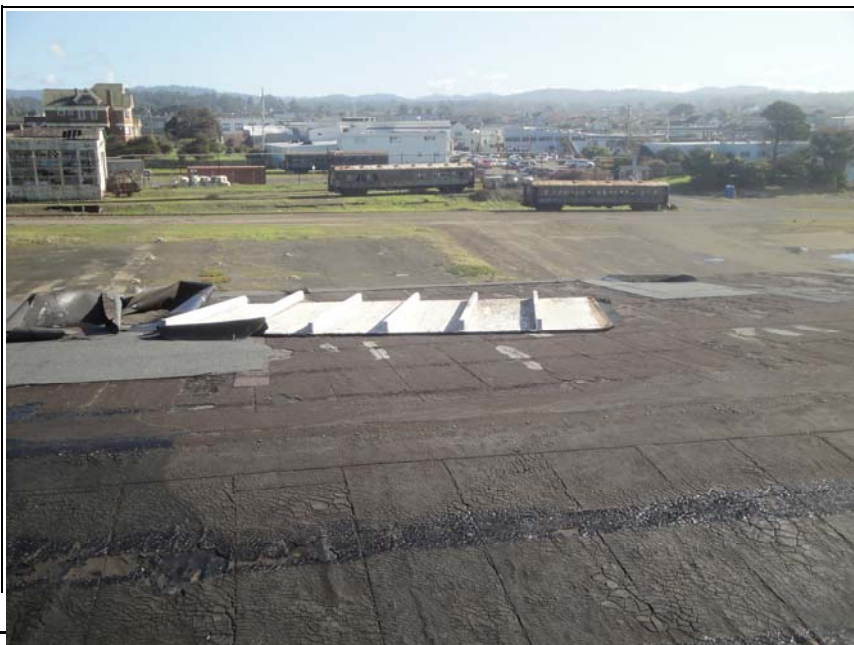
**Photo #15:**

Dry Shed #4 Roof Damage  
and 16'-0" x 8'-0" Plywood  
and 2x4 Purlin Debris on  
Roof

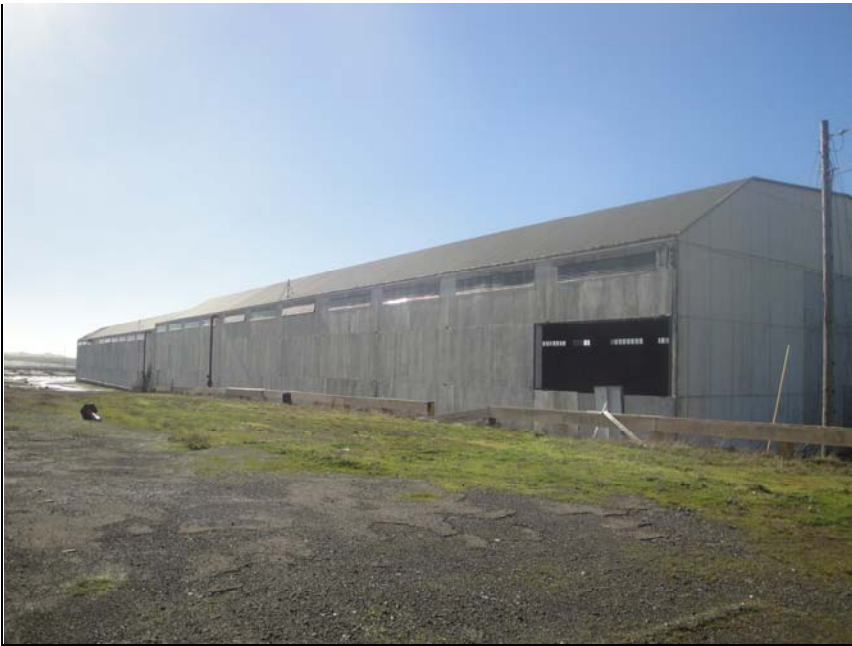
**Photo #16:**

7. An approximately 20'-0" x 16'-0" damaged open area in the plywood sheathing, wall studs, and walers was observed on east wall of the building near the northeast corner of the building. See Photos 16, 17, and 18. This area was reportedly not damaged in the recent storms. The area is missing one 3x10 waler and the second 3x10 waler is split. The 2x4 studs and plywood sheathing have been lost in this area.

Dry Shed #4 East Side with Wall Damage in Northeast Corner; 20'-0" x 16'-0" Opening; Loss of Plywood Sheathing, 2x4 Studs

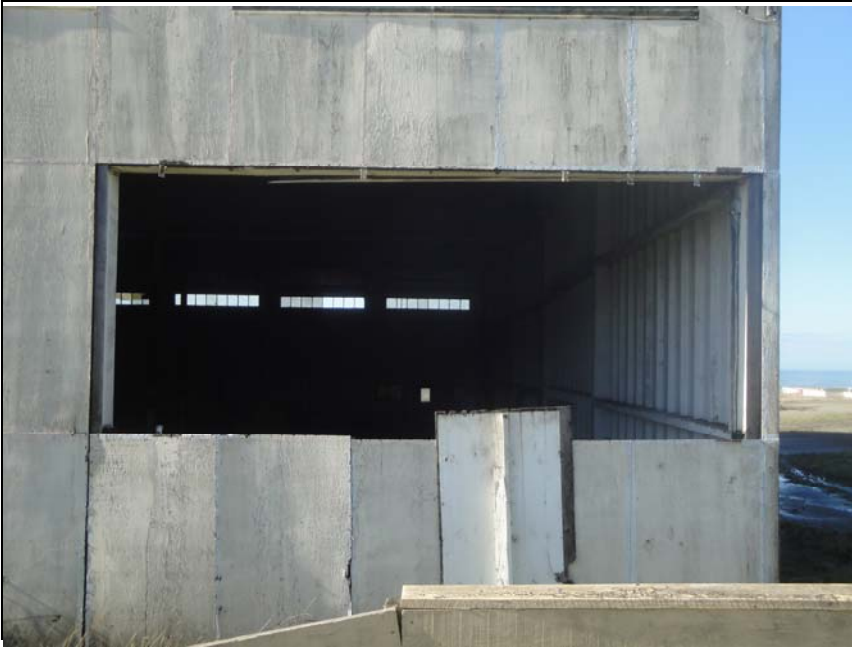
**Photo #17:**

Dry Shed #4 East Side with Wall Damage in Northeast Corner; 20'-0" x 16'-0" Opening; Loss of Plywood Sheathing, 2x4 Studs

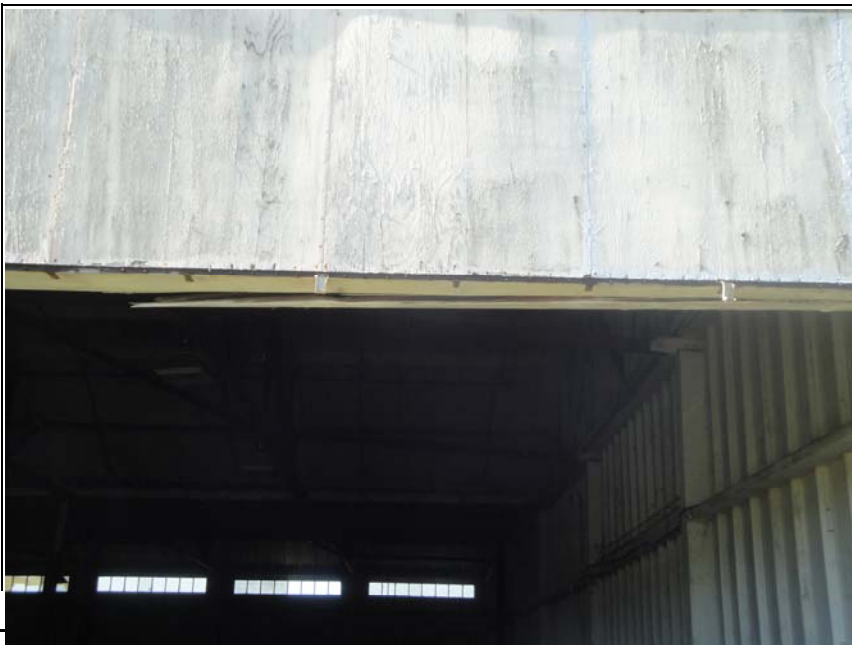
**Photo #18:**

Dry Shed #4 East Side with Wall Damage in Northeast Corner; 20'-0" x 16'-0" Opening; Loss of Plywood Sheathing, 2x4 Studs; Split 3x10 Waler
