Attachment 2: Dry Shed 4 Photos (2017)

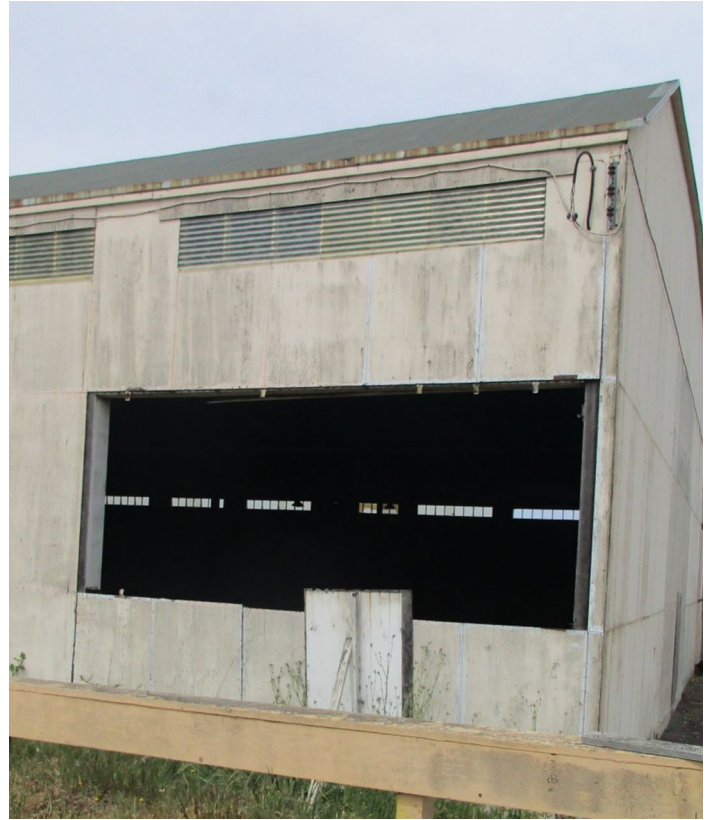
Collapsed Wall Northeast Side of Shed

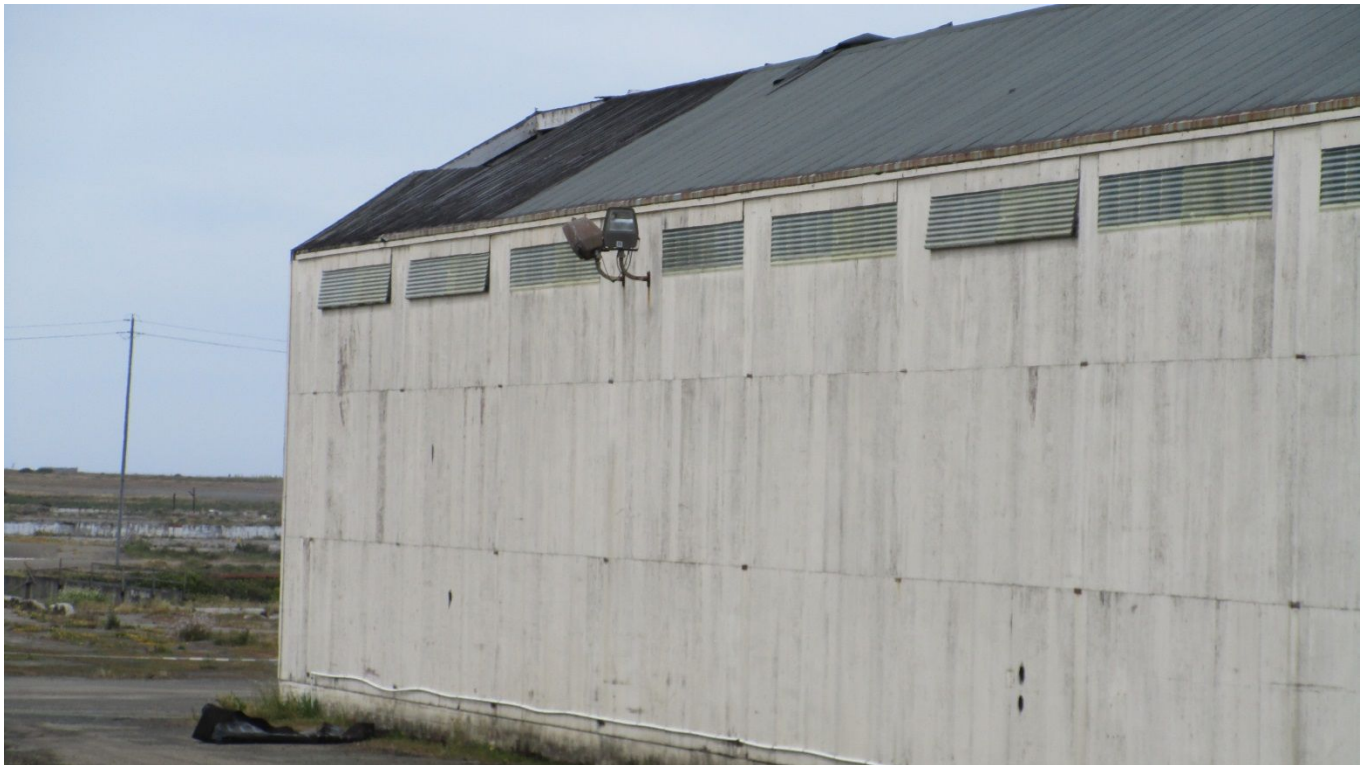
Hole in roof Southwest

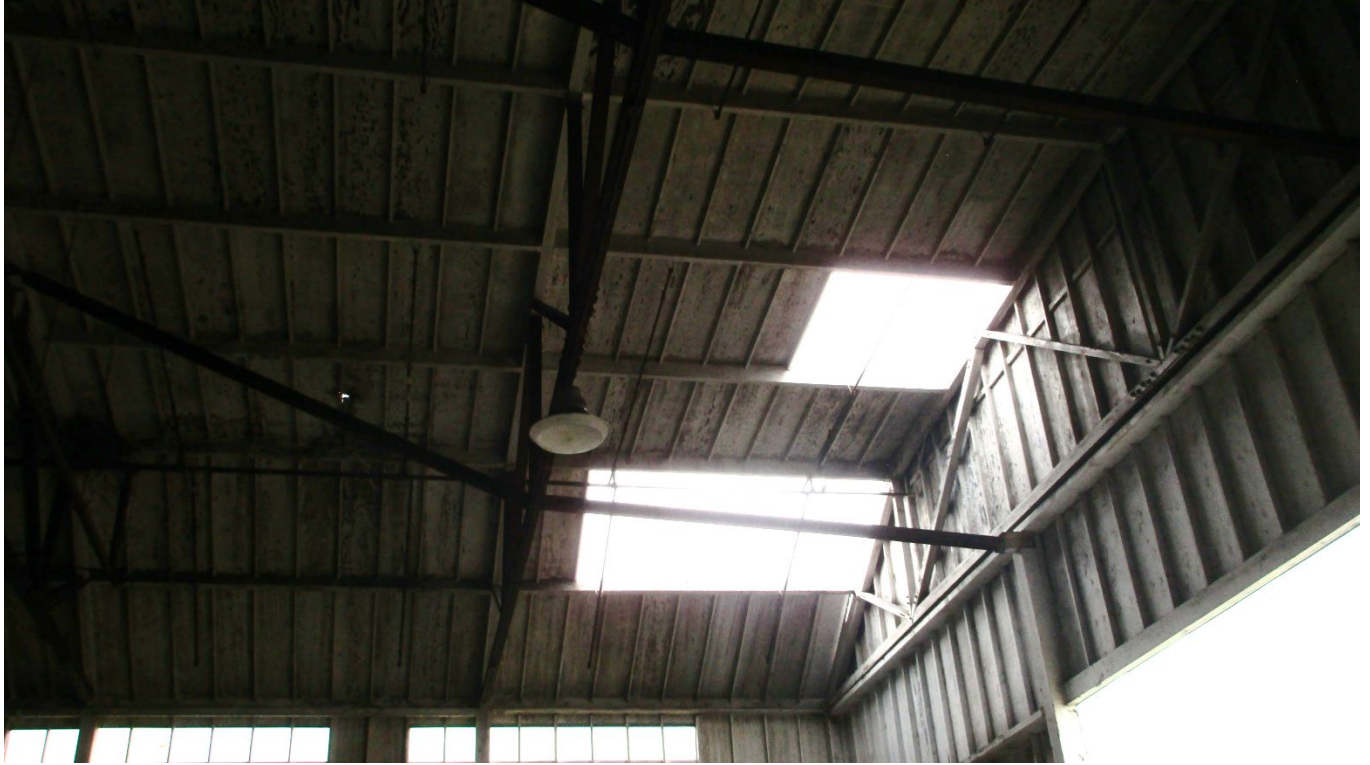
Hole in roof, interior shot

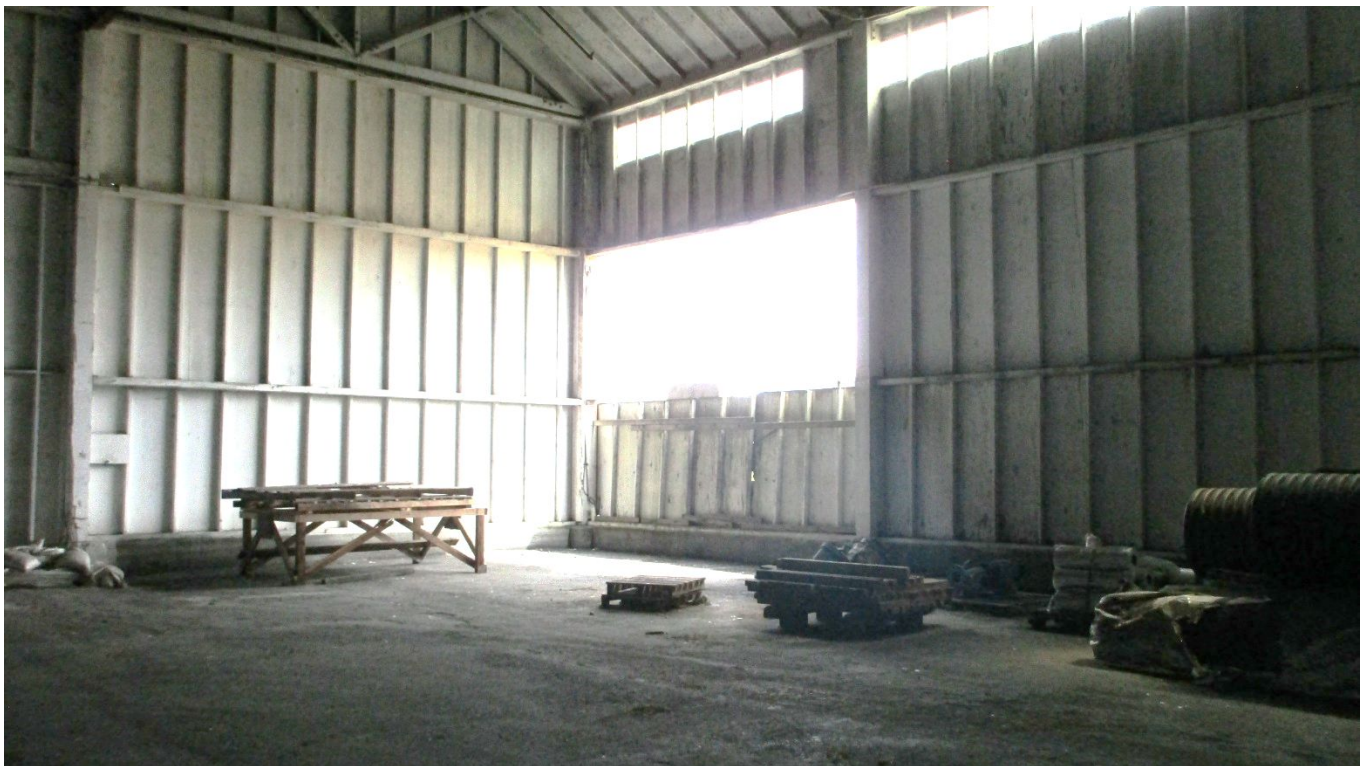
Hole in wall, interior shot

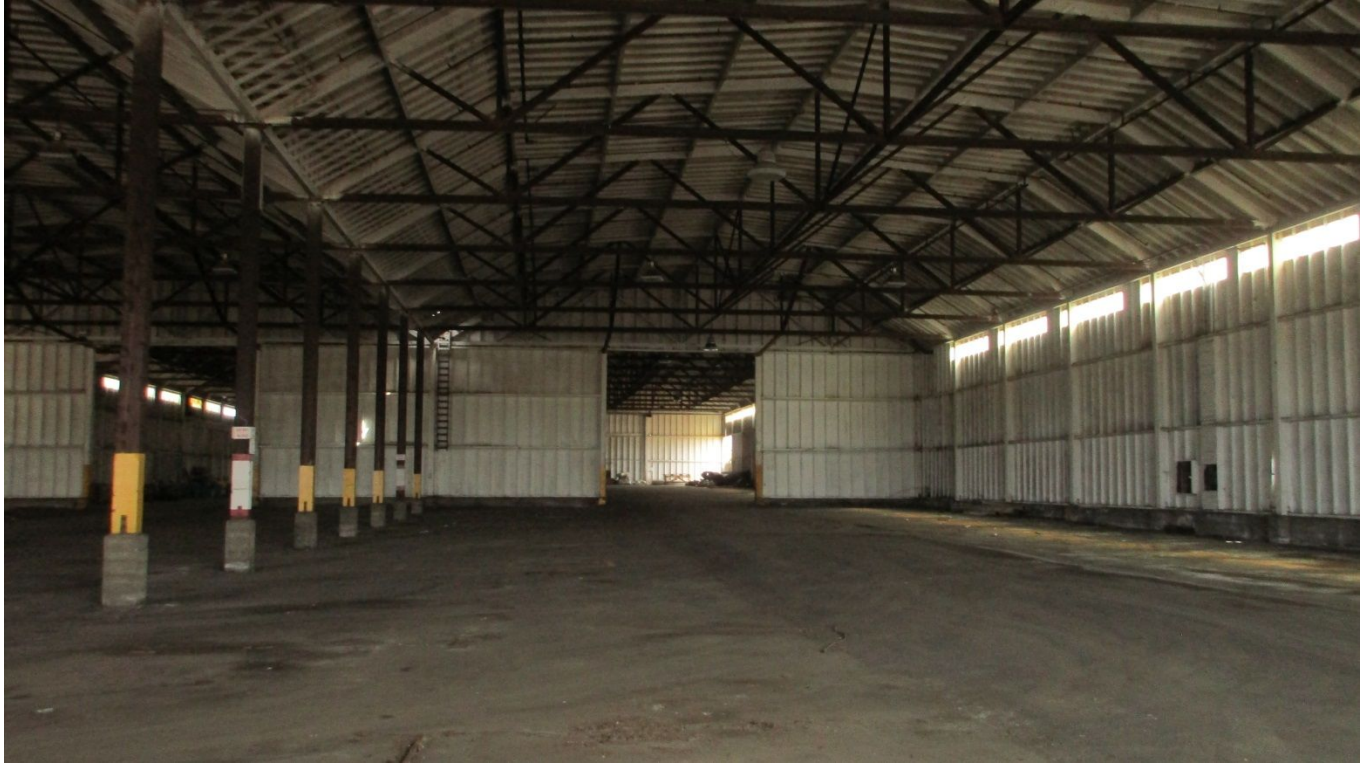
South east bay looking north, illustrates wall framing/CMU, roof structural system and asphalt floors

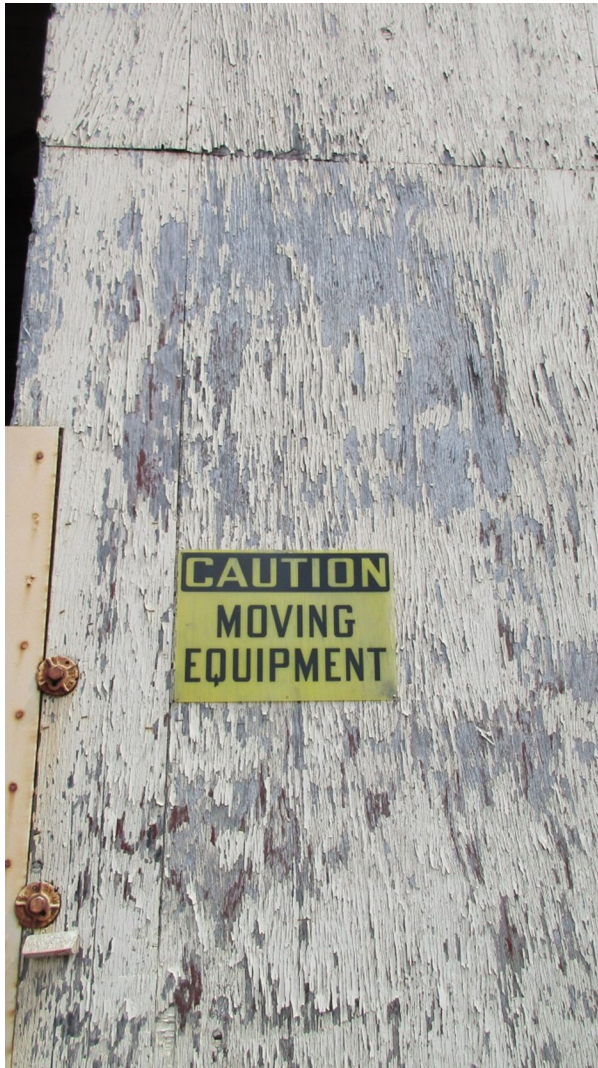
Typical deteriorated paint on external walls

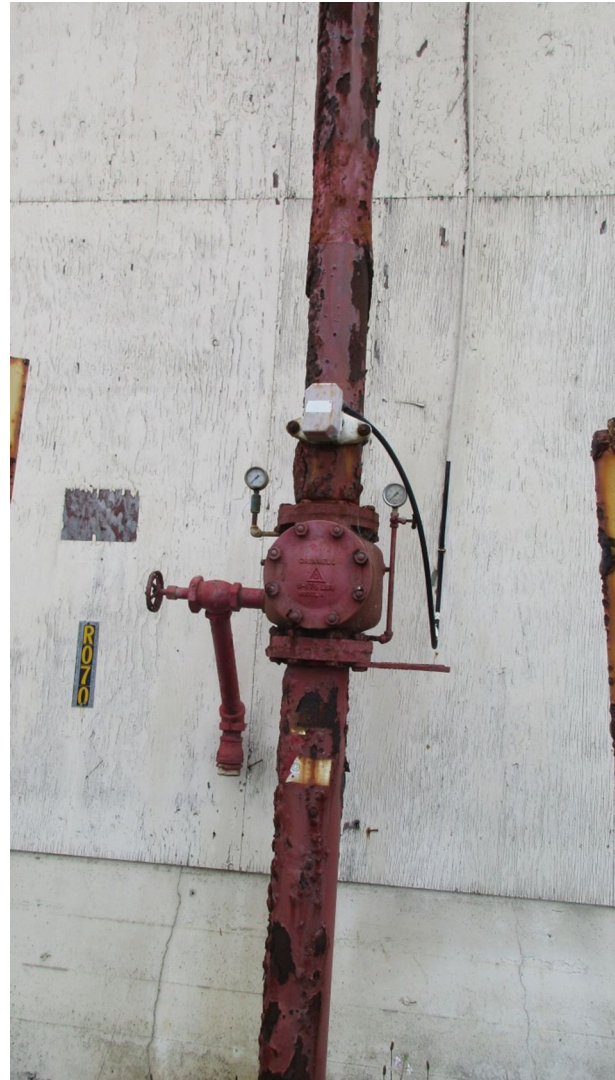
Deteriorated sprinkler main

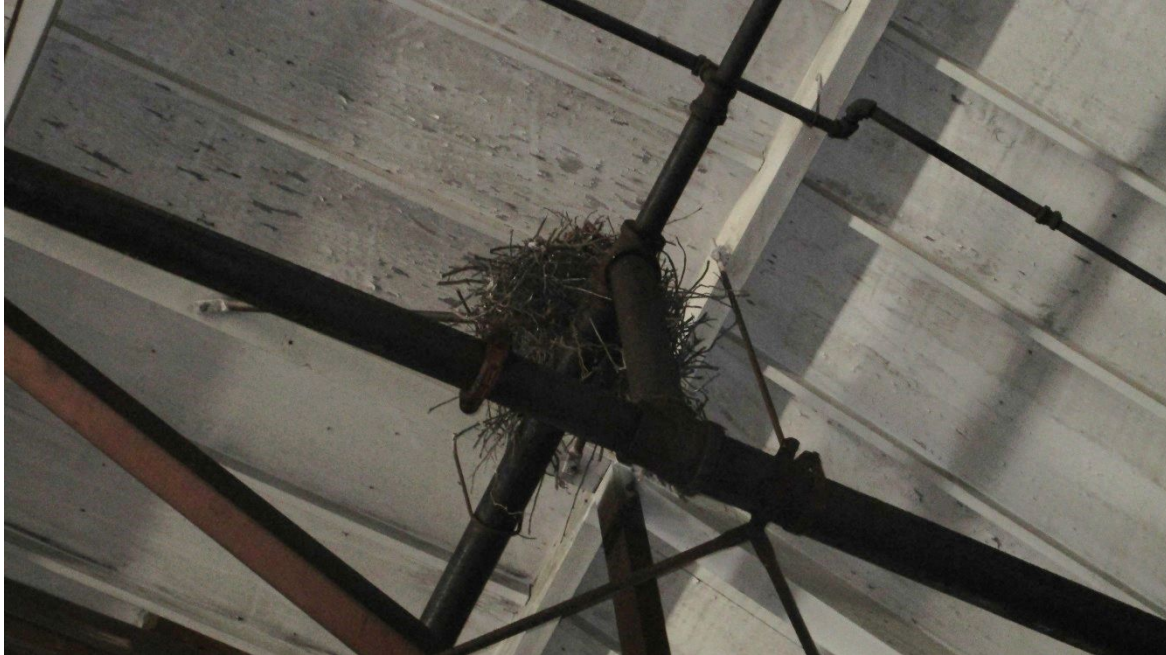
Raven nest
