**Subject: Dry Shed #4 Demolition – Coastal Development Permit Application
Georgia-Pacific LLC
90 West Redwood Avenue, Fort Bragg, CA**

subject Dry Shed #4 of Union Lumber Company Lumber Mill (Georgia-Pacific Wood Products Facility)

Subject: Structural Assessment of Storm Damage
Dry Shed No. 4
Georgia-Pacific
Fort Bragg, California
K/J 1665018*04

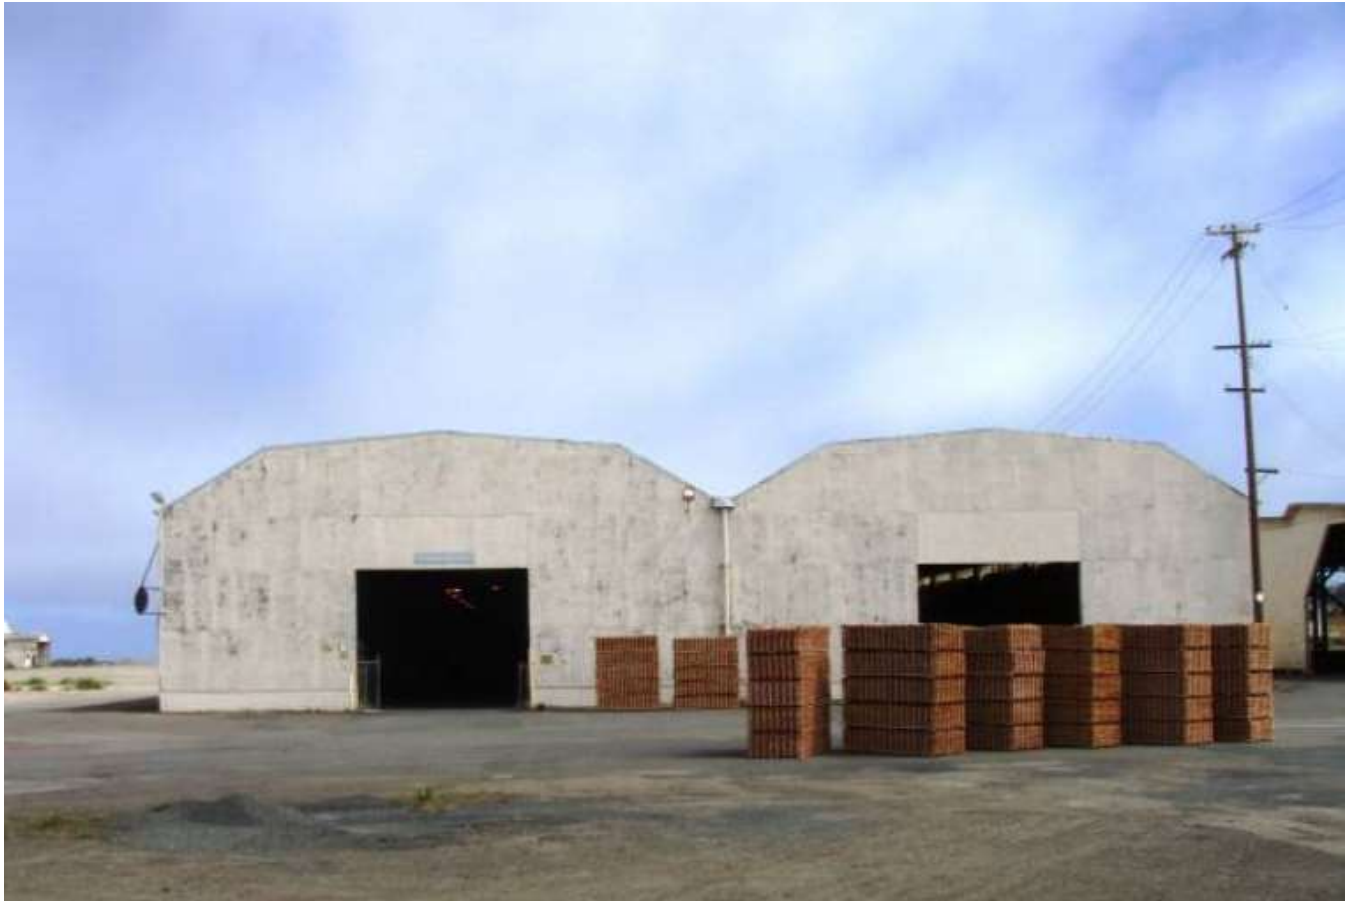
Figure 1. Dry Shed #4

TRC's circa 2003 Phase II report completed for the project described Dry Shed #4 (below, and **Figure 1**), and recommended the building eligible as a contributor to the (now defunct) Georgia-Pacific Lumber Mill Historic District.

Dry Shed #4 is a two-story warehouse-type property that appears to be four separate buildings joined at the east/west and north/south facades. The property was constructed circa 1960 and is located on the north end of the mill site, near the railroad tracks.

The building features a gambrel roof covered with rolled asphalt, exterior plywood panel walls, and a poured concrete foundation. The south façade has two open loading bays. There is no fenestration at the east façade. The north façade features one enclosed loading bay and one loading bay that retains an overhead track door. The west façade features two shed wings, one of which (at the north end) appears to hold an office. Both of the shed wings feature sing-door entrances that face west. Also at the west facade is an enclosed single-door entry (facing west).

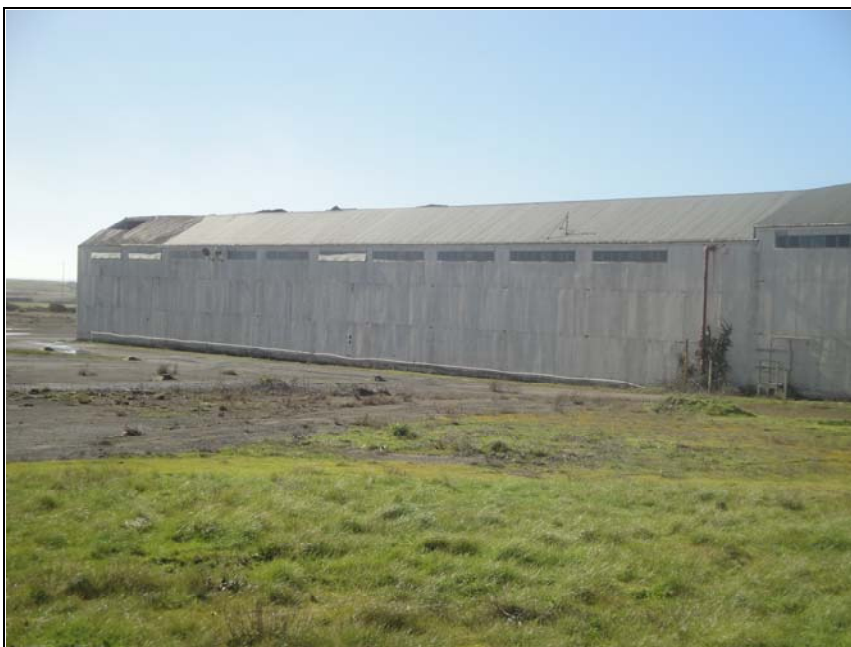
Photo #2:
Dry Shed #4 East Side with
Roof Damage in Southeast
Corner

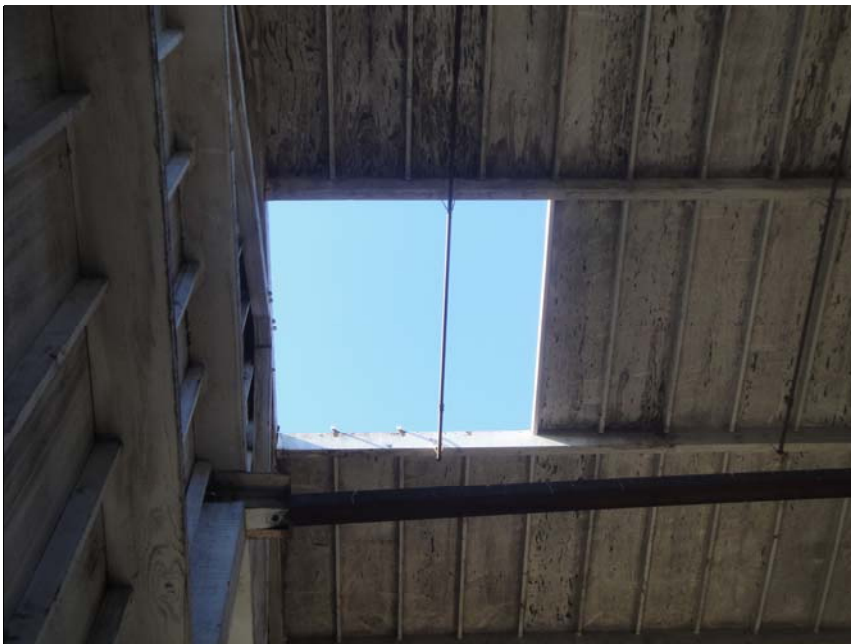
Photo #10:

3. An approximately 8'-0" x 8'-0" damaged open area in the plywood sheathing and roof purlins was observed in the roof of the building near the southeast corner of the building. See Photos 6, 7, 8, and 10.

Dry Shed #4 Roof Damage and 8'-0" x 8'-0" Opening in Southeast Corner; Loss of Plywood Sheathing and 2x4 Purlins

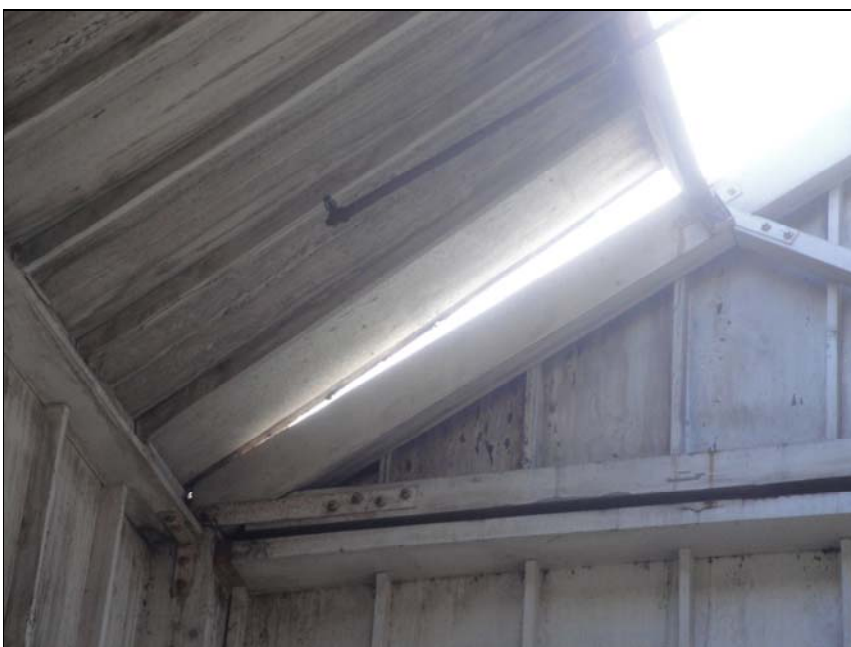
Photo #11:

4. Besides the loss of the plywood sheathing and purlins one of the girders supporting and attaching the south transverse wall to the building has pulled out of its beam hanger and has failed. See Photo 11.

5. The loss of the plywood at two openings in the roof as well as the loss of the girder in the beam seat on the southeast corner of the building removes the strength of the roof diaphragm connection to the south wall of the building in the southeast corner. It also appears that another approximately 16'-0" x 8'-0" section of roof is about to be lost from the building in the southeast corner. The remaining roof girders appeared to be in adequate condition still supporting and attaching the south gable wall to the remainder of the roof.

Dry Shed #4 East Side with Roof Damage in Southeast Corner; Rafter Pullout from Beam Seat

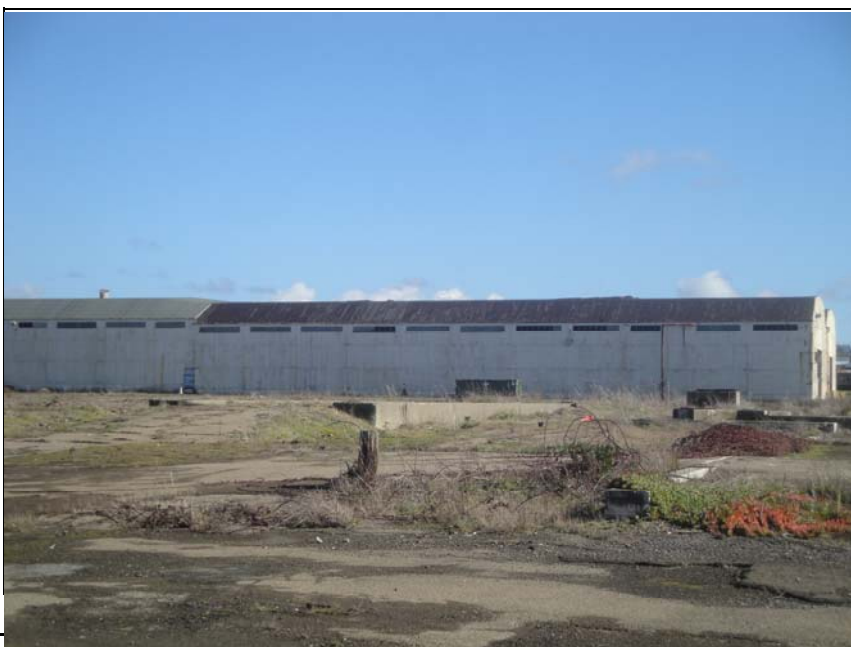
Photo #12:

8. There is a large area on the south half of the building where the modified bitumen roof material has blown off and has collected and blocks the roof drainage depression between the two roofs. There is extensive modified bitumen roofing material debris along the entire length of the south half of the roof drain cricket. The APP Modified Bitumen roofing material used on the building roof was manufactured by Dibiten. See Photo 12.

Dry Shed #4 West Side with Loss of Modified Bitumen Material on Half of Roof
