Structural Evaluation of Georgia Pacific Mill Site Storage Shed #4

August 17, 2009

Structural Retrofit Details for Storage Shed #4

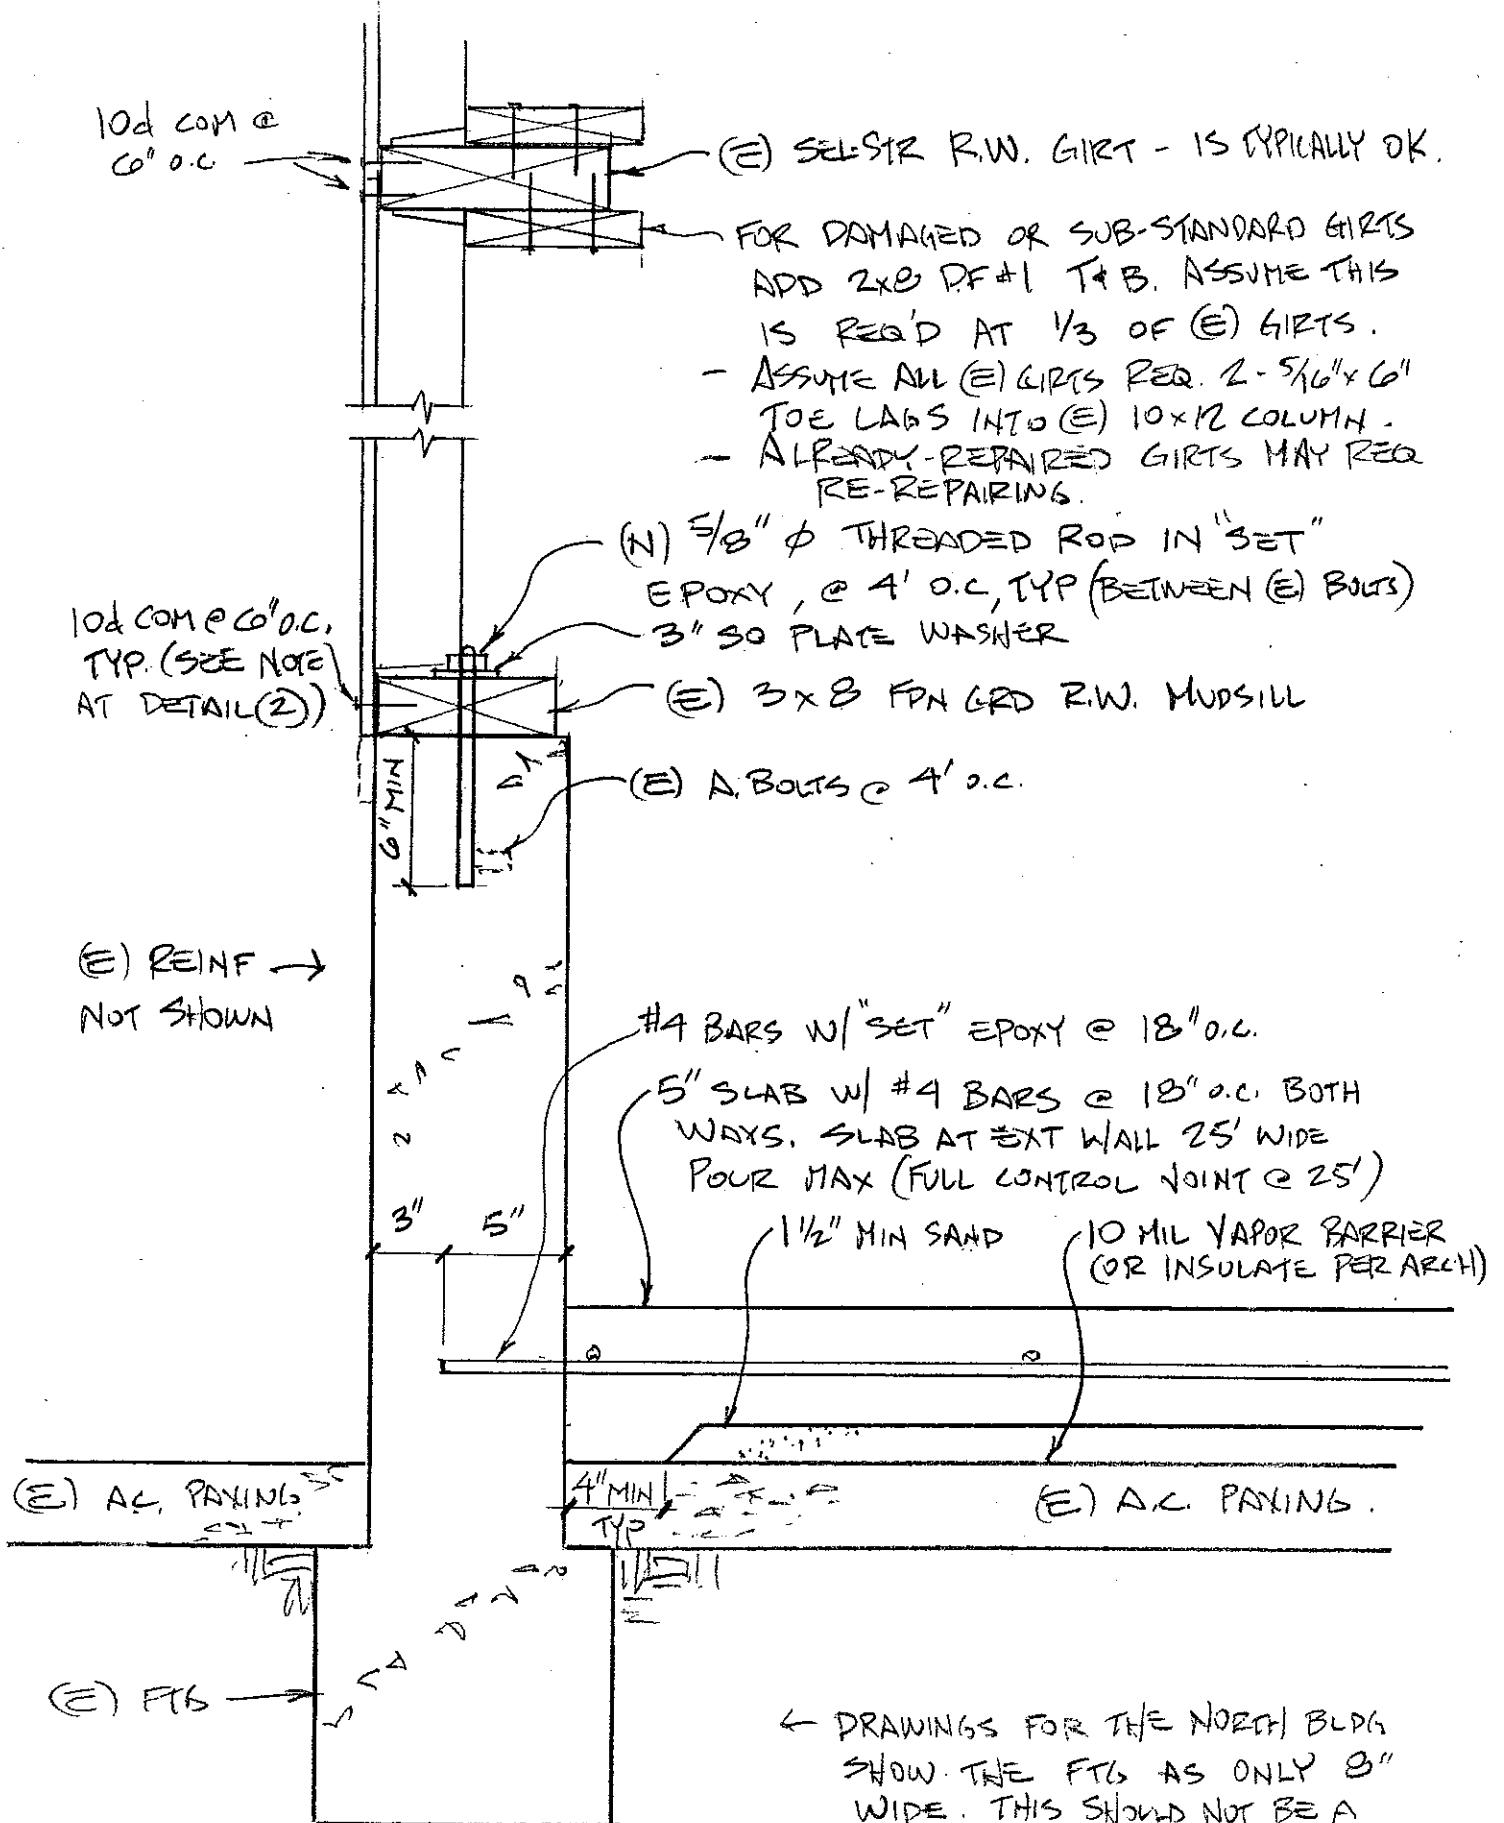
1 EXT FDN & WALL RETROFIT

According to the existing building construction drawings, the existing foundation footing size varies in that the north half of the building has footings only 8" wide (apparently), rather than the normally accepted 12" wide. Even if this unusual condition actually exists, the retrofit recommended will suffice – these are generally non-bearing walls.

The new slab is to be poured, and it is to be epoxy-doweled into the existing foundation wall. This practice – bonding a new slab to an existing foundation - does promote some cracking to the new slab, which can be reduced to acceptable amounts by proper employment of full-thickness control joints. To reduce new slab cracking to limits within "architectural slabs" more expensive retrofit methods are possible, but have not been designed by us.

The existing anchor bolts are essentially doubled, and the existing wall girts are doubled up where necessary, per previous explanations.

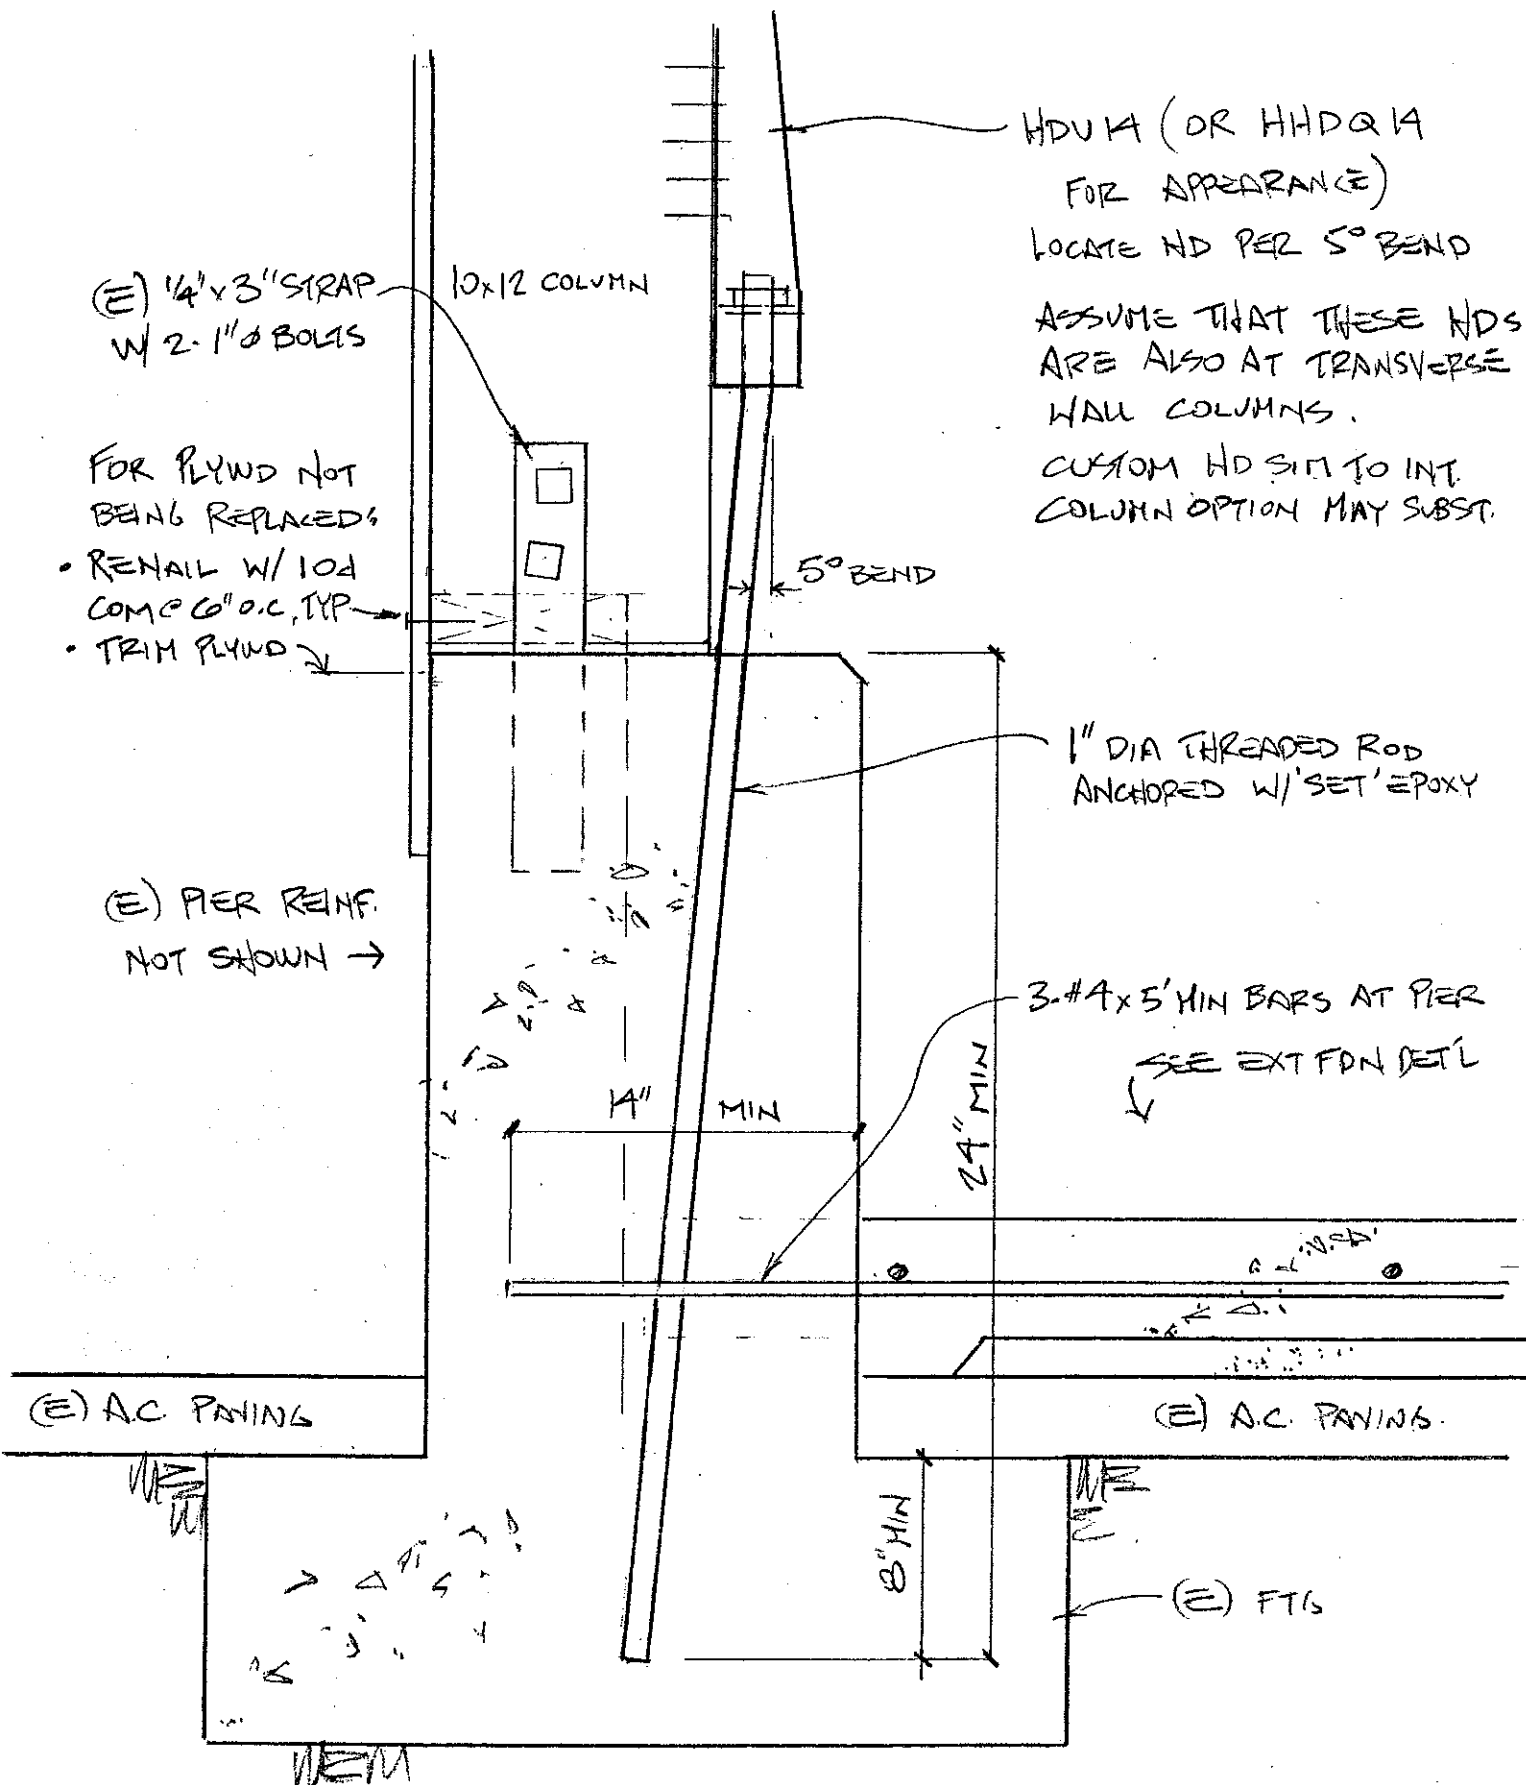
2 EXT FDN PIER & COLUMN RETROFIT

The primary requirement at the base of the existing 10 x12 redwood columns is to anchor them for wind uplift. The least expensive hold down that satisfies the worst-case design load is the HDU14 specified, a \$45 piece of hardware not including the anchor rod. The HHDQ14 is more attractive and appropriate-looking for a building such as Shed #4, and is around twice the price. It must be kept in mind that that all of the exposed hardware for this building is specified to be hot-dip galvanized or alternative corrosion protection, which is not included in these prices. More explanation is on detail 3 below.

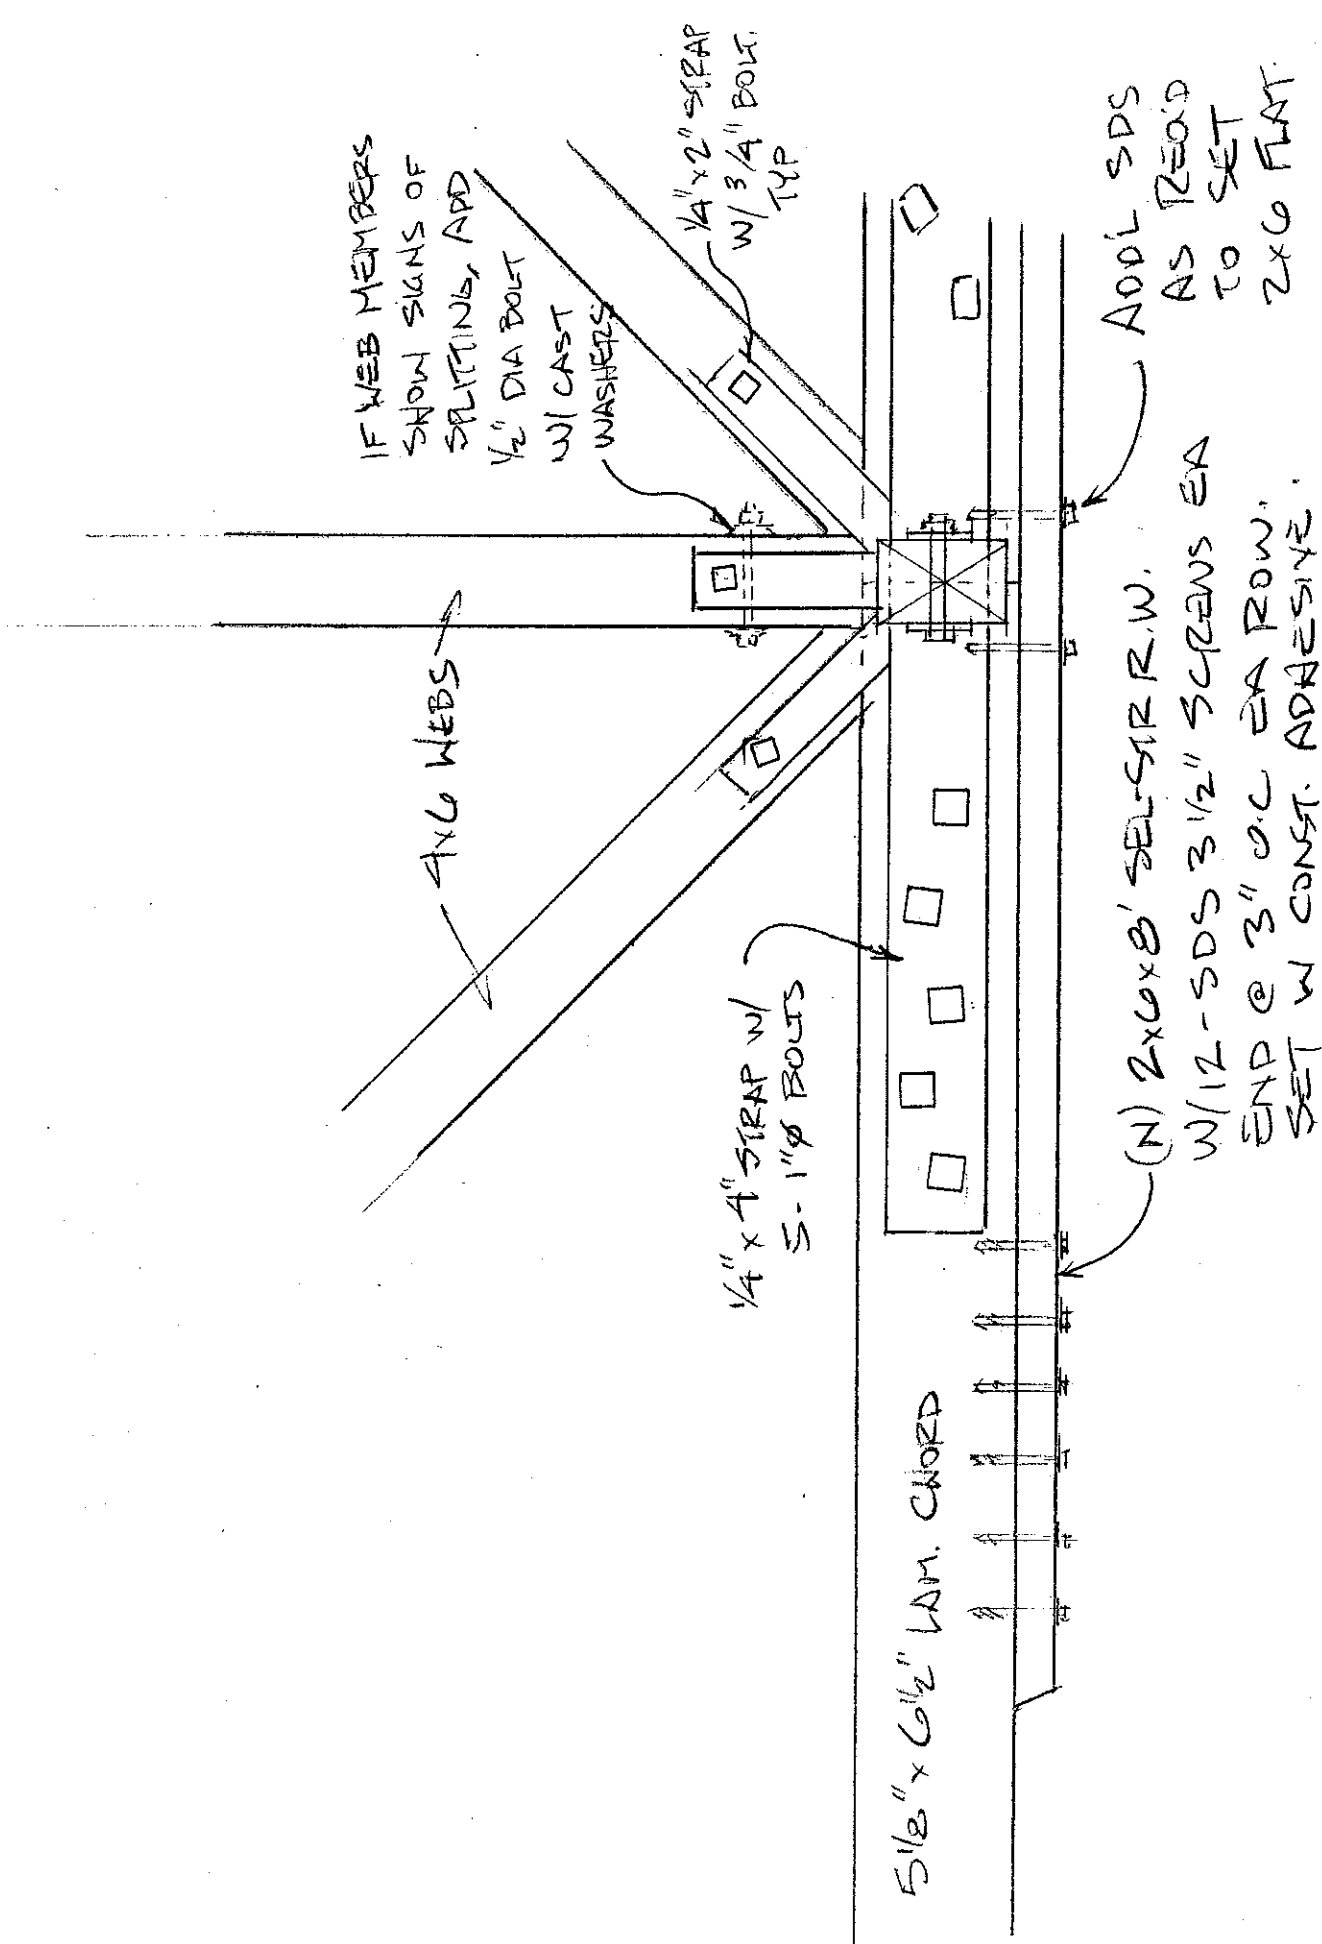
7 TRUSS MIDDLE - RETROFIT

At this location the truss bolted connection is overstressed and the truss bottom chord member itself is slightly overstressed, if the material removed by the existing bolt holes is considered. Thus a wood tie is designed to connect in both directions outside of the existing steel connection in a manner that will reinforce the existing connection and the truss chord tension strength. This detail could be ignored at interior partition locations.

THIS RETROFIT IS NOT REQ'D WHERE ADDING A WALL UNDER THE TRUSS.

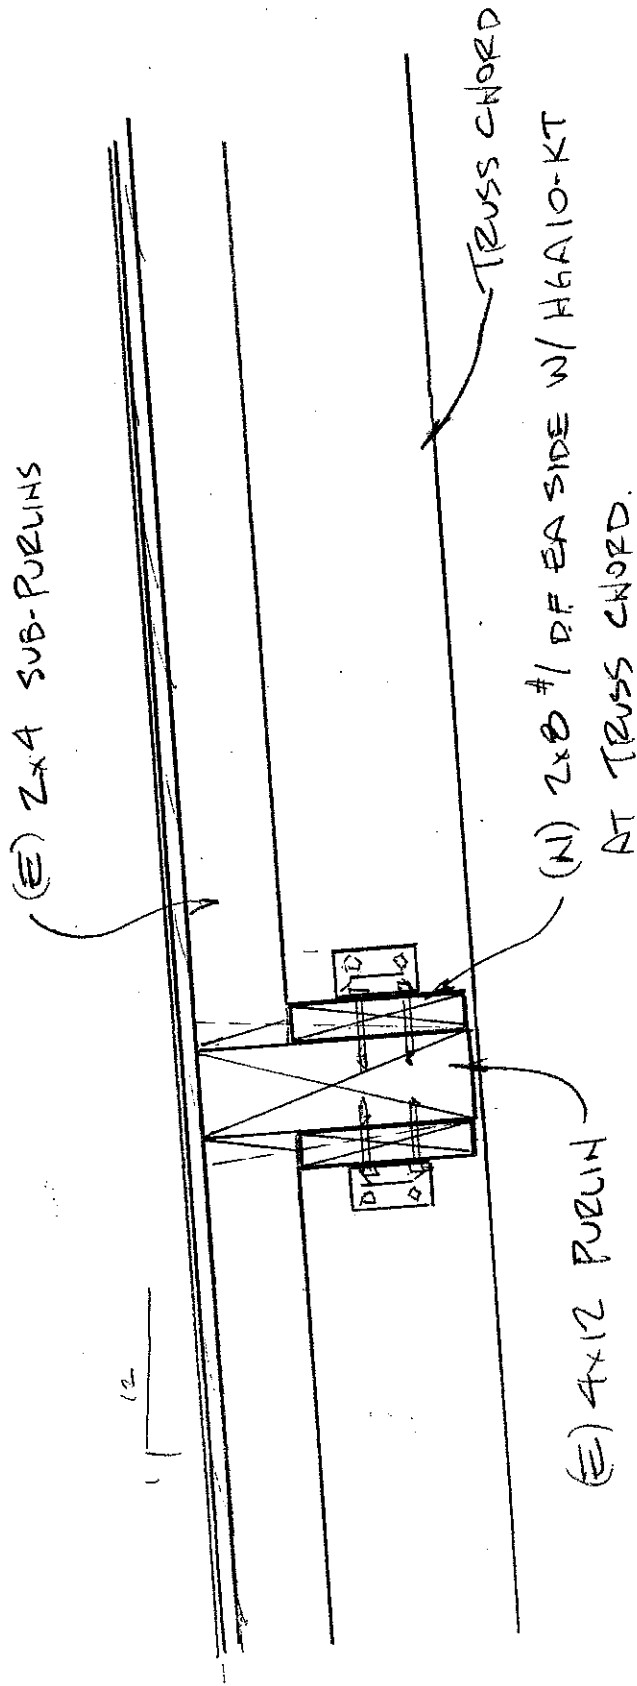
3 RETROFIT OF FAULTY PURLINS

This detail is based upon the idea that the 40-year performance of the existing purlins should be a legitimate factor in determining how many of them to reinforce with new parallel members. For contemporary design of a building in Fort Bragg with the geometry of Shed #4, the typical combination of purlin size and lumber grade present on Shed #4 would not be specified – they would be one size bigger. However, most of the purlins appear to have performed satisfactorily over their life to date, with a fire sprinkler system present. Unless the proposed new use of the building will place additional burden on these members, most of them should be ok as is, in the quantity noted on the detail.

It is assumed that all of the purlins will need the additional connection specified for wind uplift loads.

THIS IS REQ'D ONLY AT APPROX 15% OF (E) PURLINS.
 ASSUME REMAINDER OF PURLINS REQ. 2-5/16" x 6" LAG
 SCREWS INTO TRUSS CHORD (CAN SUBST. 1/4" x 6" SDS),
 FOR WIND UPLIFT ANCHORAGE. (PURLINS @ TRUSS JOINTS OK)
