CITY OF FORT BRAGG 416 N. FRANKLIN, FORT BRAGG, CA 95437 PHONE 707/961-2823 FAX 707/961-2802

COUNCIL COMMITTEE ITEM SUMMARY REPORT

MEETING DATE:	MARCH 11, 2020	
TO:	PUBLIC WORKS AND FACILITIES COMMITTEE	
FROM:	SANDY ARELLANO; PUBLIC WORKS PROJECT ANALYST	
AGENDA ITEM TITLE:	RECEIVE REPORT AND PROVIDE DIRECTION TO STAFF CONCERNING THE GUEST HOUSE MUSEUM POST CLOCK REPLACEMENT

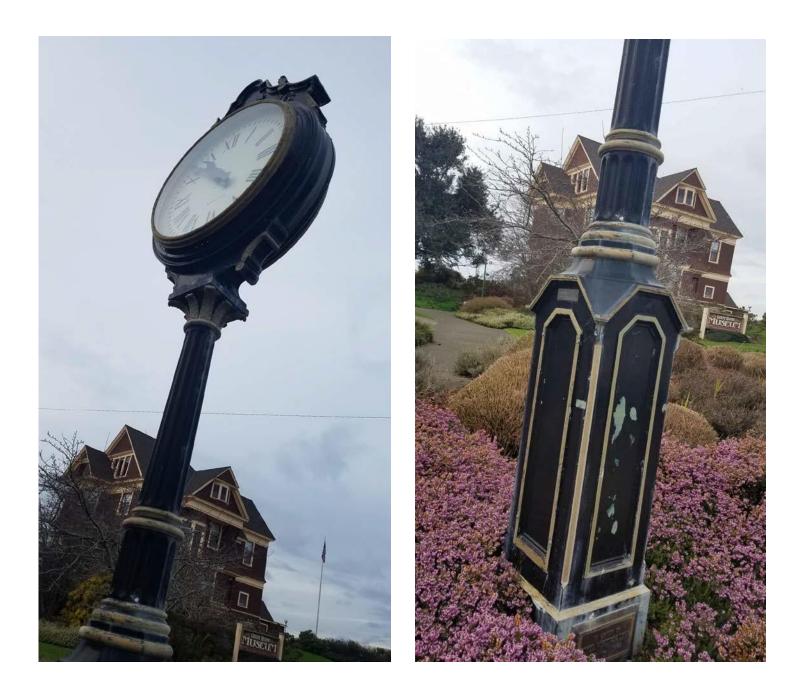
Attachment II

Images of the clock showing weatherized polycarbonate and corrosion

Staff recommends replacing the current clock with an exact replica as per the original provider's recommendations. The original clock provider Electric Time Co. Inc. are not only the lowest in cost for replacement bidder, they are also a well-known and distinguished commercial clock manufacturing company with impeccable reviews, and are highly recognized by their fellow competitors. They are also the only manufacturers to offer an anodized undercoat, which adds an additional layer of protection from our environments salty sea air which as we know is damaging to any surface. As far as the City's current staff is aware, the existing clock has been dysfunctional during the last decade and agree it is time to be replaced. The quoted price conforms to the budgeted funds available.

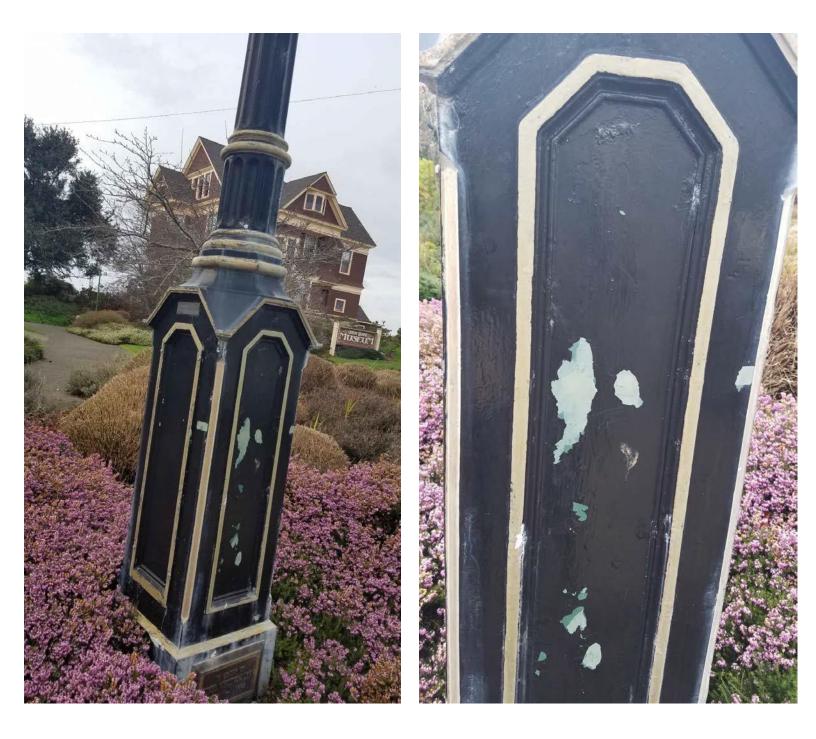
Attachment III

Close-up images showing erosion damage
