Noyo Center for Marine Science Marine Field Station

Sea Level Rise Adaptation Study

PREPARED FOR EHDD | NCMS
DECEMBER 2025

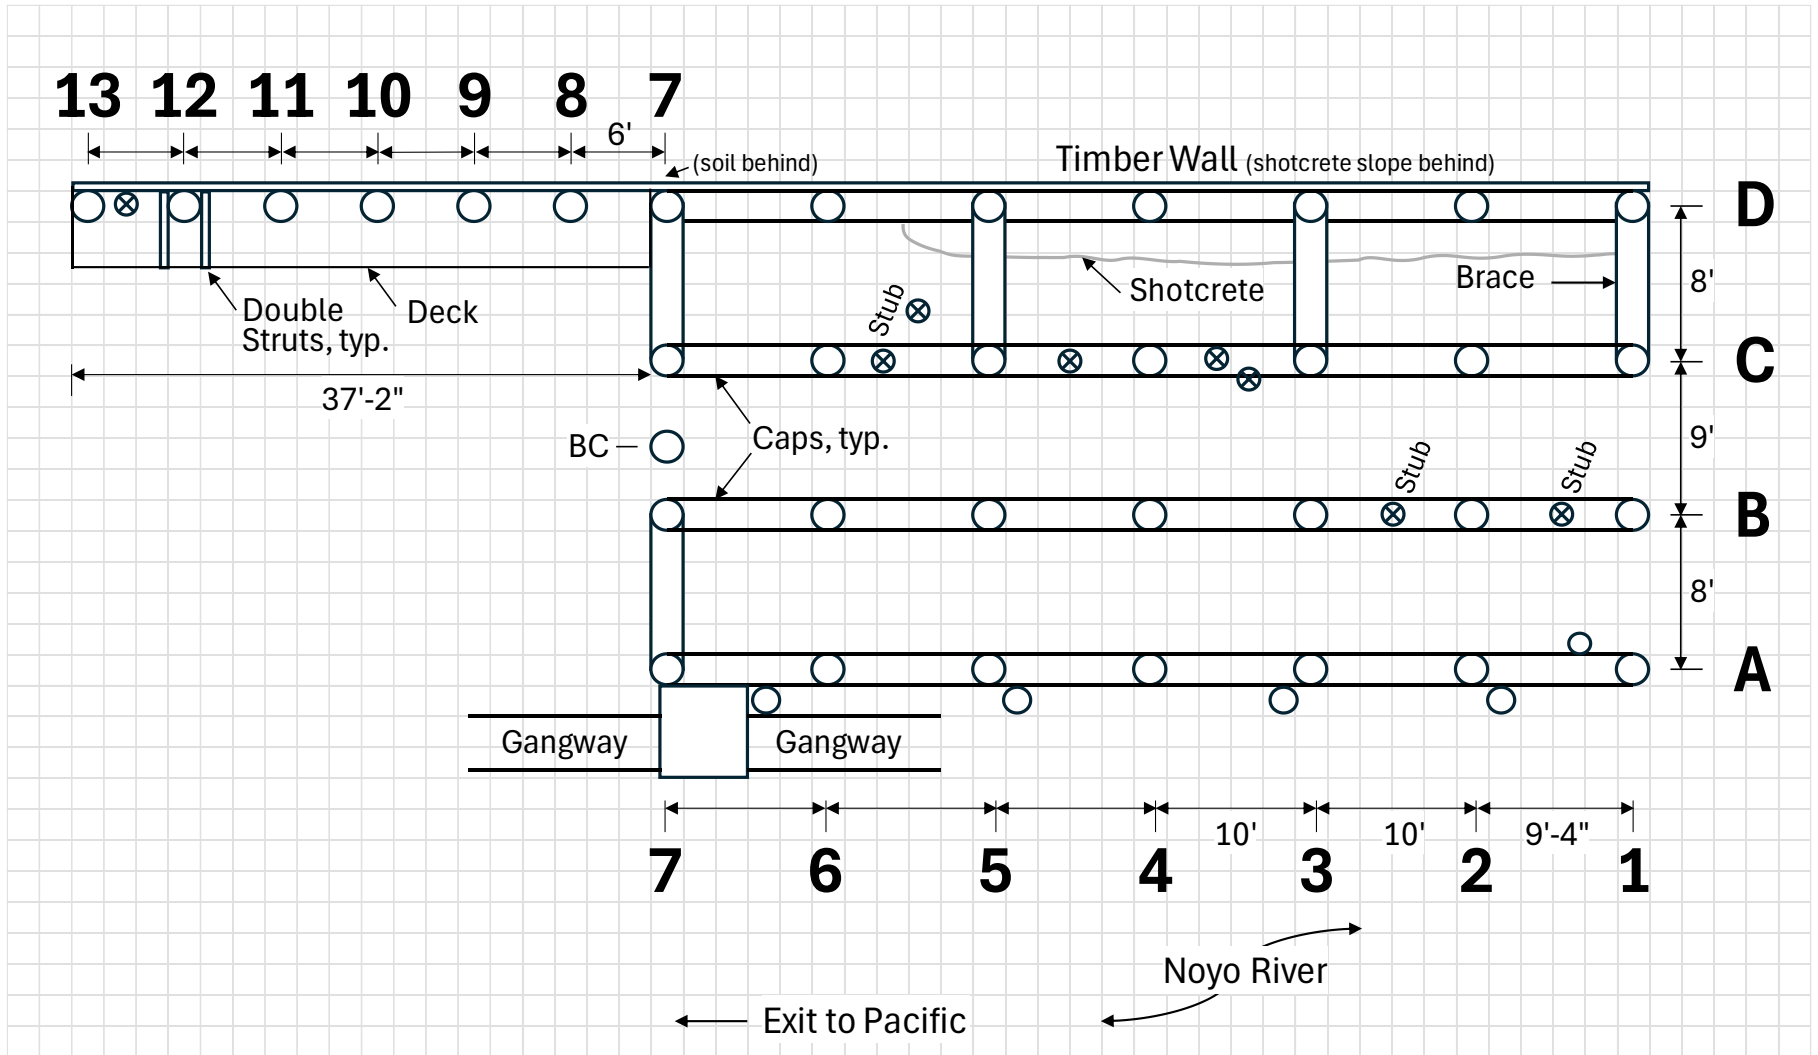
Figure A-1: Wharf Structure Inspection Plan.

Pile	Rating	Comment
D-1	No damage	3.5' stick
C-1	Minor	
B-1	Minor	
B-2	Minor	~14' stick. small bolt holes
B-3	Moderate	~14' stick
B-4	Moderate	~14' stick
B-5	Moderate	~16' stick
B-6	Major	~16' stick. Cracks/check ½" deep, extend down from soffit. Hollow sound. ~50% remain.
BC-7	Minor	~17' stick
B-7	Major	~17' stick. long check
C-7	Moderate	~10' stick. Hollow sounding slots 4' from soffit.
CD-7 brace	Moderate	Poor bearing at C-7. Ineffective
D-7	Moderate	~7' stick. ~25% loss
C-6	Minor	~10' stick.
D-6	Minor	~7' stick. Smaller dia. pile ≈10"
C-5	Minor	~9' stick. Small hole
CD-5 brace	Moderate	Some softness in intertidal zone
D-5	Moderate	6.5' stick. 10° batter in bent axis. ~25% loss
C-4	Severe	~10' stick. checks extend 5' from soffit 60% section loss 4' from soffit down 1 ft
D-4	Major	8' stick. Hollow. Backside missing. ~40% loss
C-3	Minor	8' stick
CD-3 brace	Minor	Fully bearing, a little softness at MHW
D-3	Minor	6' stick. crack gouge < ½"

D-2.75	Minor	6' stick. ~16" Ø butt, some softness at surface
C-2	Minor	8' stick. small holes/gouges
D-2	Minor	6' stick. ~16" Ø butt, a few surface level gouges
C-1	Minor	10' stick. ¼" check wide oozing creosote
CD-1 brace	Moderate	Small checks ≈ 1" deep
D-1	Minor	4' stick. 16" butt
A-7	Moderate	14.5' stick. Some surface softness at intertidal
A-6.5 fender	Top severe Major remaining	14.5' stick. guide pile/fender pile small amount of wear due to collar Hollowed at top down 32"
A-6	Minor	14.5' stick. ~1" deep checks at top ⅛" opening

Pile	Rating	Comment
A-5	Minor	13.6' stick. small check at top
A-4.75	Moderate	13.5' stick. checks \approx 1/2" wide. Guide pile / fender pile, wear at face from float
A-4	Minor	13.25' stick. Surface level gouges. Small checks at top
A-3.25	Minor to Major	13.75' stick, 3/8" wide checks. Guide pile / fender core eroded at top 19" down
A-3	Moderate	13.75' stick. Gouge 2" deep \times 6" wide
A-2	Minor	13.5' stick. No load transfer from cap (can move it with foot) Pile in minor condition
A-1.25	Major to severe	13.75' stick. Fender pile/guide checks > 0.5". Hollow at WL \sim 40-50% section loss
A-1.1	Moderate	13.75' stick, \sim 7" of bearing. 3" \varnothing gouge 1/2" deep at water 1/2" wide check extends to center
A-1	Minor	13.75' stick. \sim 18" \varnothing butt, bearing and guide pile.
D-8	Moderate	8.5' stick
D-9	Moderate	
D-10	Moderate	
D-11	Moderate	Smaller \varnothing than others

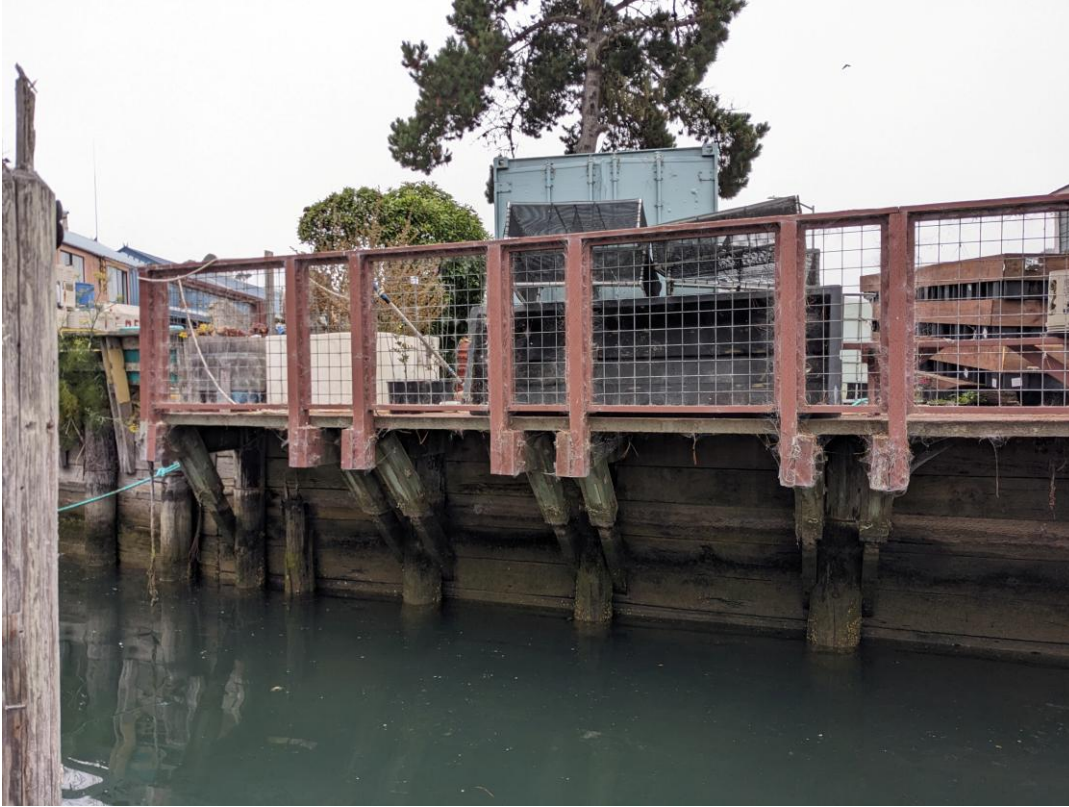
Timber wall and deck along yard looking northwest.

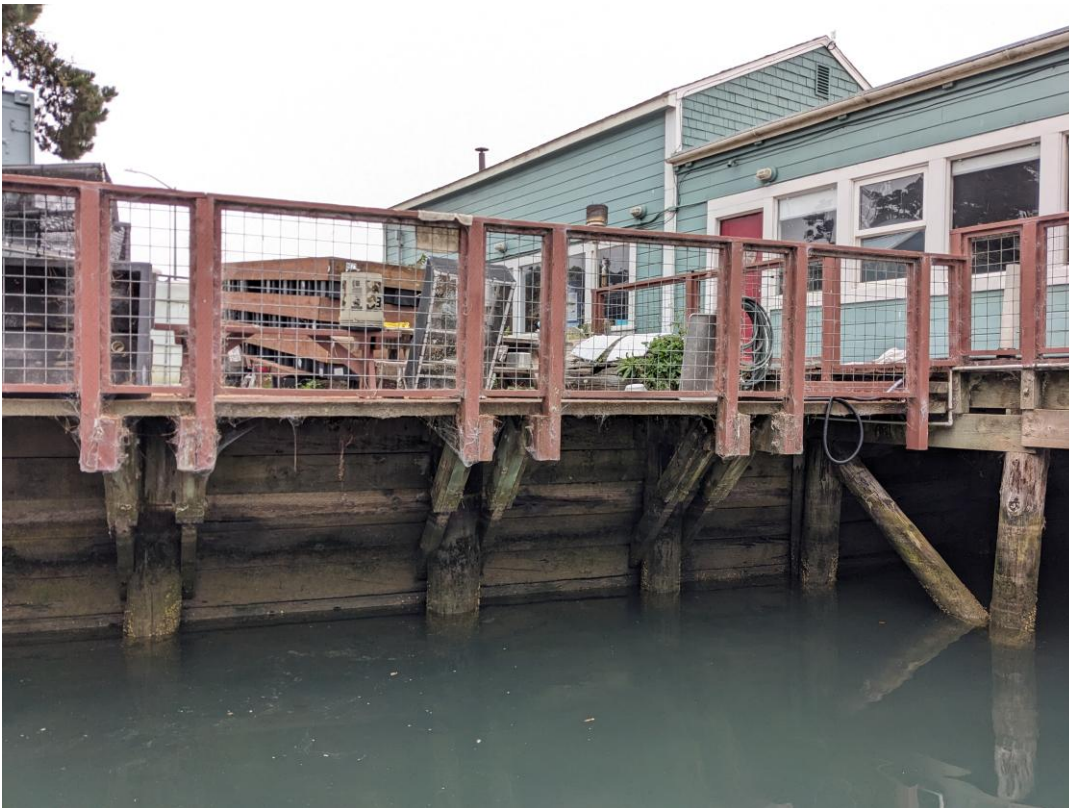
Timber wall and deck along yard looking northeast.

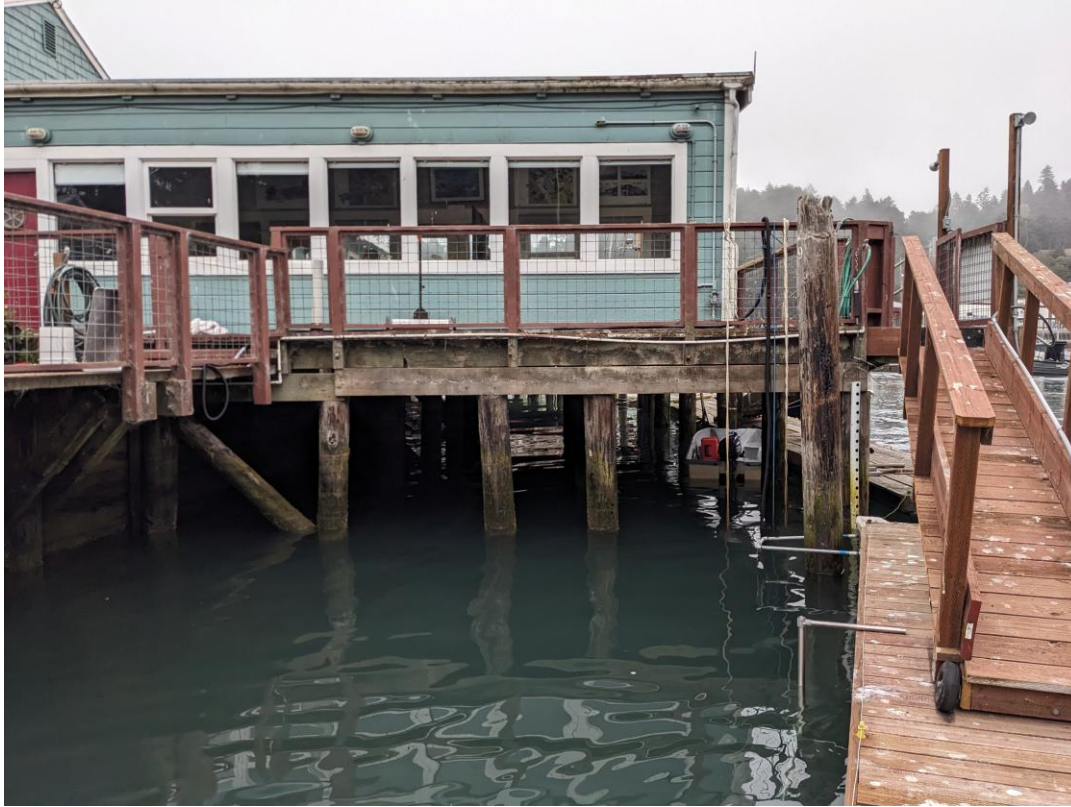
View of pile-supported and deck gangway looking east.

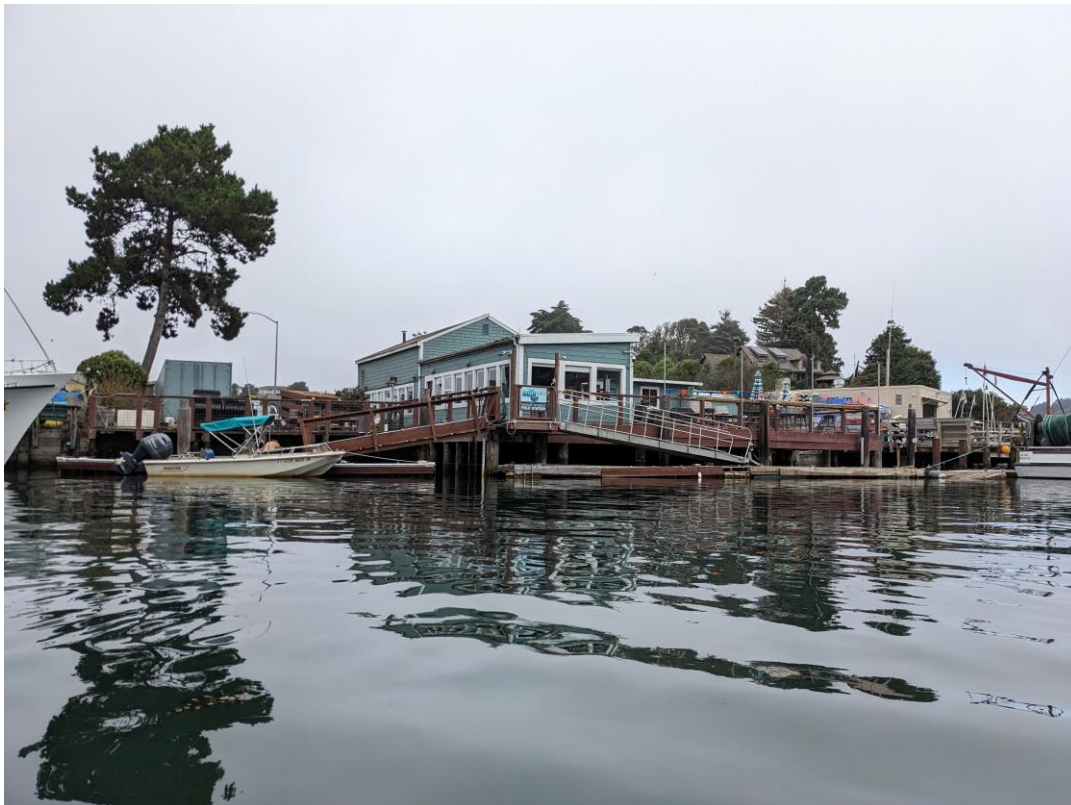
Waterside view of Marine Field Station looking north.

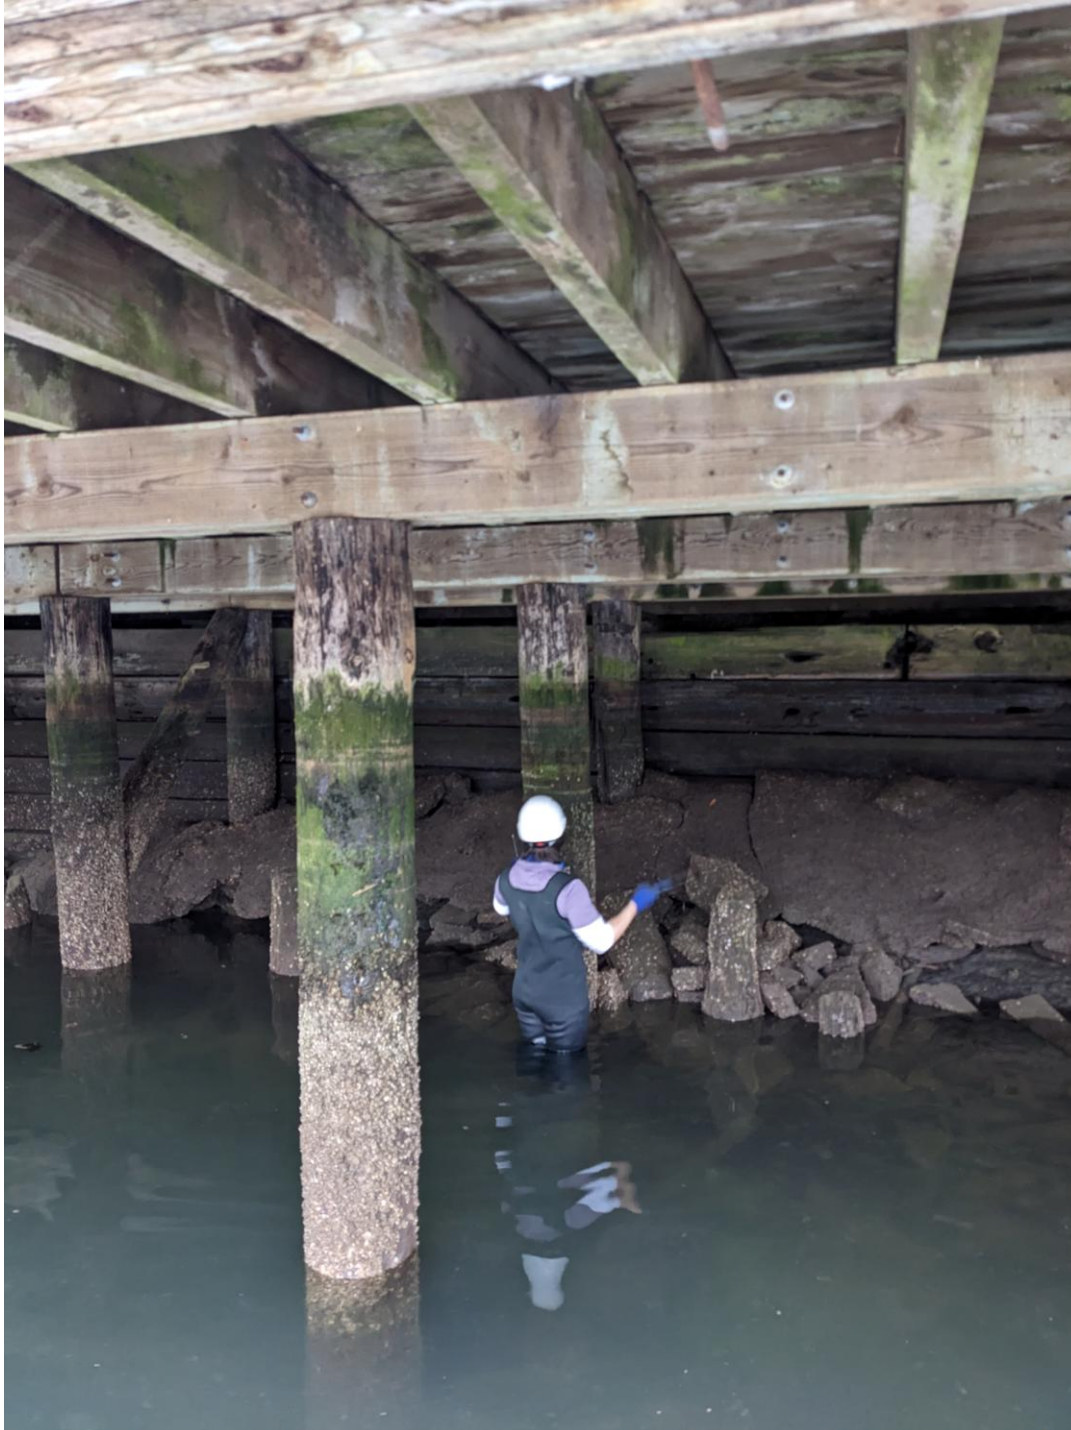
View under deck, shotcrete over riprap above waterline.
