FORT BRAGG FREIGHT TERMINAL

TECHNICAL MEMORANDUM

Geotechnical Exploration
Proposed Development
1280 North Main Street, Fort Bragg, California

**STORMWATER CONTROL PLAN AND
NO DISCHARGE TECHNICAL REPORT
FOR
DIRECT TRANSFER FACILITY
1280 NORTH MAIN STREET
FORT BRAGG, CALIFORNIA**

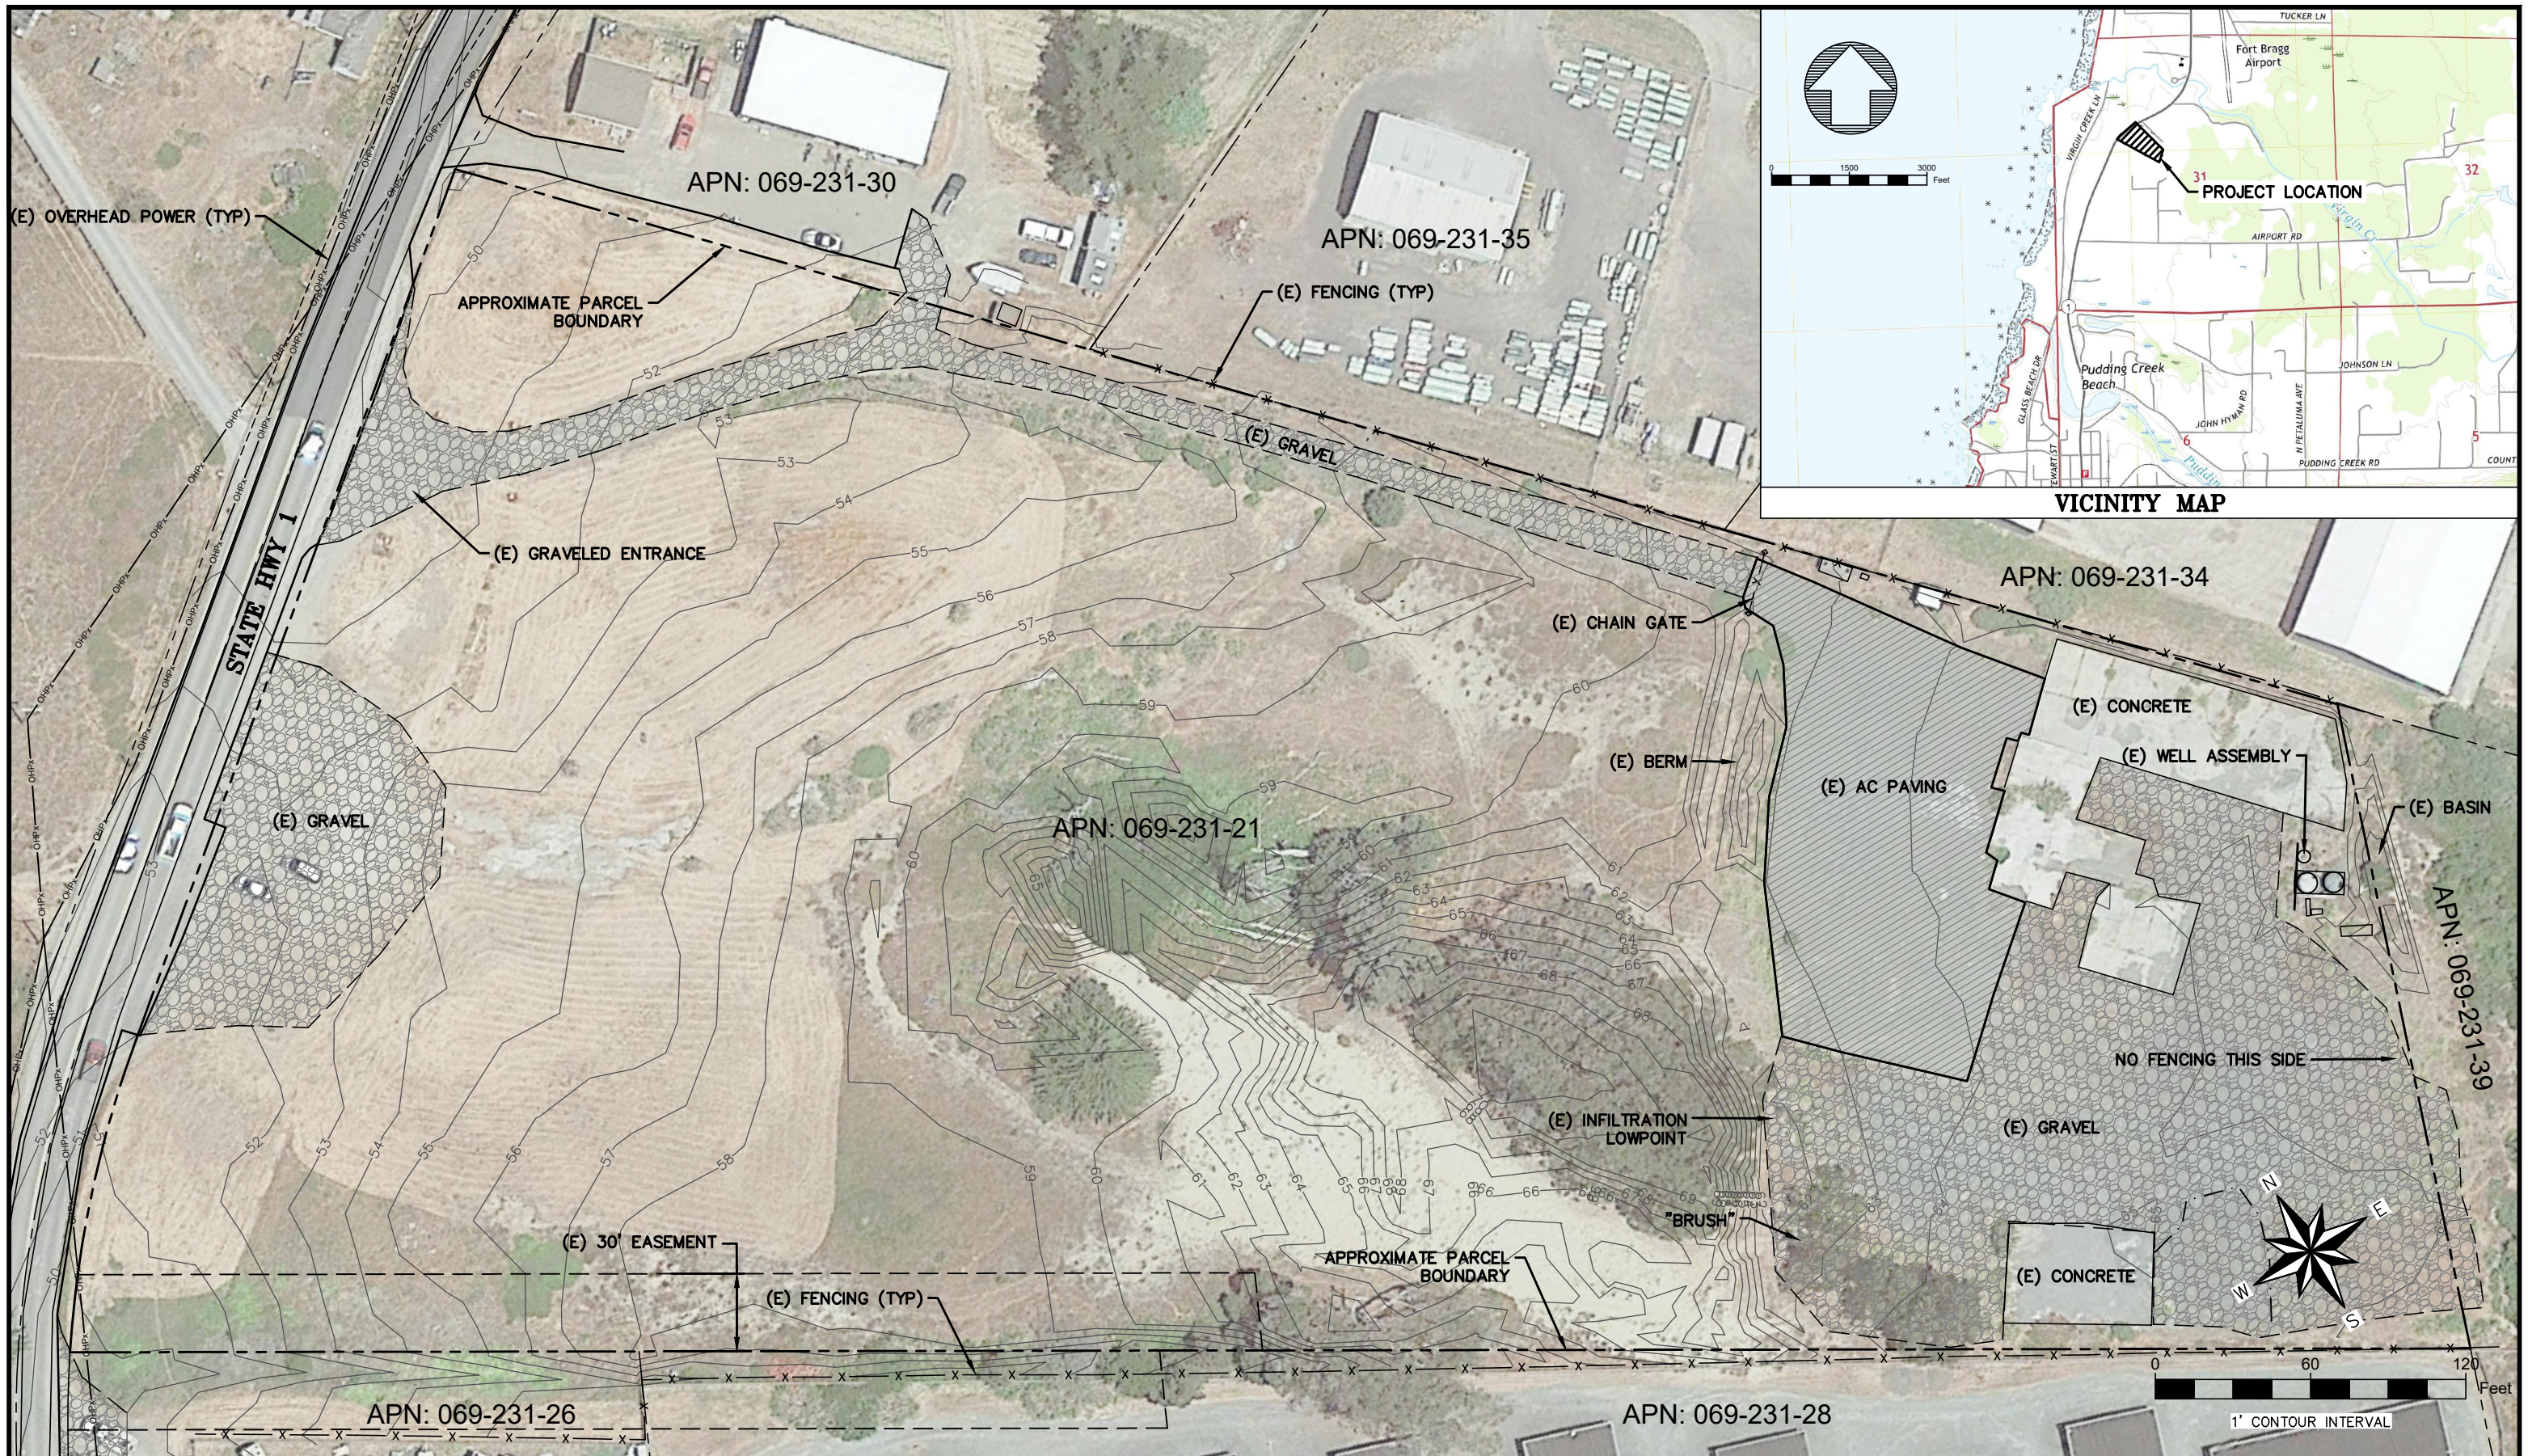
DRAWING: FIGURE 1
SHEET: OF
DATE: 8/3/2022

EXISTING CONDITIONS

1. RE-PAVE EXISTING DRIVEWAY (ENCROACHMENT PERMIT REQUIRED BY CALTRANS FOR RE-PAVING).
2. INSTALL FENCING AS SHOWN. ALL NEW FENCING SHALL BE 2-INCH MESH AT LEAST 5-FEET IN HEIGHT WITH T-POST (OR SIMILAR) SUPPORTS AT 10-FOOT INTERVALS.
3. EXISTING BIOLOGICAL RESOURCES INTENTIONALLY NOT SHOWN IN DETAIL ON THIS DOCUMENT, REFER TO BIOLOGICAL RESOURCE REPORT.
4. NEW LOADING RAMP TO BE CONSTRUCTED IN THE SIZE AND LOCATION SHOWN. RAMP SHALL INCLUDE A SLOPED RAMP ON THE SOUTHEAST SIDE, THEN AN UPPER LEVEL "UNLOADING" AREA. PEDESTRIAN HANDRAIL SHALL BE PROVIDED ON THE TWO SIDES OF THE RAMP WITH NO RAILING AT THE UNLOADING/LOADING TRANSITION.
5. NEW GATED ENTRY TO BE COORDINATED WITH ADJACENT OWNER. ANTICIPATE CHAIN LINK SWING GATE WITH SLATS.
