Rural Recreation and Tourism Grant Application for Multi-Rec Room and Gym Rehab

HEATHER GUREWITZ, MCRP

COMMUNITY DEVELOPMENT DEPARTMENT

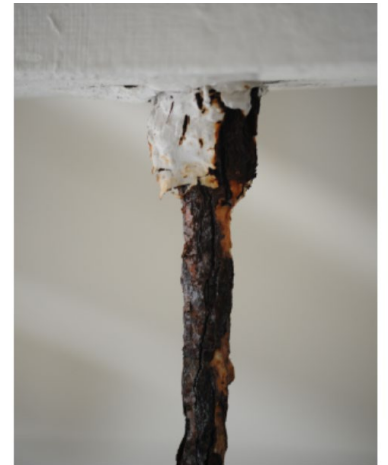
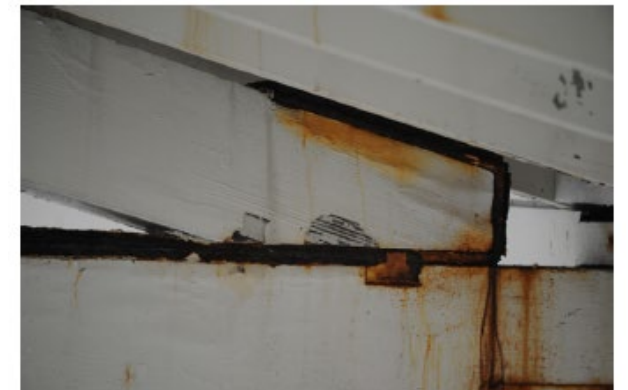
2010 Structural Report Contd.

“The most immediate concern involves the pool building. Years of a corrosive environment from pool chlorine and lack of proper maintenance has caused significant corrosion and rusting of the steel components. The following areas are the most critical:

- The catwalk at the west end of the building has badly deteriorated steel rod support hangers (see photo, this page). We cannot determine a reliable capacity for these members.
- The pool truss heel connections are also severely deteriorated (see photo, this page). It is assumed that the bolts through the connection have not corroded to the same extent as the exposed steel plate and are providing the strength in this connection but it is not readily apparent.”
