# STRUCTURAL AND USE STUDY OF CITY HALL EAST

PREPARED for  
**CITY OF FORT BRAGG**

MAY 2010

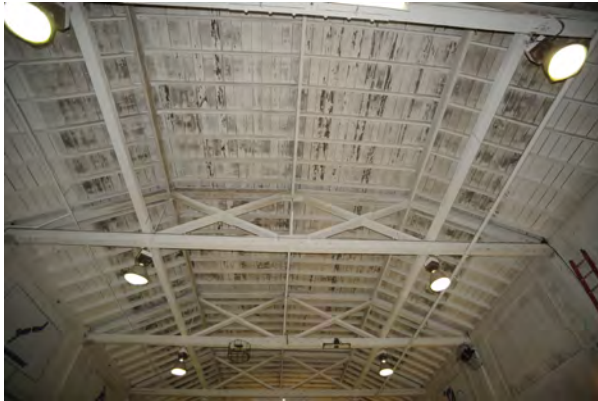
TRUSS AND GYMNASIUM

The main trusses in both buildings are made of heavy timber with steel connections and are exposed. The Gym truss is similar to a Gambrel Truss with crossed web members instead of single diagonals. The truss and its connections appear to be in good condition.

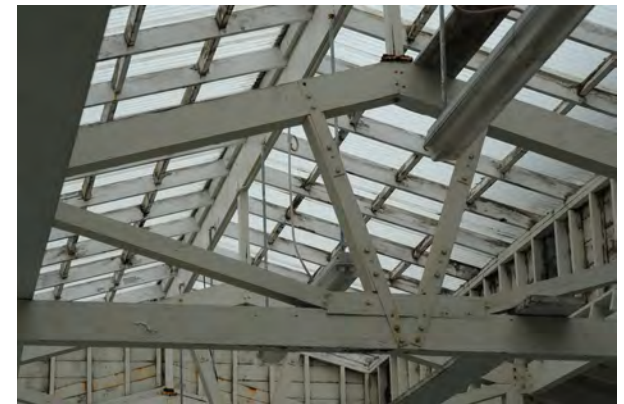
The pool truss is a classic Howe Truss that has been modified since the original construction. The connections are showing heavy corrosion and deterioration, with the worst exhibited at the heel joints. The condition of the steel plates at the joint are severely deteriorated.

TRUSS AND ATRIUM AT POOL
