***Re: November 27, 2017 City Council Meeting Regarding  
Dry Shed #4 Coastal Development Permit and Demolition***

Subject: Coastal Development Permit Application  
Former Georgia-Pacific Wood Products Facility  
90 West Redwood Avenue, Fort Bragg, Mendocino County, California

### **Coastal Development Permit Application**

Subject: Structural Assessment of Storm Damage  
Dry Shed No. 4  
Georgia-Pacific  
Fort Bragg, California  
K/J 1665018\*04

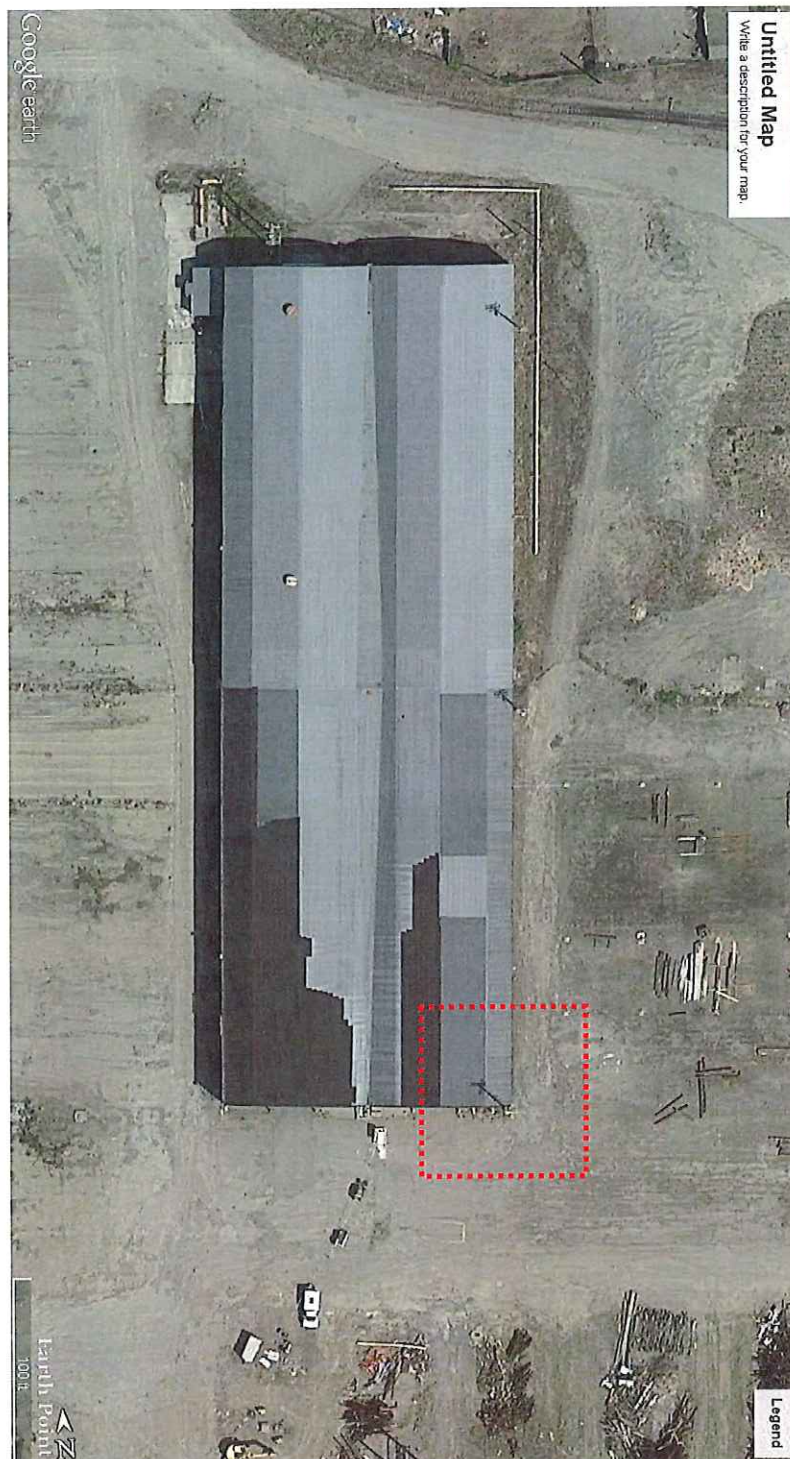
**Figure 1: Building Restriction Area**

inside and outside the building in the general vicinity. The loss of additional roof framing or damage to wall framing could cause the south wall of the building to become unstable requiring shoring or bracing. The Owner should take measures to restrict activities in the general vicinity shown in Figure 1. Do to the limited intended remaining use of the building we would not recommend further non-destructive testing of building materials or exploratory removal, sampling, testing or physical measurements of the overall structure. As previously noted, it is clear that the physical properties of the construction materials have degraded significantly with water and wind related damage to the plywood sheathing and wall and roof structural wood framing members. The loss of the modified bitumen roof waterproofing material from many areas of the south half of the building has contributed to the degradation of the wood roof framing.
