# **Fort Bragg Wetland Report**

Best Development Group, Sacramento, California

March 2021

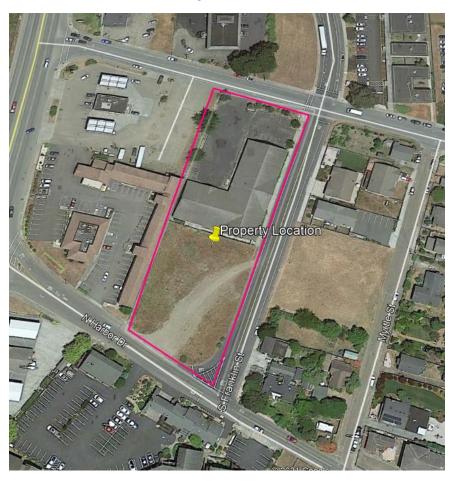
Figure 1

The parcel property consists of three lots located on the west side of South Franklin Street in the south-central part of Fort Bragg. The legal location includes portions of the Northwest ¼ of Section 18, Township 18 North, Range 17 West (Figure 1). The northern most parcel is a paved parking lot with the center parcel covered with a large building. The southern parcel is vacant and therefore the subject area of this report.

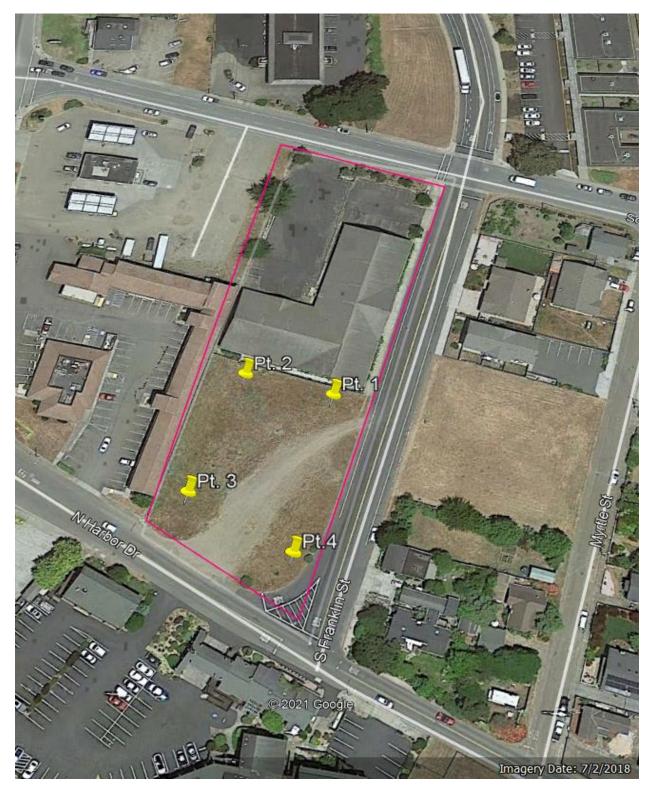
Figure 2 Test Plot Locations

No indicators of any type of wetland, stream course, vernal pools or vernal swales were found on the site. There were a limited number of wetland plants found but their frequency of presence was insufficient to constitute a wetland site. There was no evidence of hydric soil nor any wetland hydrology found. No part of this parcel may be considered a wetland area. Table 1 summarizes the data collected at each test plot location.

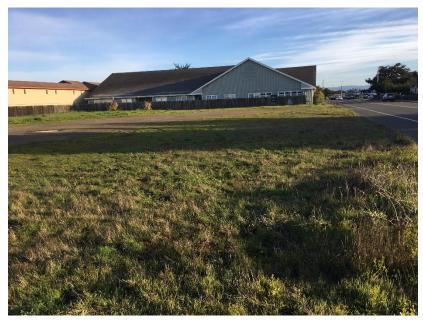
Photo 1 looks north across the southern parcel with South Franklin Street on the right. The building in the center is on the middle parcel. Annual grasses and forbs dominate the south parcel as seen in the photo, no wetlands are evident.

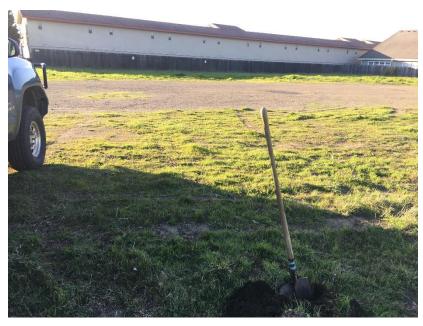
Photo 2 is taken at Sample Plot 4 looking north west across the southern parcel. The fence in the distance is the western edge of the parcel. No wetlands are evident.
